Cogges Link Road: Jacobs Observations on Extent of Flooding July 2007

Site visits were carried out on 25 July 2007 by two Jacobs personnel in connection with the CLR project. Their report included photographs, the locations of which are shown in Plan 1.

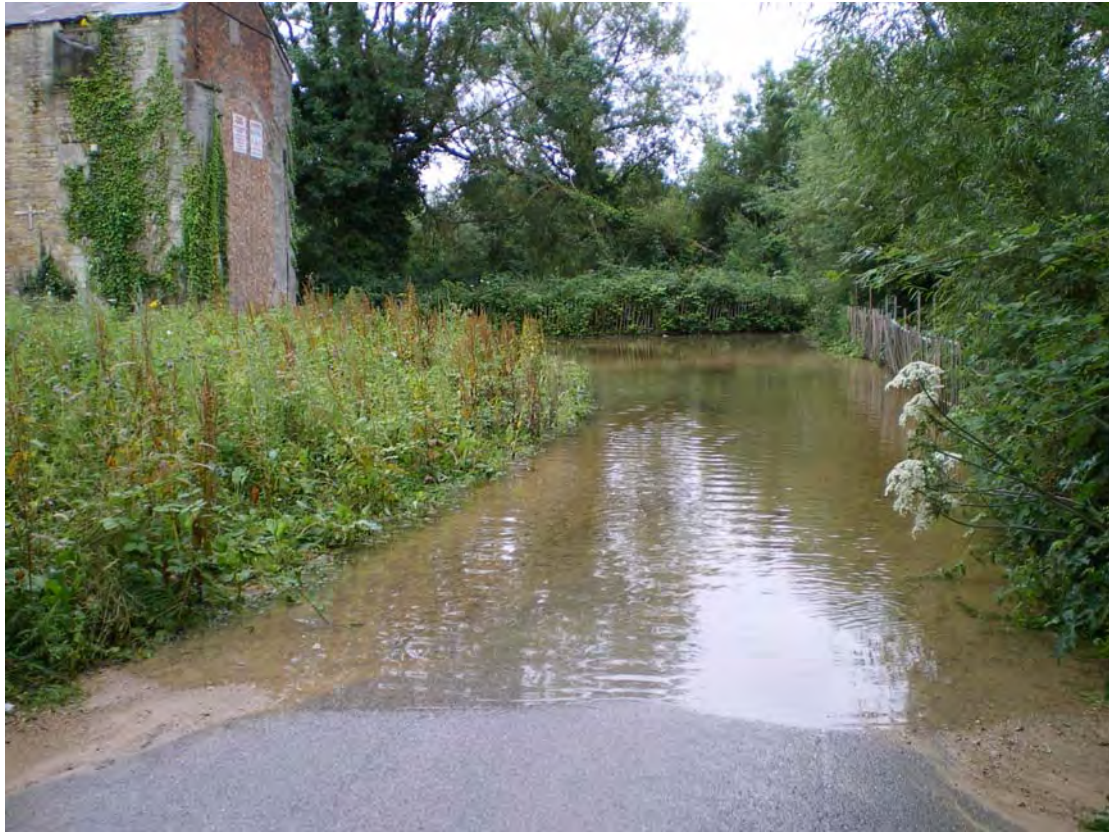
Photograph 001 Flooding on the access road by the mill where the water seems to have come from the channel to the west of the mill.

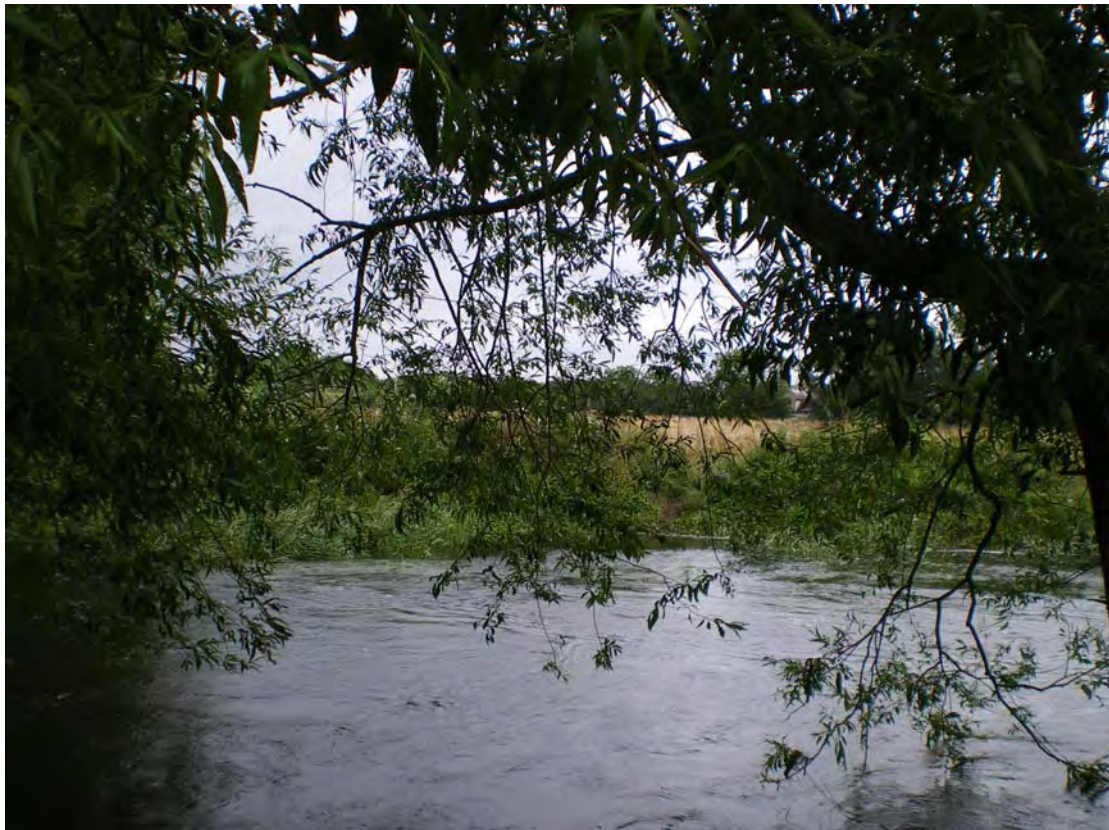
Photograph 002 East bank of the East Channel of the Windrush. There was no evidence of the bank being overtopped or even that the waters of the Windrush had reached the top of the bank as they had done on the west bank.

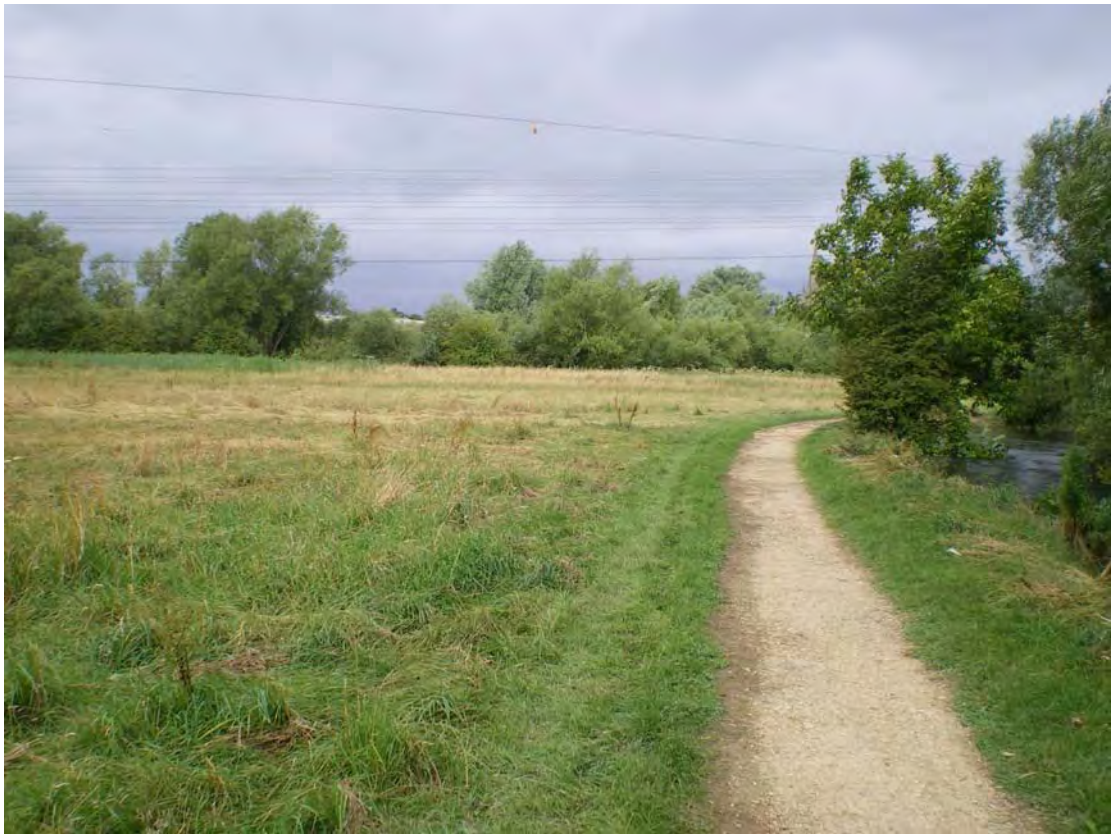
Photograph 003 View from the south showing two areas of vegetation flattened by out of river flooding which are marked on the copy of the photograph in Appendix 2.

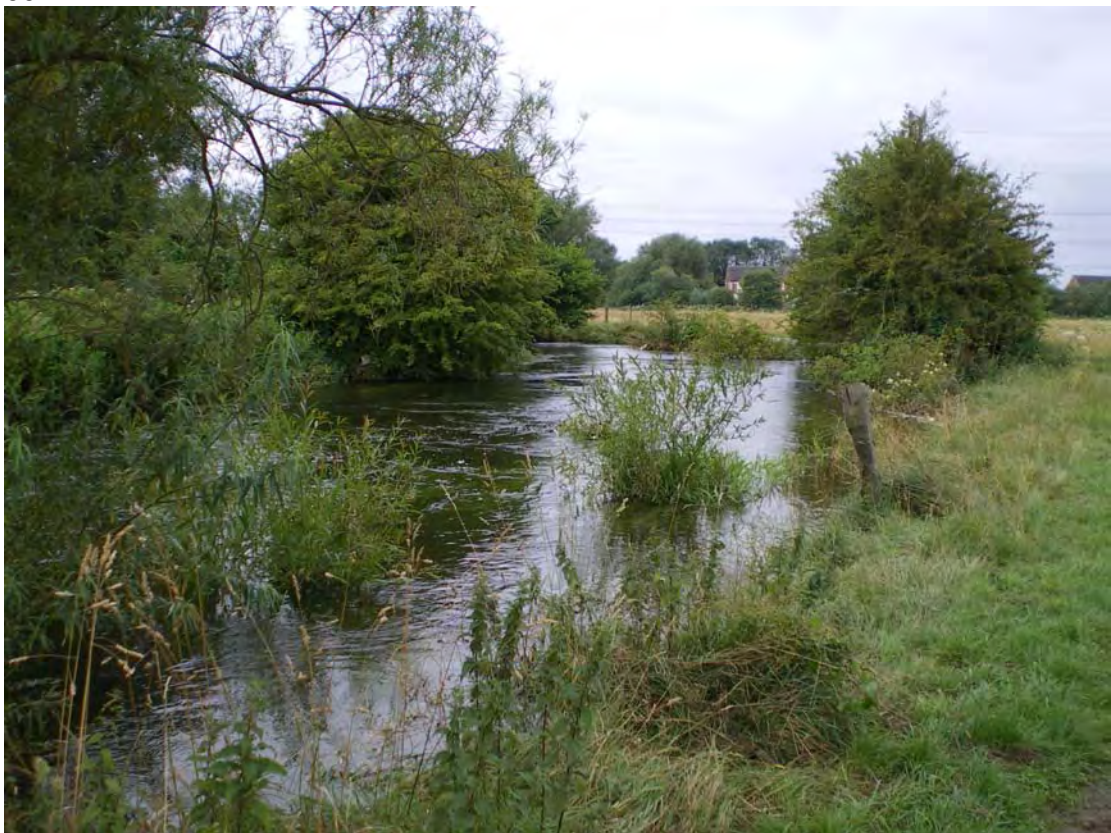
Photograph 004 A fairly typical view downstream of the water coming over the lower edge of the bank as outlined by the trees and shrubs but not overtopping the entire bank and flooding the country park.

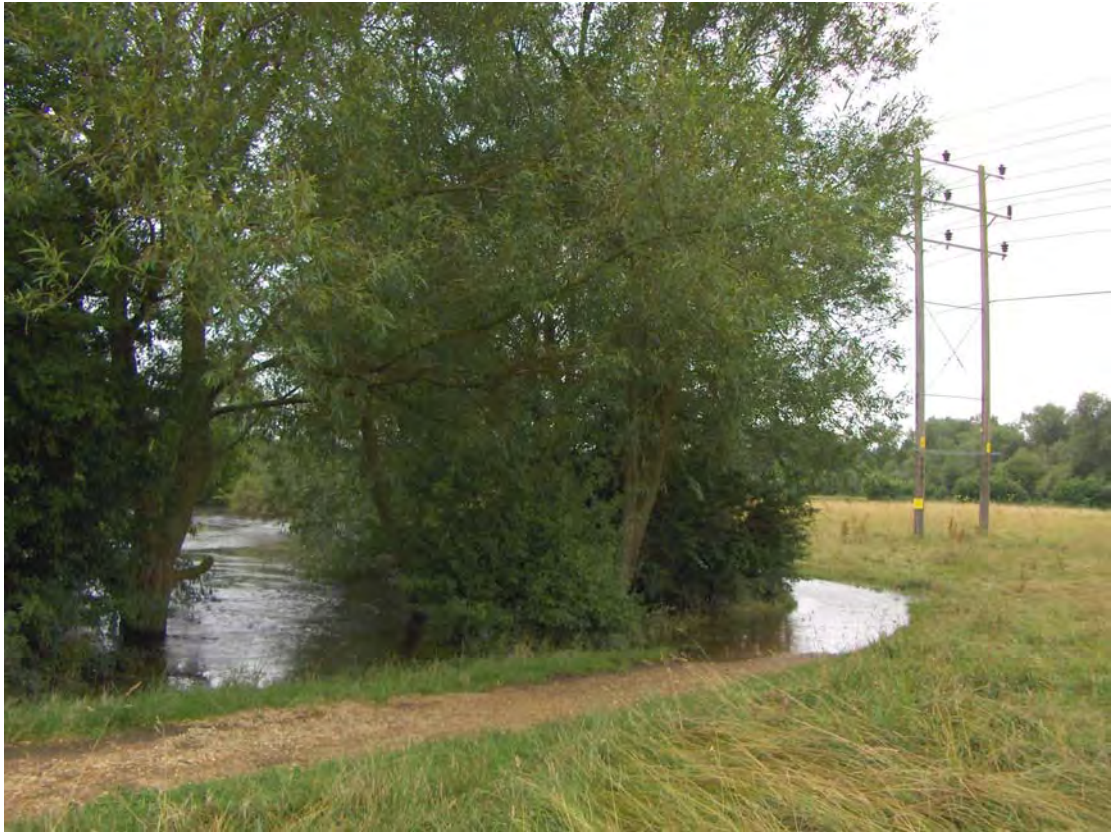
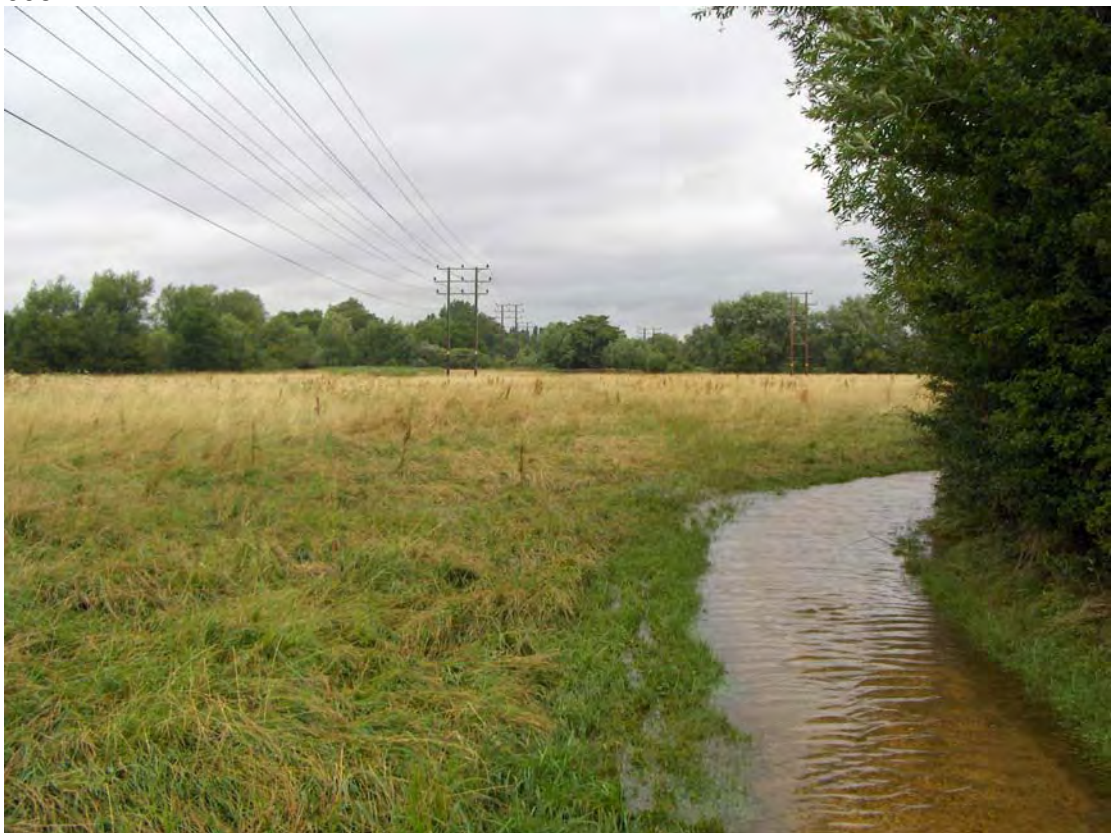
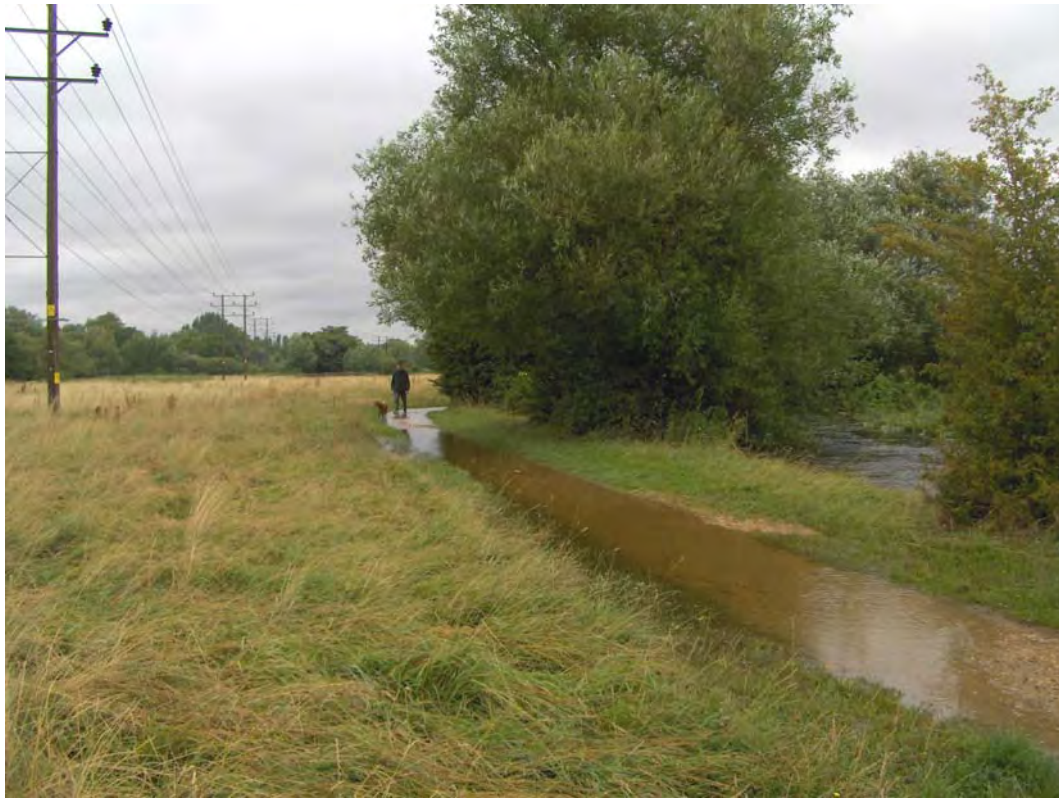
Photograph 005 – 007 Flooding was still in evidence where the East Channel of the Windrush had topped the bank at a bend in the river.

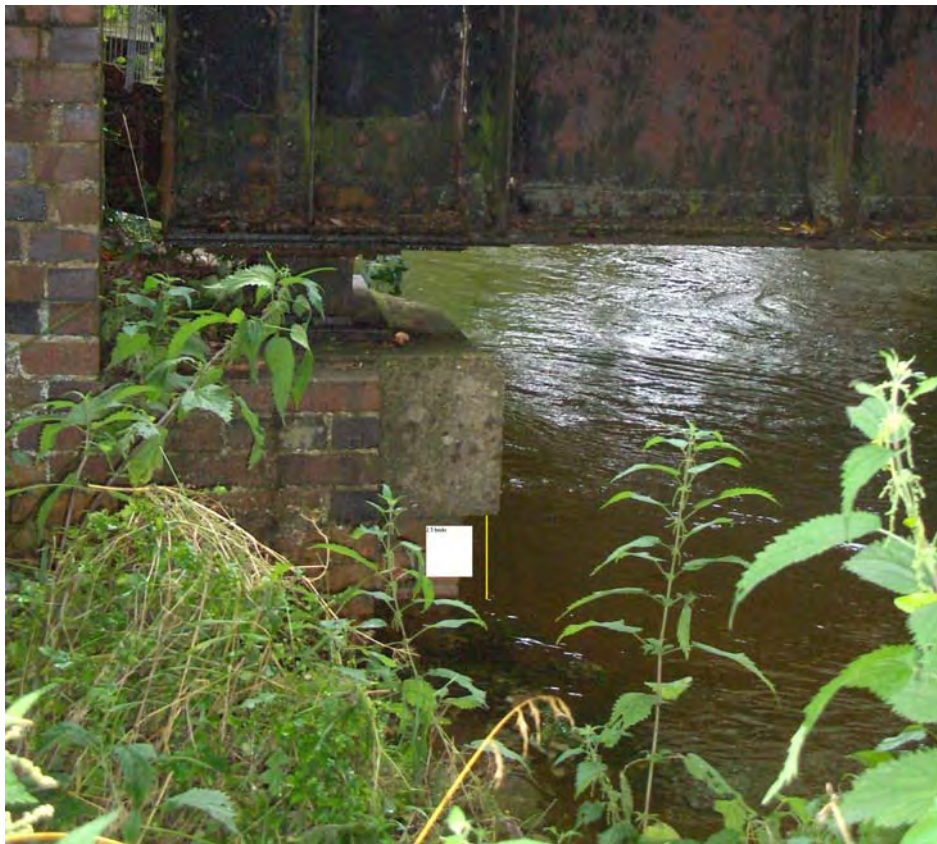
Photograph 008 At the derelict railway crossing of the East Channel. The water level was about 2.5 bricks below the concrete overhang.

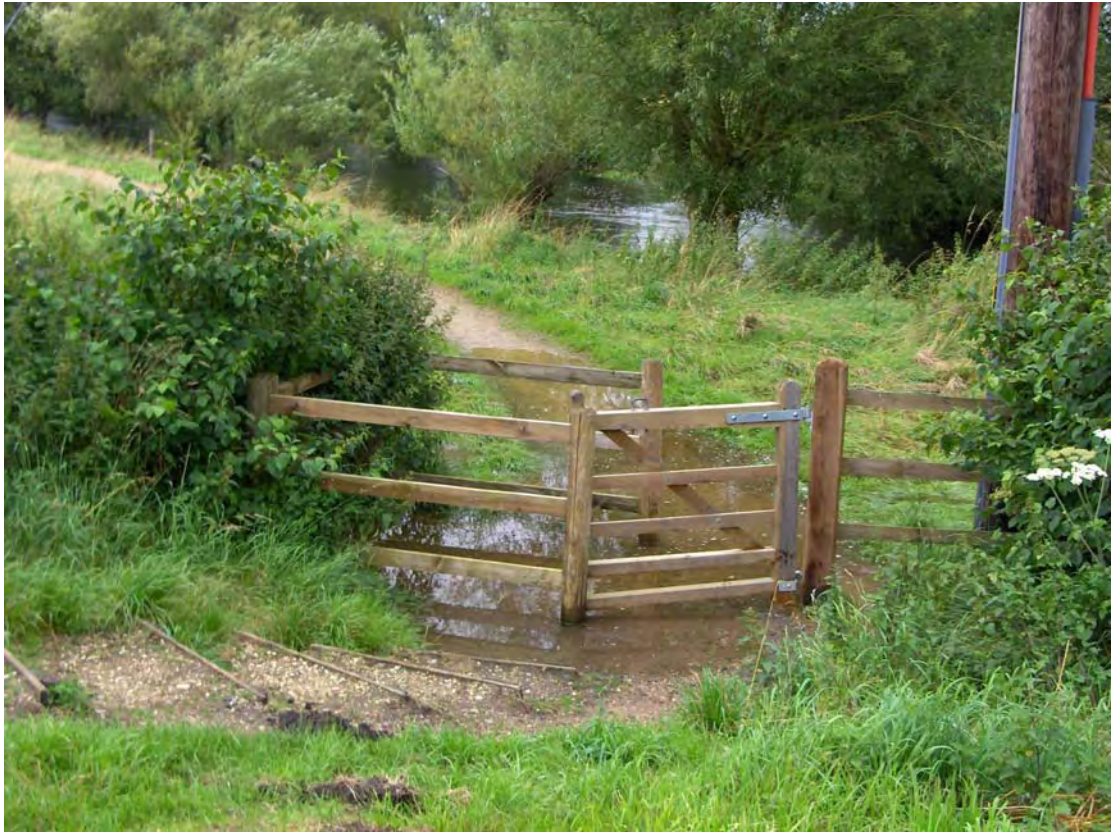
Photograph 009 The standing water seen at the gates was continuous with the water level in the river.

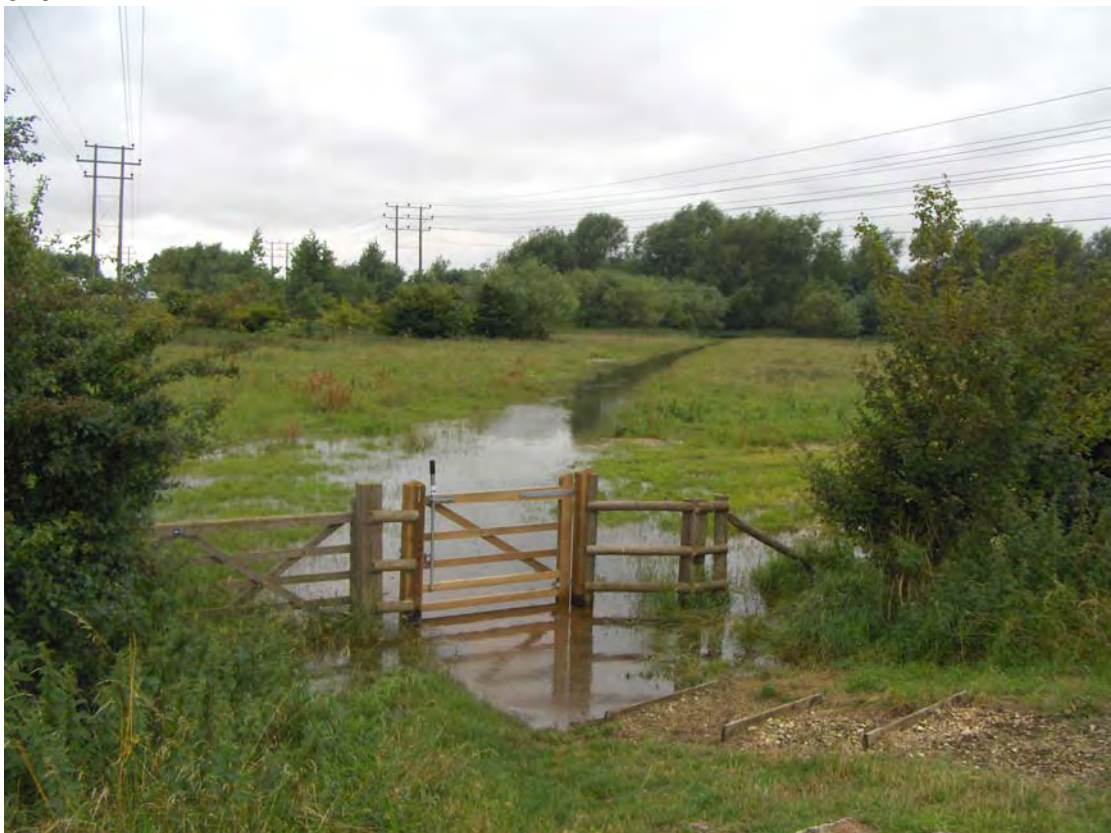
Photograph 010 The central part of the field was waterlogged with standing water along the line of the footpath.

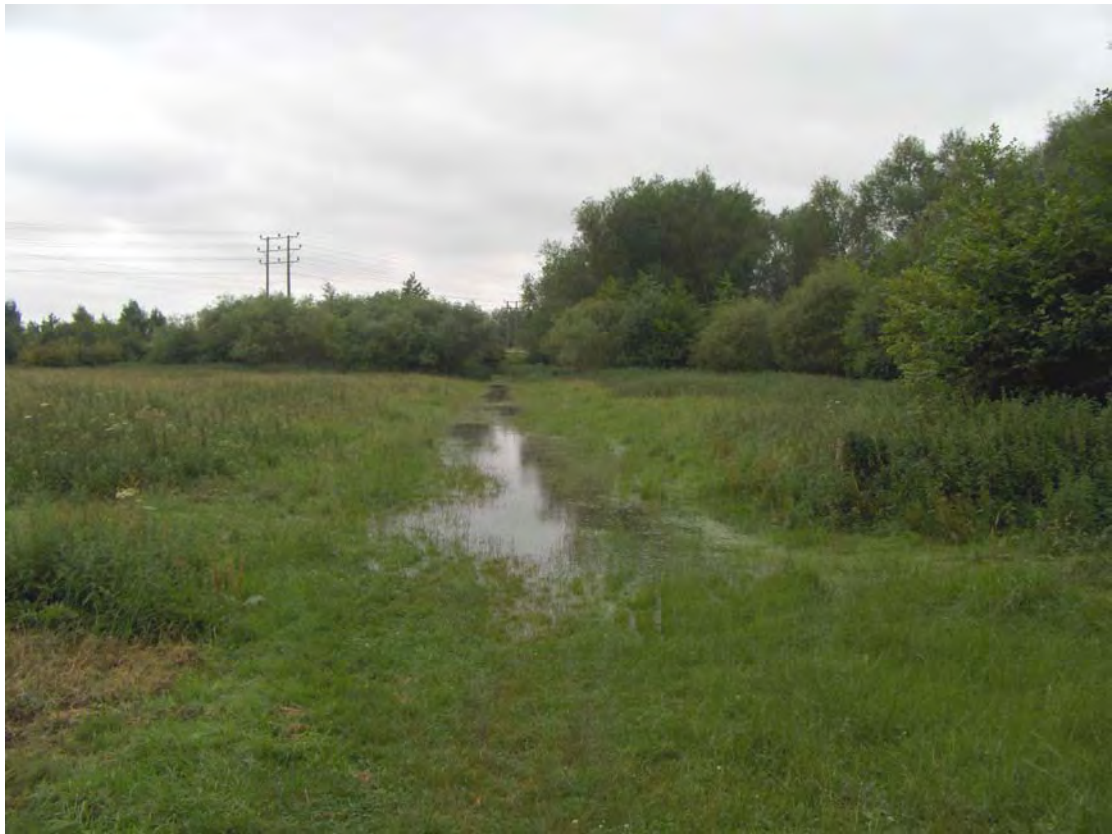
Photograph 011 The land either side of the footpath was waterlogged.

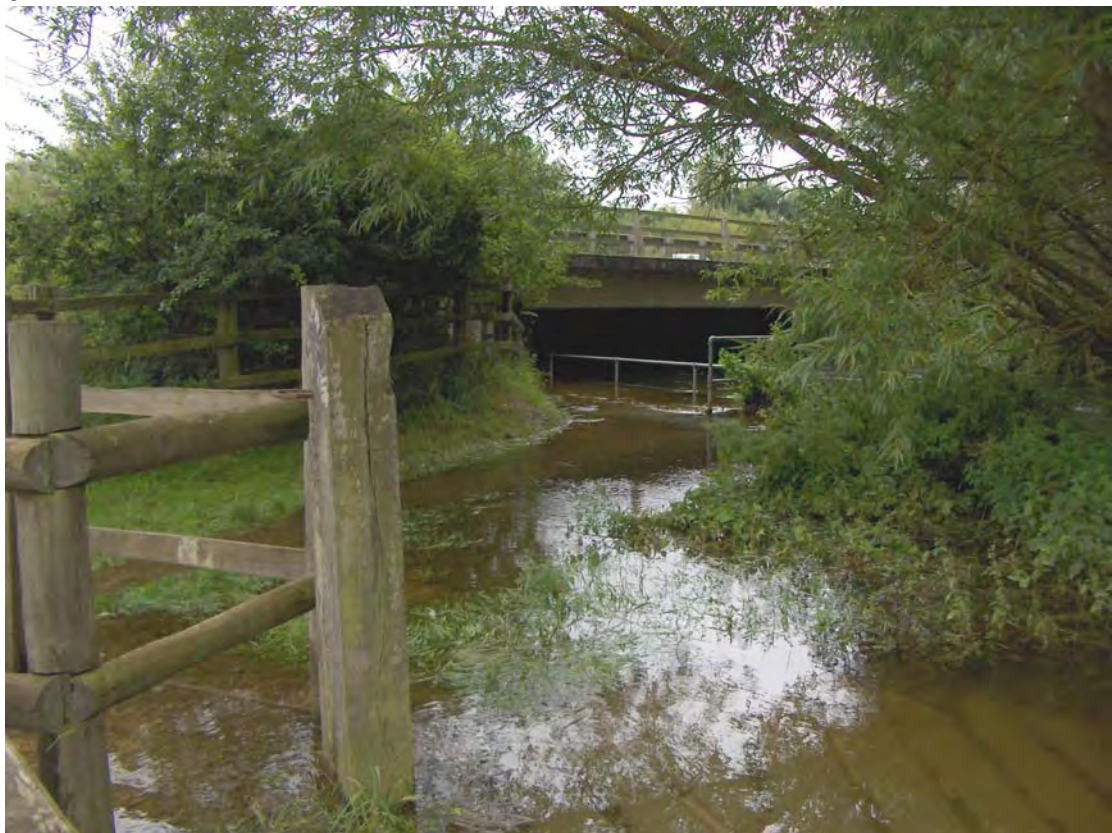
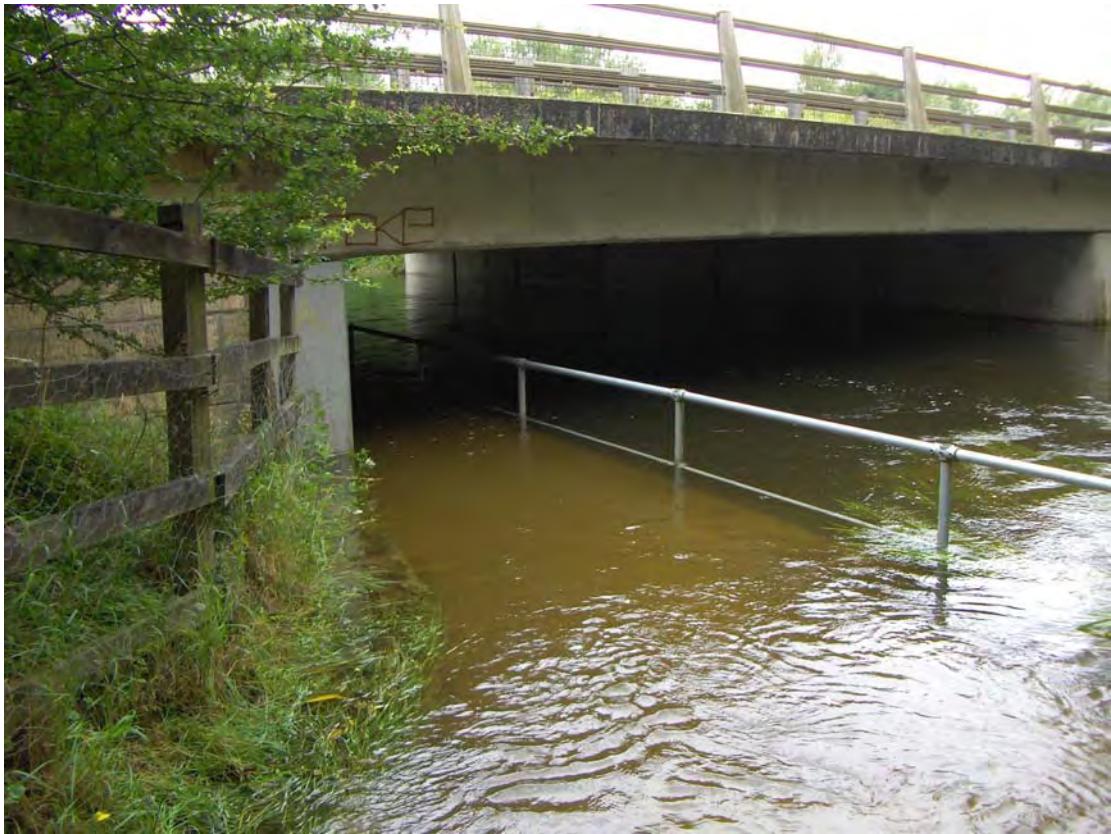
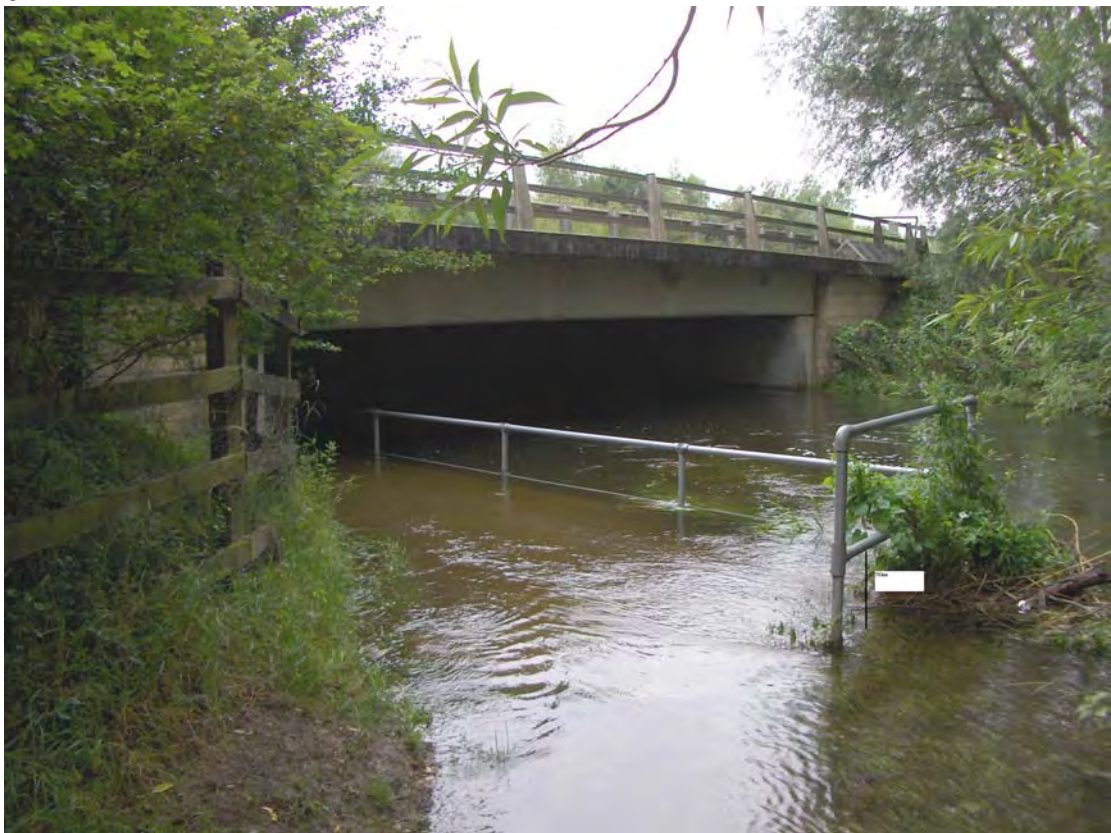
Photographs 012 -14 The banks had been overtopped on the east bank at the A40 overbridge of the West Channel. The dimension marked between the water level and the base of the rail on Photograph 14 is 350mm

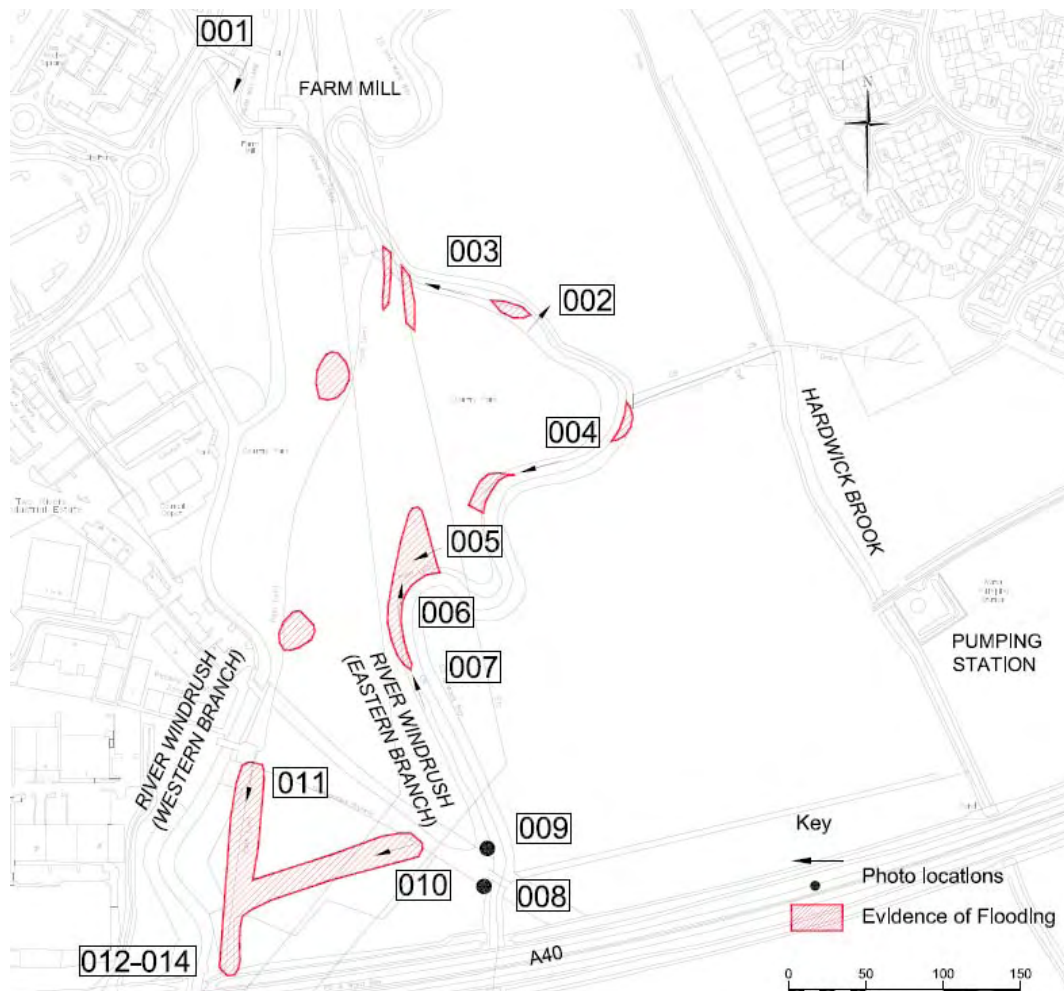
Plan 1 showing locations of evidence of flooding and photographs

- The level of water at the south side of the culvert beneath the mill was at soffit level.
- The level of the water was noted at two further locations – see Photographs 008 and 014
- The areas seen to be flooded or where evidence was seen of recent flooding are marked approximately on Plan 1.
