NEWBRIDGE

Maintenance & Strengthening Feasibility Study

JUNE 2008

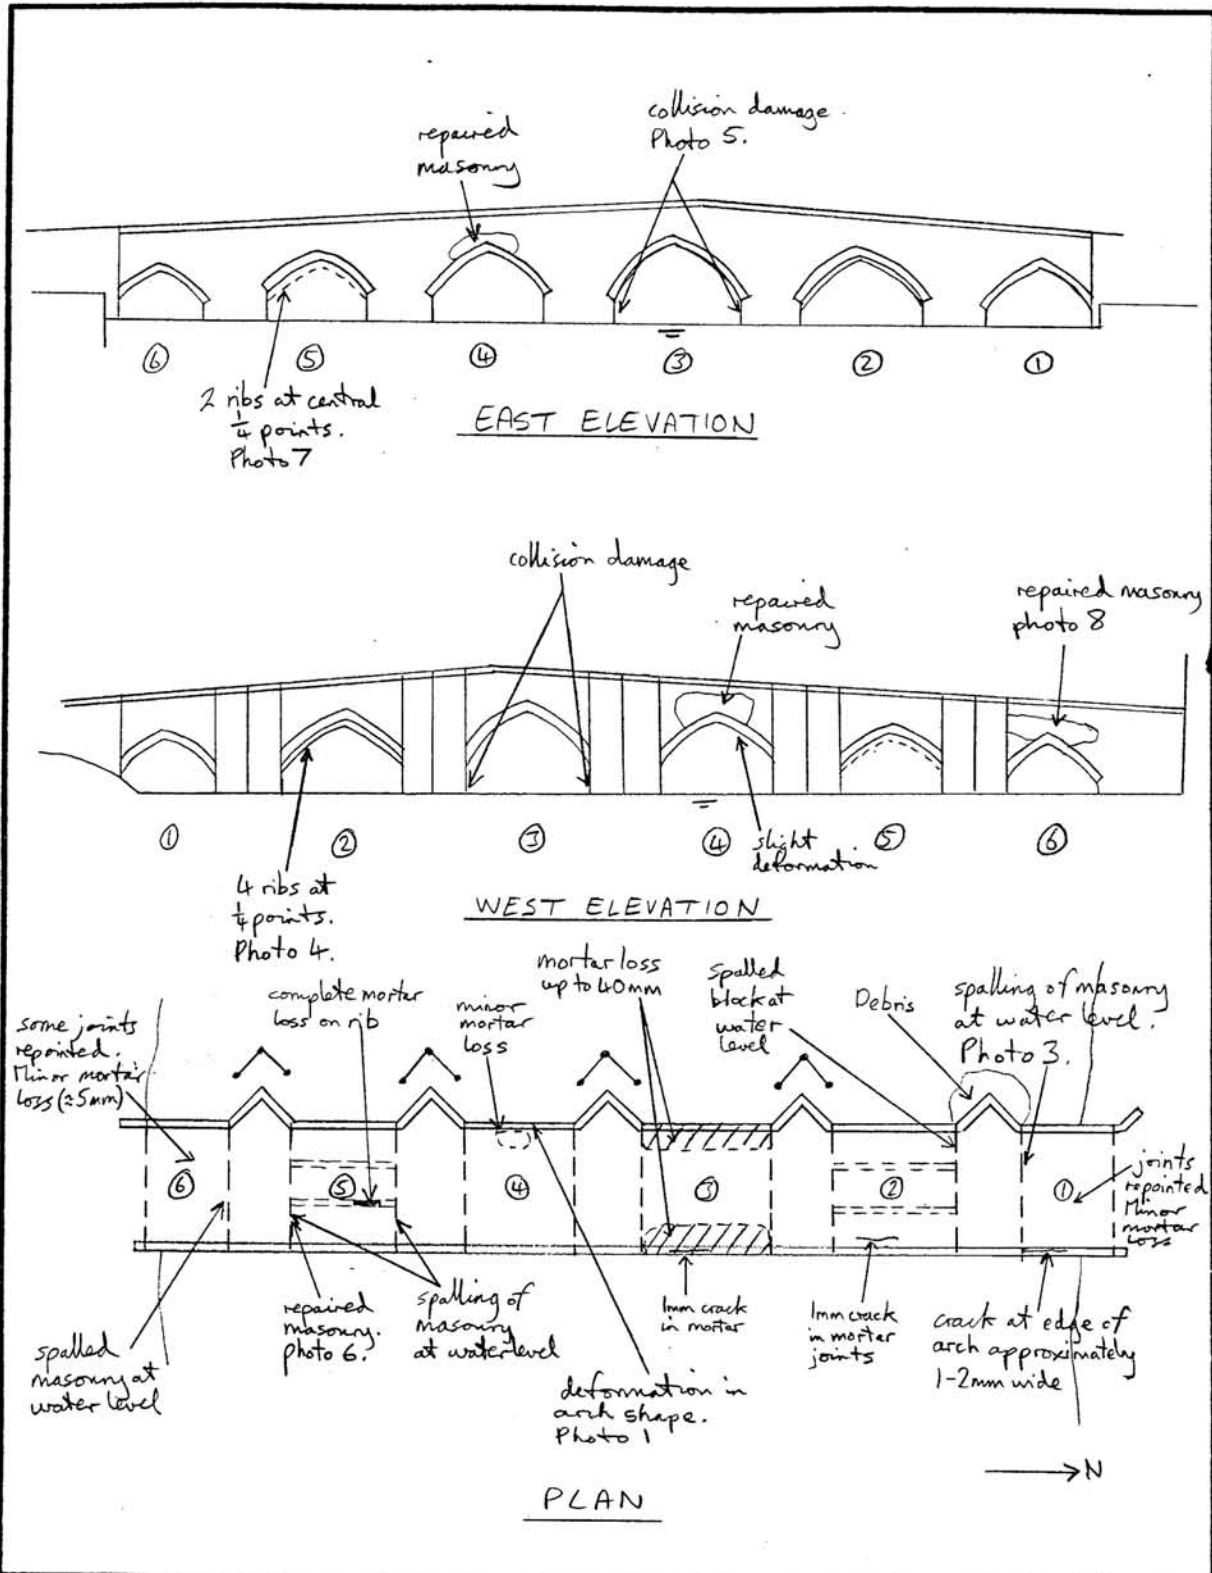
Project OXFORD BRIDGE INSPECTIONS (GROUP 26)		Drawn S. Pallatt
Title NEW BRIDGE OCC NO. 90		Scale N.T.S.
		Date DEC 93
		Checked
		Approved
		Drg. No. B2562/90/SK 1

The bridge is reported as being in generally good condition, with a few defects in each arch – small longitudinal cracks towards the edge of the arch barrels in arches 1, 2 and 3; spalled masonry up to 10mm at the water level; minor mortar loss in all arches; and collision damage to piers beneath arch 3 from boats. A slight deformation of arch four's west elevation was reported. The defects were accounted for in the 1993 Stage 1 Assessment with reduced factors, which were also used in the 1996 Stage 2 Assessment. A copy of defect drawing from the report, Drg. No. B2562/90/SK1, is included in appendix C.

The inspection recommended filling and monitoring of the longitudinal cracks, and repointing of the joints where necessary. Also pier damage beneath arch 3 needed repair.

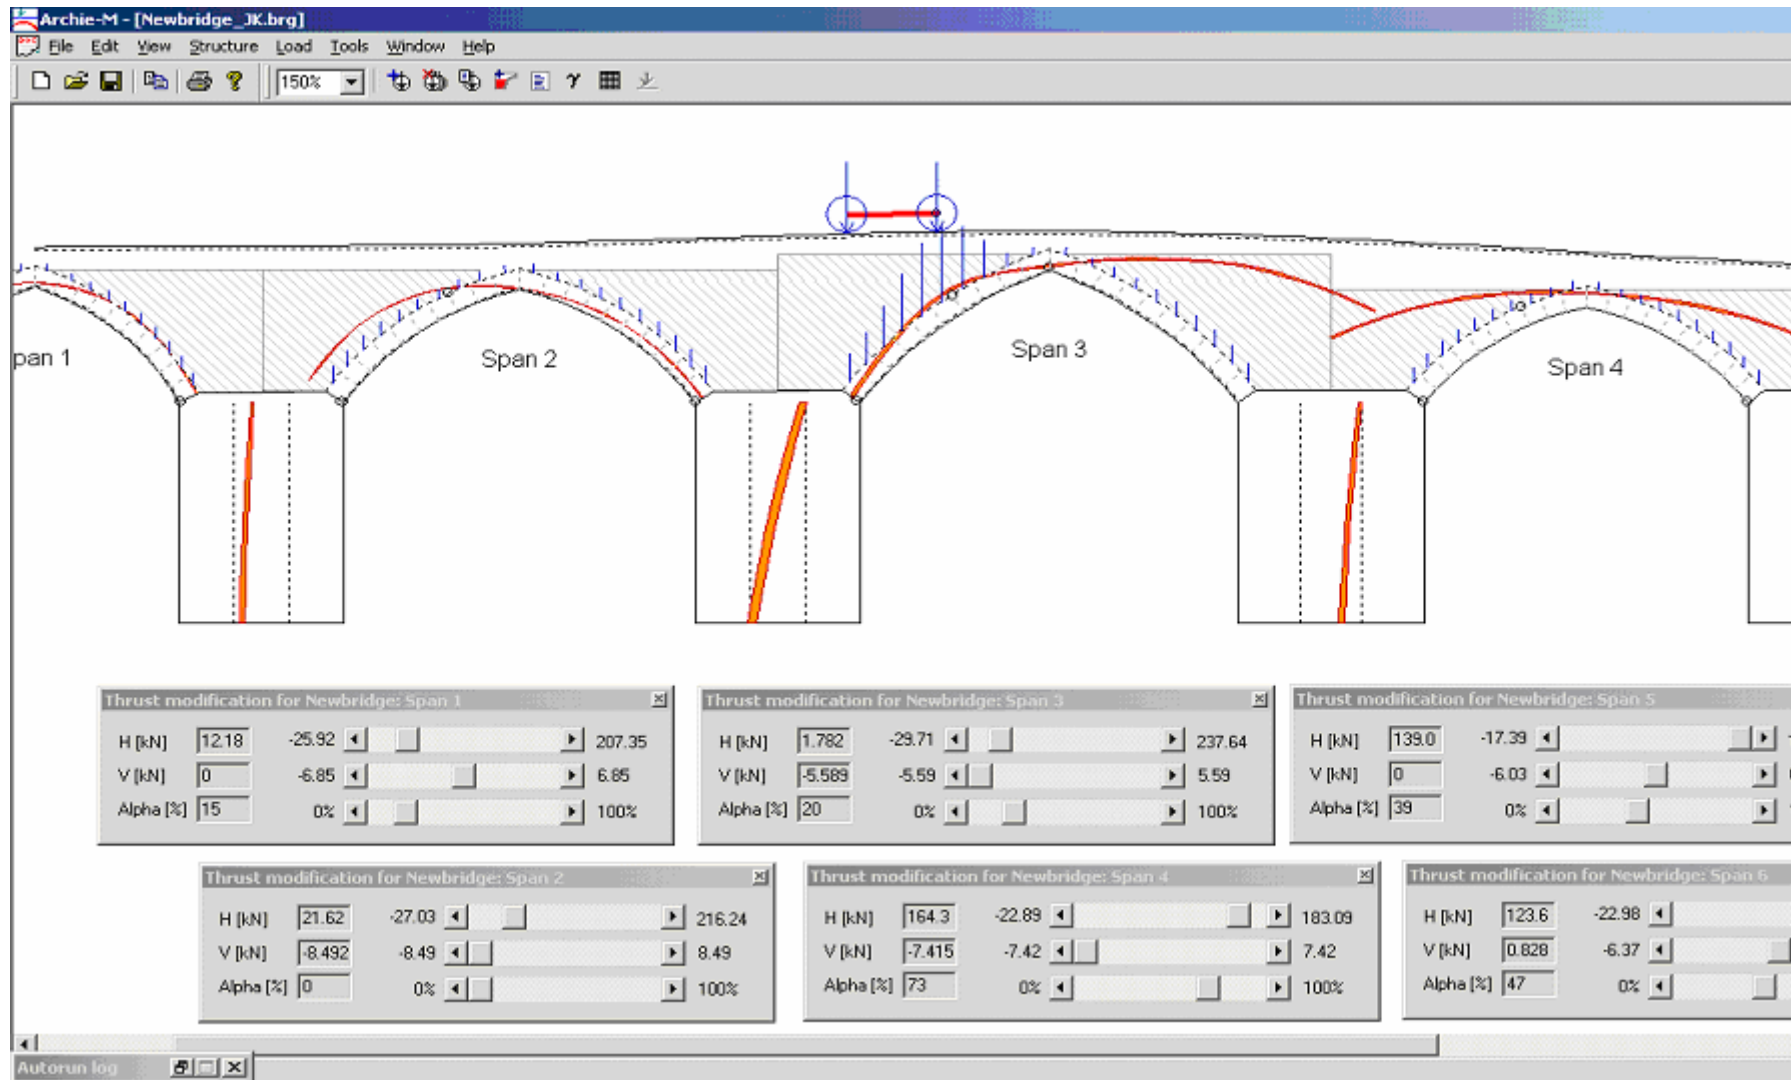
Worst Arch Case

Results of a preliminary review carried out with Archie-M analysis software using the survey and construction data recorded as part of previous assessments
