Oxfordshire  
Highways

# **Cogges Link Road Geomorphology Study**

B0834600/Doc/CLR/Geo April 2008

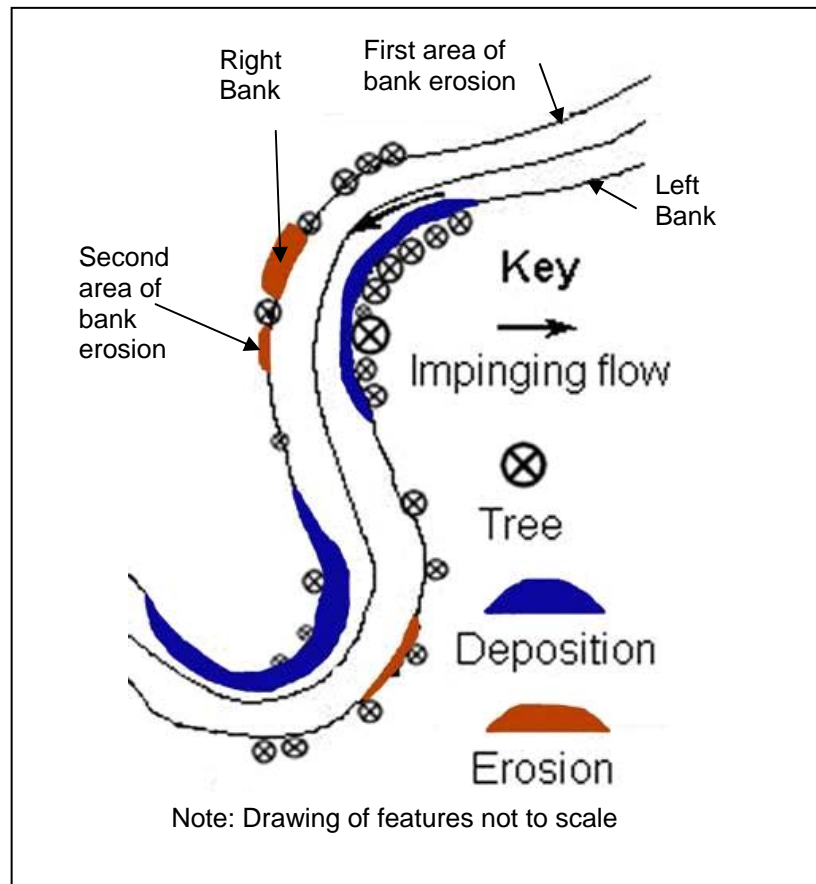
Figure 4: Bank erosion at the location of the proposed bridge crossing on the Eastern Branch of the River Windrush

- 4.2.9 A bank erosion assessment was carried out on the outer bank line at the location of the proposed bridge crossing (SP36121 08976) (ie the area of bank erosion). This assessment was important to determine the cause(s) of the failure and whether this would then have an effect on the proposed bridge crossing at this location.

- 4.2.10 The bank erosion assessment revealed that an area of bank erosion that encompassed 7.5m of the bank length and 3m in depth had occurred just downstream of the bend apex (Photograph 16 and 17; Figure 4). Bank height was approximately 1m with the upper 0.2m being formed of alluvial material (gravels and cobbles present in significant amounts) and the lower 0.8m being a cohesive silty-clay mix. The rectangular form of the erosion area and its disjointed nature compared to the rest of the bank line suggests that this erosion has not resulted solely from bank erosion. It is likely that a tree, or several trees, were present at the site but collapsed after being undermined by erosion of the bank toe. The location of the bank erosion appears to be at a point on the bank that is experiencing impinging flow as the water flows round the bend (Photograph 15, Figure 4). At the downstream end of the eroded area, a tree is currently leaning into the channel on the bank edge (Photograph 15 and 18) providing further evidence for this form of failure mechanism. The width of the bank area affected would have been created as the root plates of the tree were upended taking part of the bank with it as the tree fell. It is likely that the remains of the tree were removed following its collapse leaving a hole in the bank edge. There is evidence to suggest that eddies created by flow separation along the bank line has created further erosion, through slab failure, in the downstream limit of the eroded bank (Photograph 16). However, this process is not causing the erosion of significant amounts of bank material. As such, it is not anticipated that further erosion of this nature would continue to occur to any significant extent.

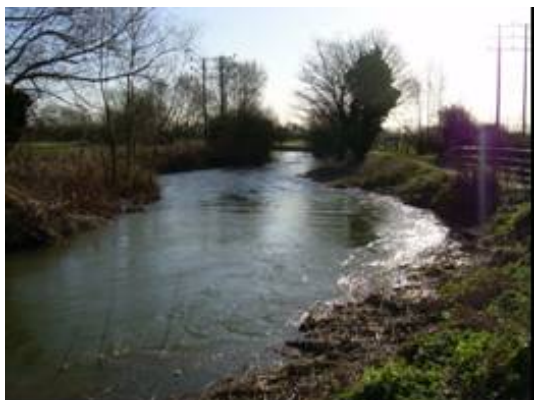
- 4.2.3 At the start of the project reach (ie upstream) there is long straight section of channel (Photograph 1). This has a significantly steeper bed gradient than in the main project reach. At this location, the River Windrush flows over an old terrace of the River Thames as the river enters the main Thames floodplain. The bed of the channel appears to be a mix of natural gravels and coarser deposits indicating that it could be palaeohydrological sediments (derived from the terrace) or that it could have been used as a ford crossing at some stage (coarser sediments perhaps having been artificially laid). There is a large depositional berm on the right bank within this part of the reach (Photograph 1). Tree lining is scattered along both channel banks.

Plate 1: Steep gradient reach

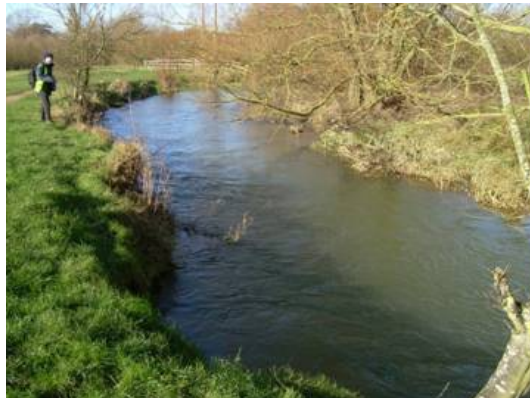
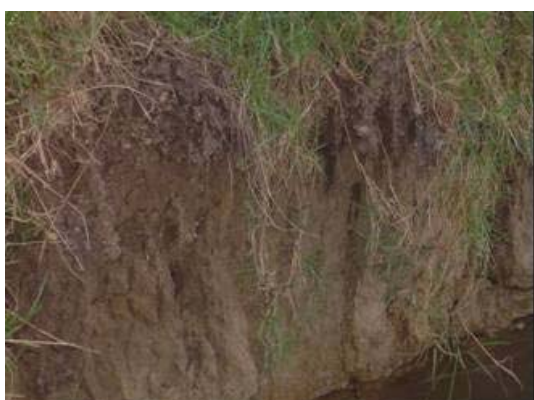
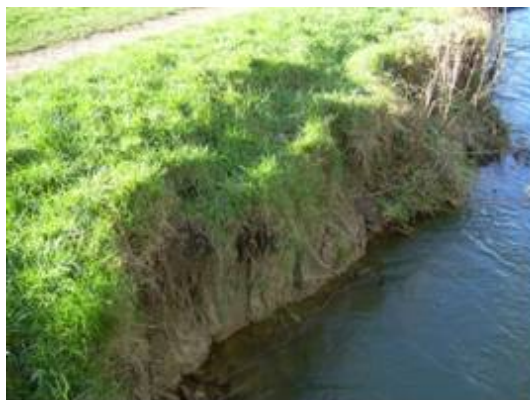
- 4.2.5 At the lower limit of straight section there is a bend which is suffering from minor bank erosion on the right bank (Photographs 4-7). The bank is composed primarily of a cohesive clay (Photographs 5 and 6). A depositional berm is forming on the inner left bank (Photograph 7).

Plate 4: Eroding bank

Plate 5: Eroding bank

Plate 6: Eroding bank

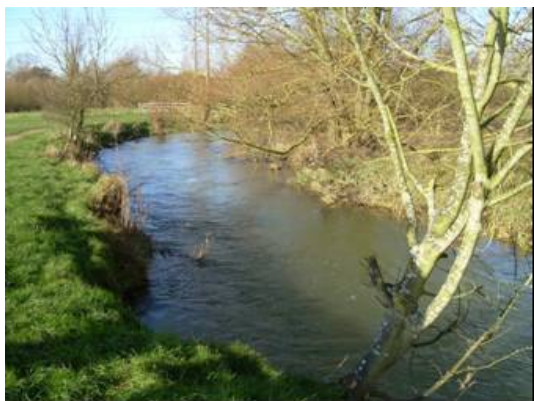
Plate 7: Meander bend

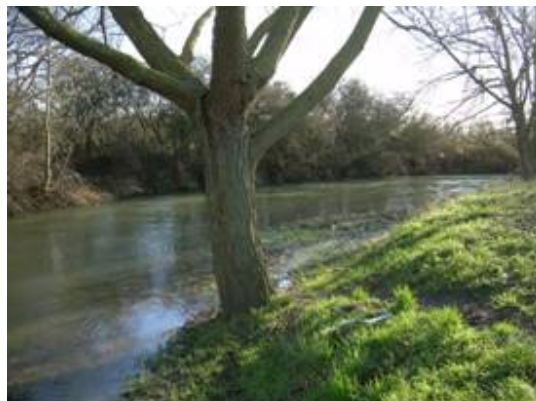
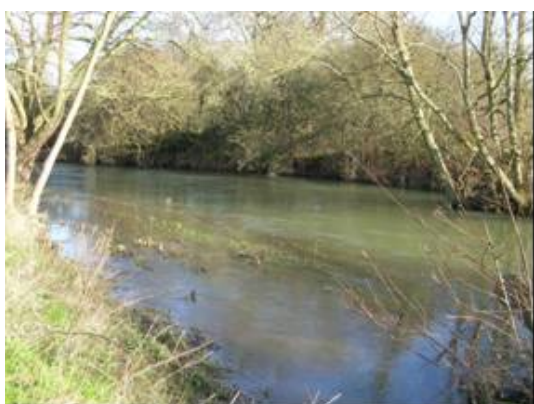
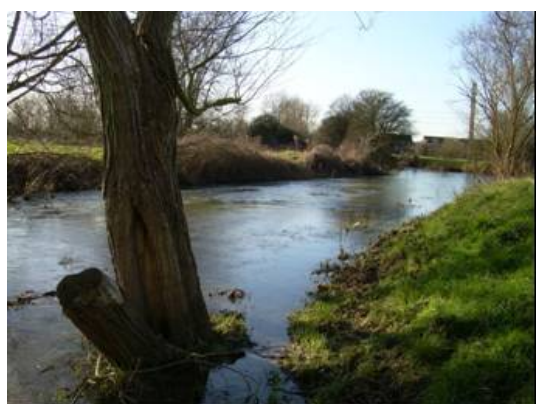
- 4.2.6 The meander bend is a long continuous loop that has a large berm, which is at a lower elevation than the top of the bank. The berm is vegetated with coppiced willows in places (Photographs 8 -10). This was partially under water on the day of the survey. A small concrete culvert enters the channel along the outer bank. The outer bank line is well vegetated with a small amount of bank erosion along the entire length.

Plate 8: Depositional berm

Plate 9: Depositional berm

Plate 10: Depositional berm

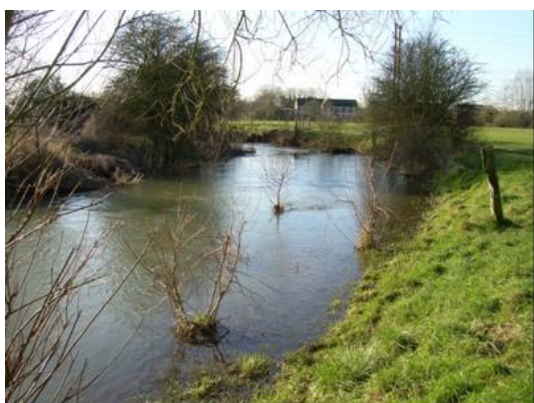
- 4.2.7 At the location of the proposed road crossing, the channel has a depositional berm on the inner left bank (Photograph 15) and is suffering from erosion on the outer bank (Photographs 11-17). This bank erosion is different form from the rest of the erosion observed within the project reach and has been caused by a tree falling into the channel, potentially due to the bank being eroded at the toe. The tree has since been removed but the hole in the bank remains. This is the same for the second area of bank erosion observed slightly further downstream

Plate 11: Meander bend at point where the proposed road crosses

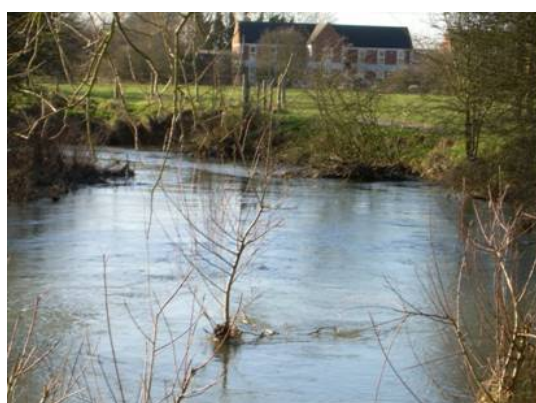
Plate 12: Area of bank erosion (now fenced off)

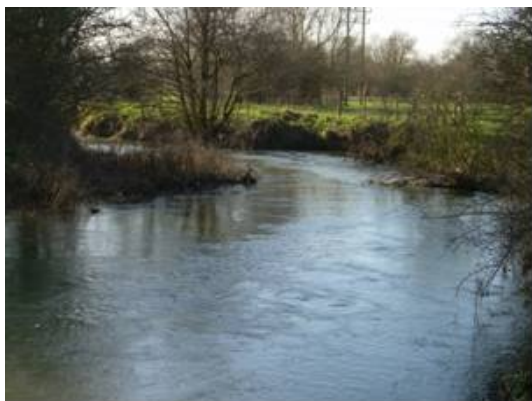
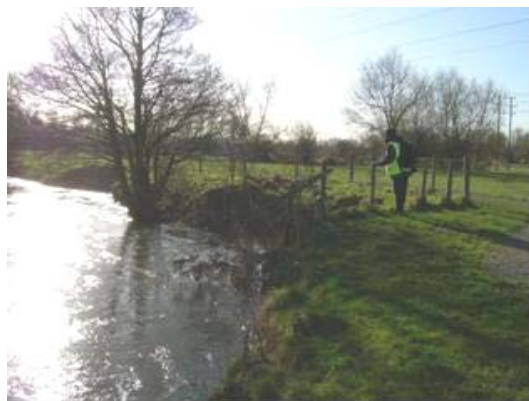
Plate 13: Area of bank erosion  
(now fenced off)

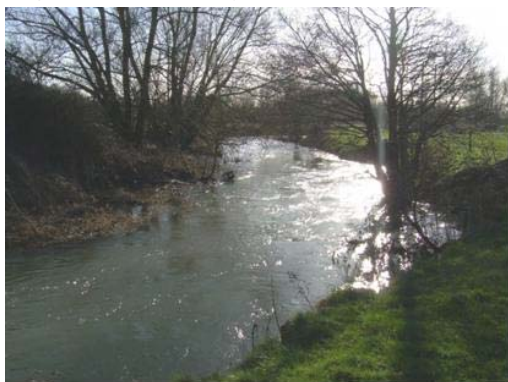
Plate 14: Area of bank erosion  
(now fenced off)

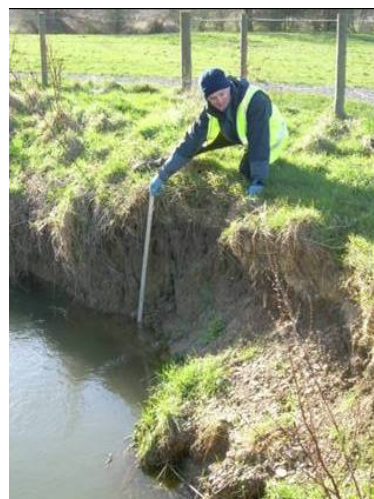
Plate 15: Area of erosion (now fenced off)

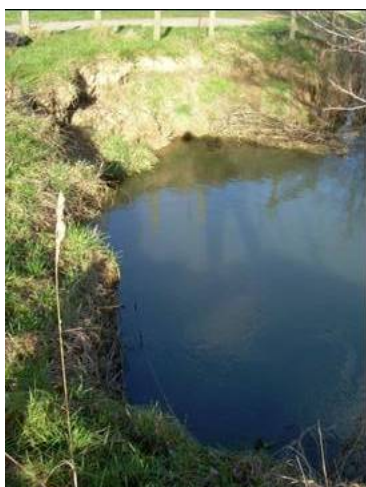
Plate 16: Eroded bank

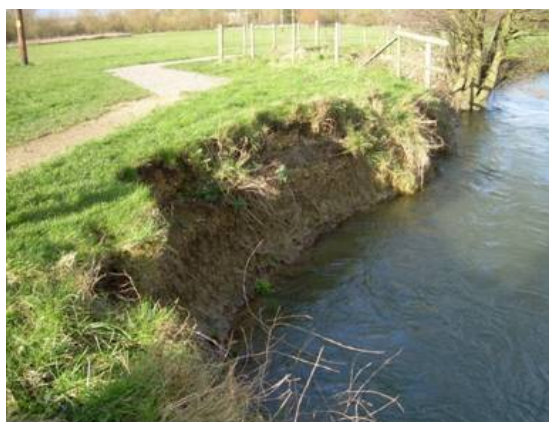
Plate 17: Eroded bank

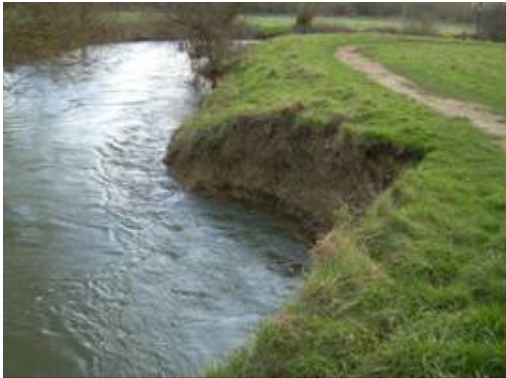
- 4.2.11 A further area of bank erosion is present downstream of the remaining tree (Photographs 18 and 19). It is likely that this area of erosion has been caused by a similar process (erosion of bank toe followed by tree collapse) as the form of bank erosion is similar.

Plate 19: Second eroded bank

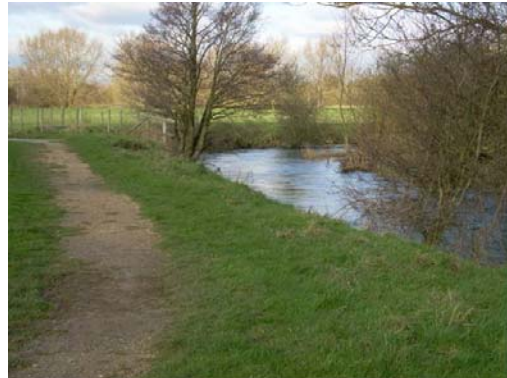
on the same bend (Photographs 18-20). A bank erosion assessment was undertaken on the first area of bank erosion, the details of which are presented later in the report.

Plate 20: Looking upstream to the bank erosion at the meander bend

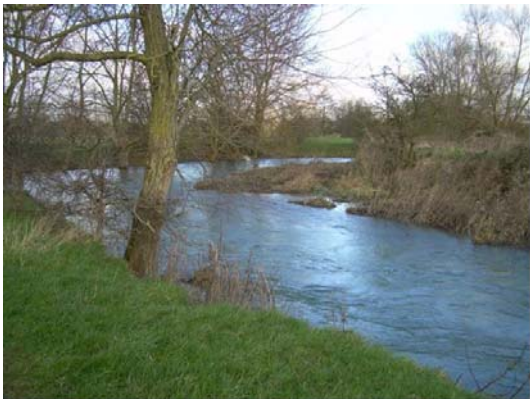
- 4.2.8 Downstream of the proposed road crossing another sharper bend exists that is experiencing more bank erosion on the outer bank line firstly on the left bank (Photograph 21), then on the opposite right bank downstream. As is common throughout the reach, depositional berms have developed on the inside of both bends (Photograph 21).

Plate 21: Meander bend

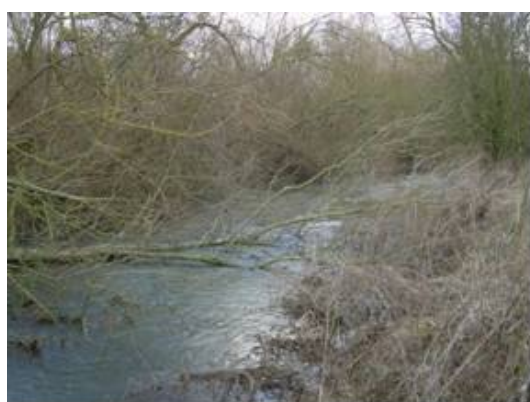
Plate 27: Depositional berm

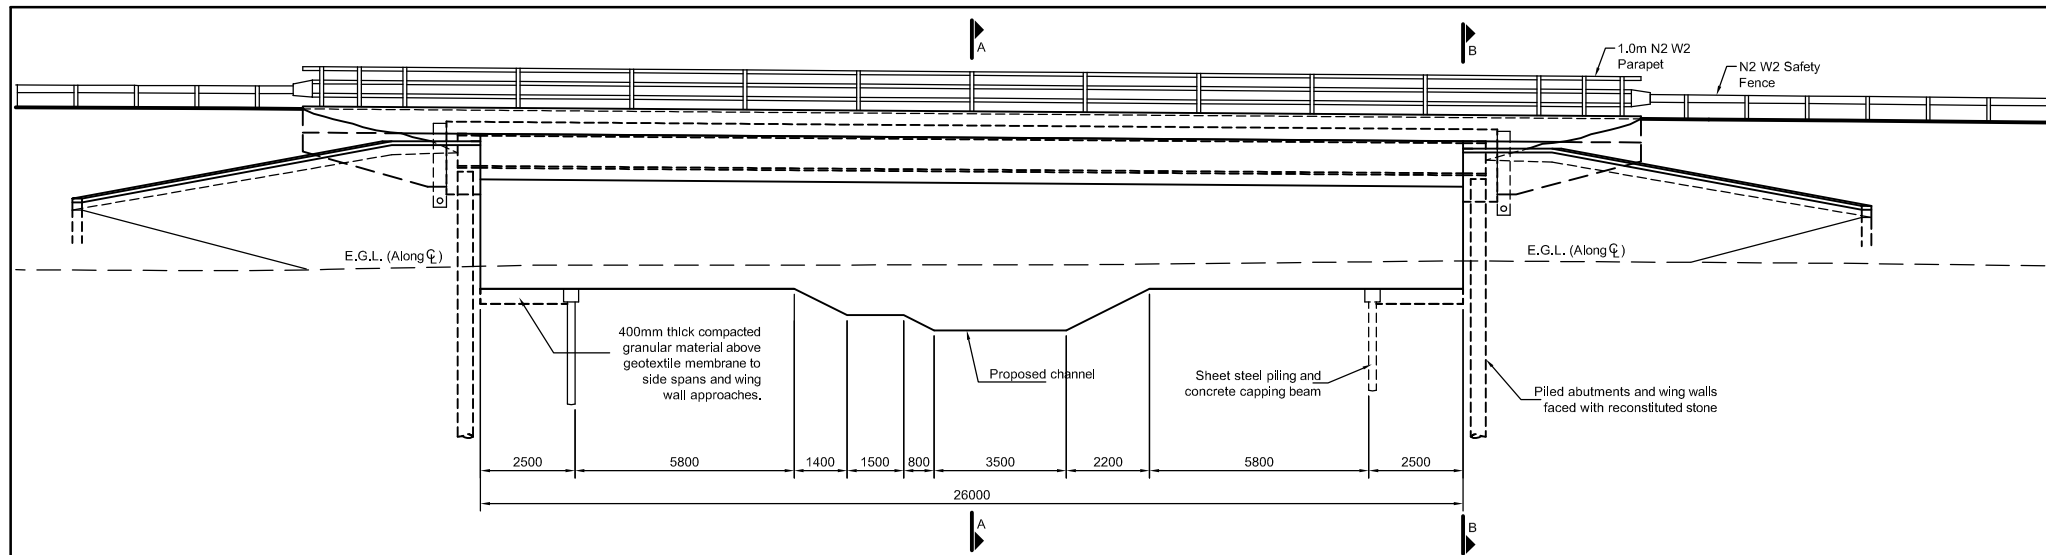
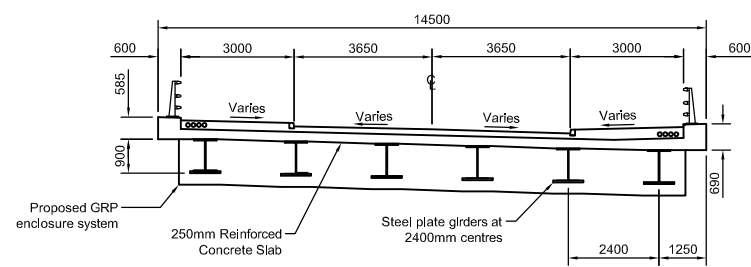
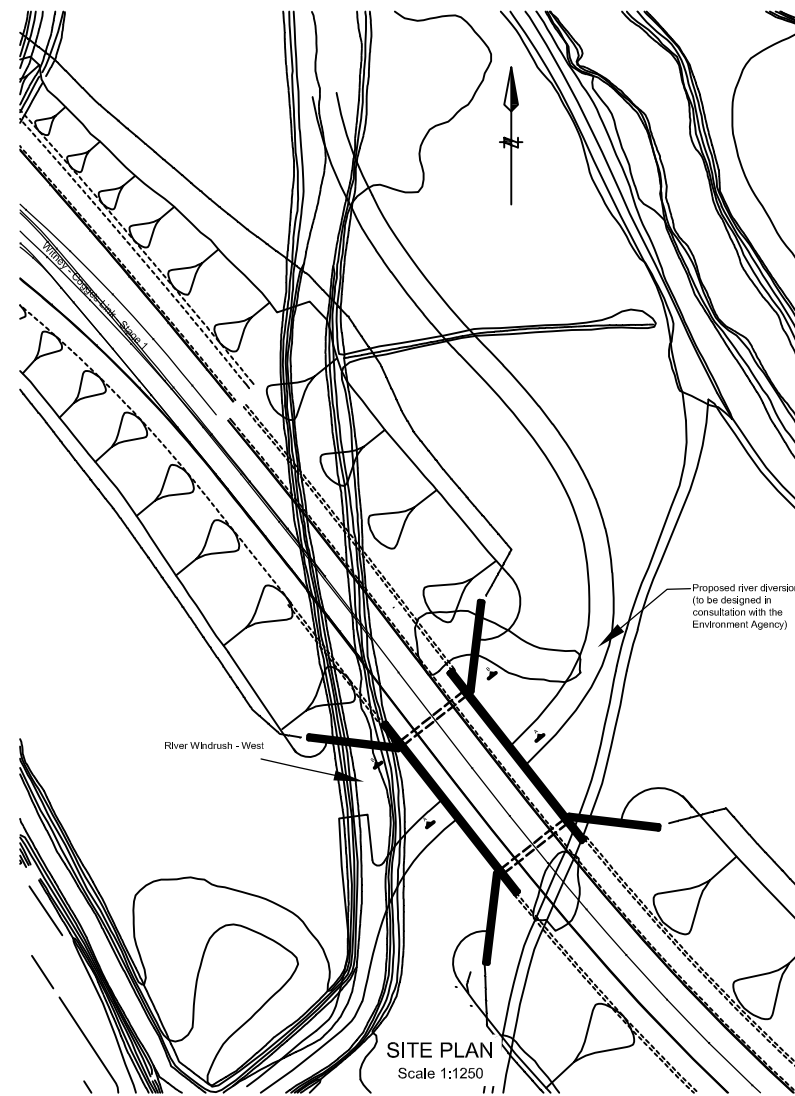
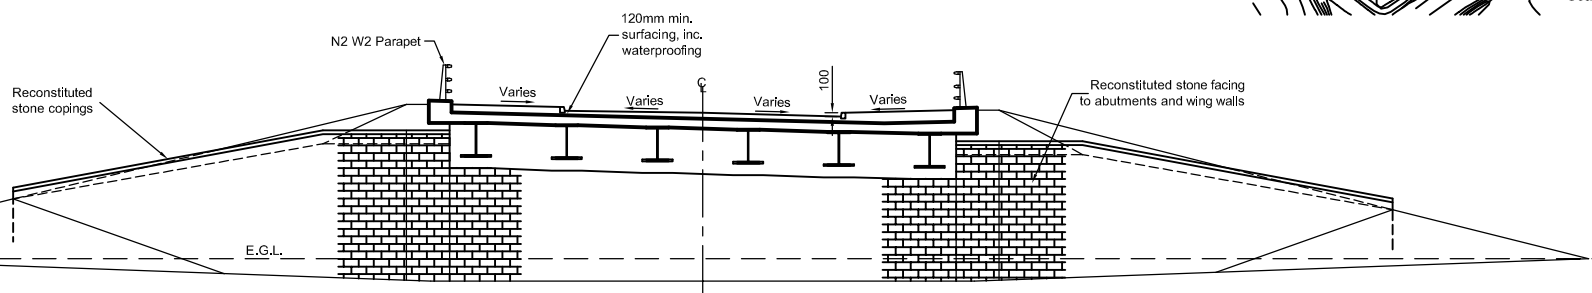
Drawing Number  
**FIGURE 5**

5.1.2 The road would require a diversion of around 70m of the western branch of the River Windrush. Currently the proposals show the river diversion having three very sharp bends, two to allow passage under the bridge and one to rejoin the eastern branch downstream of the bridge. It is unlikely that this degree of bend sharpness would develop under any natural circumstances. Whilst it could be possible in this particular location for the diverted channel to remain in this form as the river has very low energy (and therefore the risk of erosion is negligible) it is not recommended that a diversion of this shape should be constructed. It would be preferable that a more natural channel form be developed that enhances the current geomorphological processes that are operating in the reach (ie largely depositional). A form could be constructed that encouraged the natural deposition of sediment on the inside of the bend and a steeper outer bank line is recommended. A steep bank would also be beneficial habitat both for kingfishers and water voles. There is no reason to use any form of bank protection in the reach since it is predominantly undergoing deposition and the diversion would actually encourage this further through the creation of a reduced bed gradient. Preliminary alternative outline designs for the proposed diversion, are detailed in section 6. Where the channel passes under the proposed bridge the recommended sheet piling will be more than sufficient to protect the bridge pier and thus no erosion protection mats would be necessary.

6.1.2 The revised diversion drawings of the western branch of the River Windrush depict three bends with a lower radius of curvature to channel width (Figure 7). In addition, on the inside of each of the bends a gentle slope from the top of the bank to the bed is proposed to encourage preferential deposition within the channel (on the inside of the bends). Steep outer bank profiles are recommended as they represent good habitat for both kingfishers and water voles and in this location, within a very low energy environment, there is negligible risk of adjustment occurring. This is further inhibited by the underlying geology which is a cohesive clay beneath a thin layer of alluvial material.
