Cogges Link Road Riparian Mammals

B0834600/Doc/CLR/22 April 2008

Oxfordshire Highways
Cogges Link Road
Riparian Mammal Survey

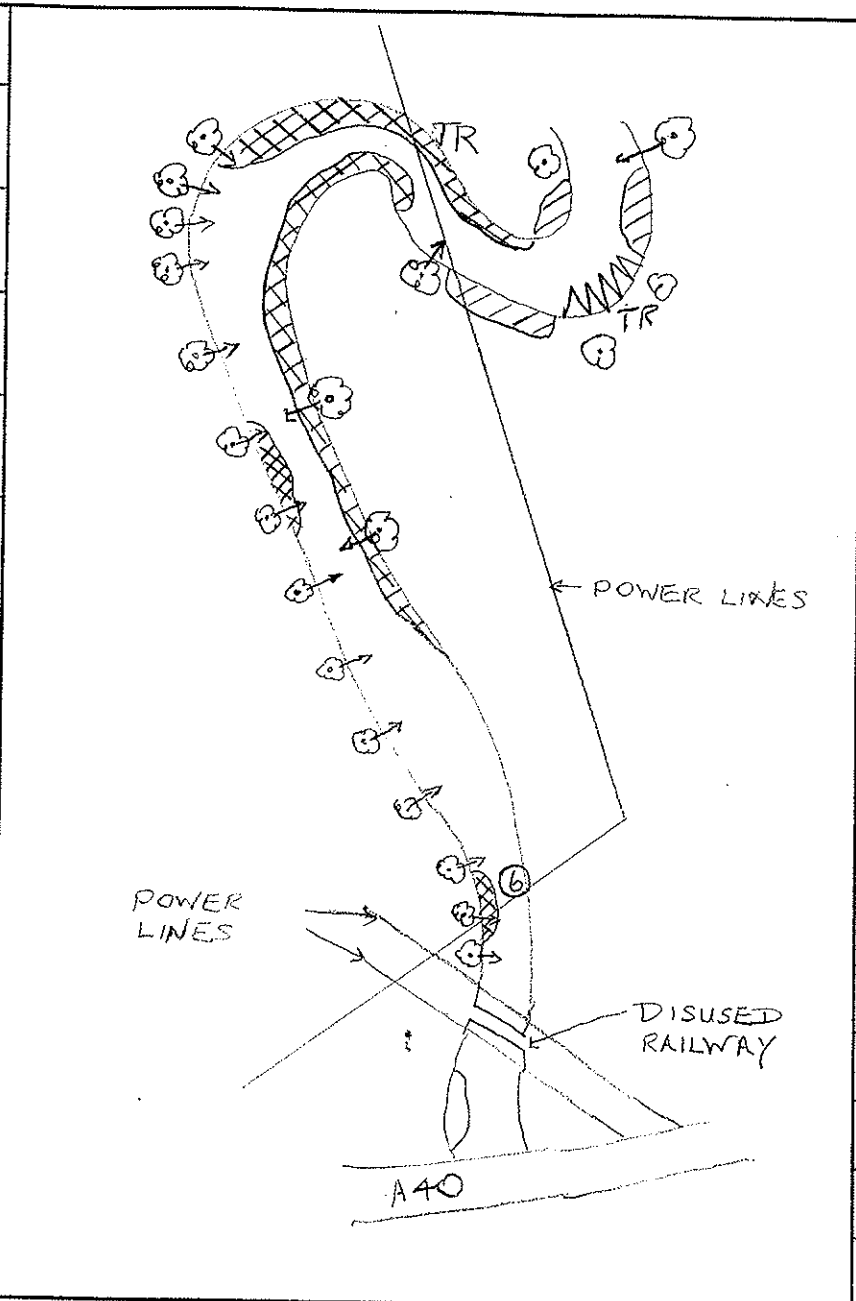
⑥ Burrow / Latrine / Feeding station
