Arch Strength Assessment

Problems with Newbridge

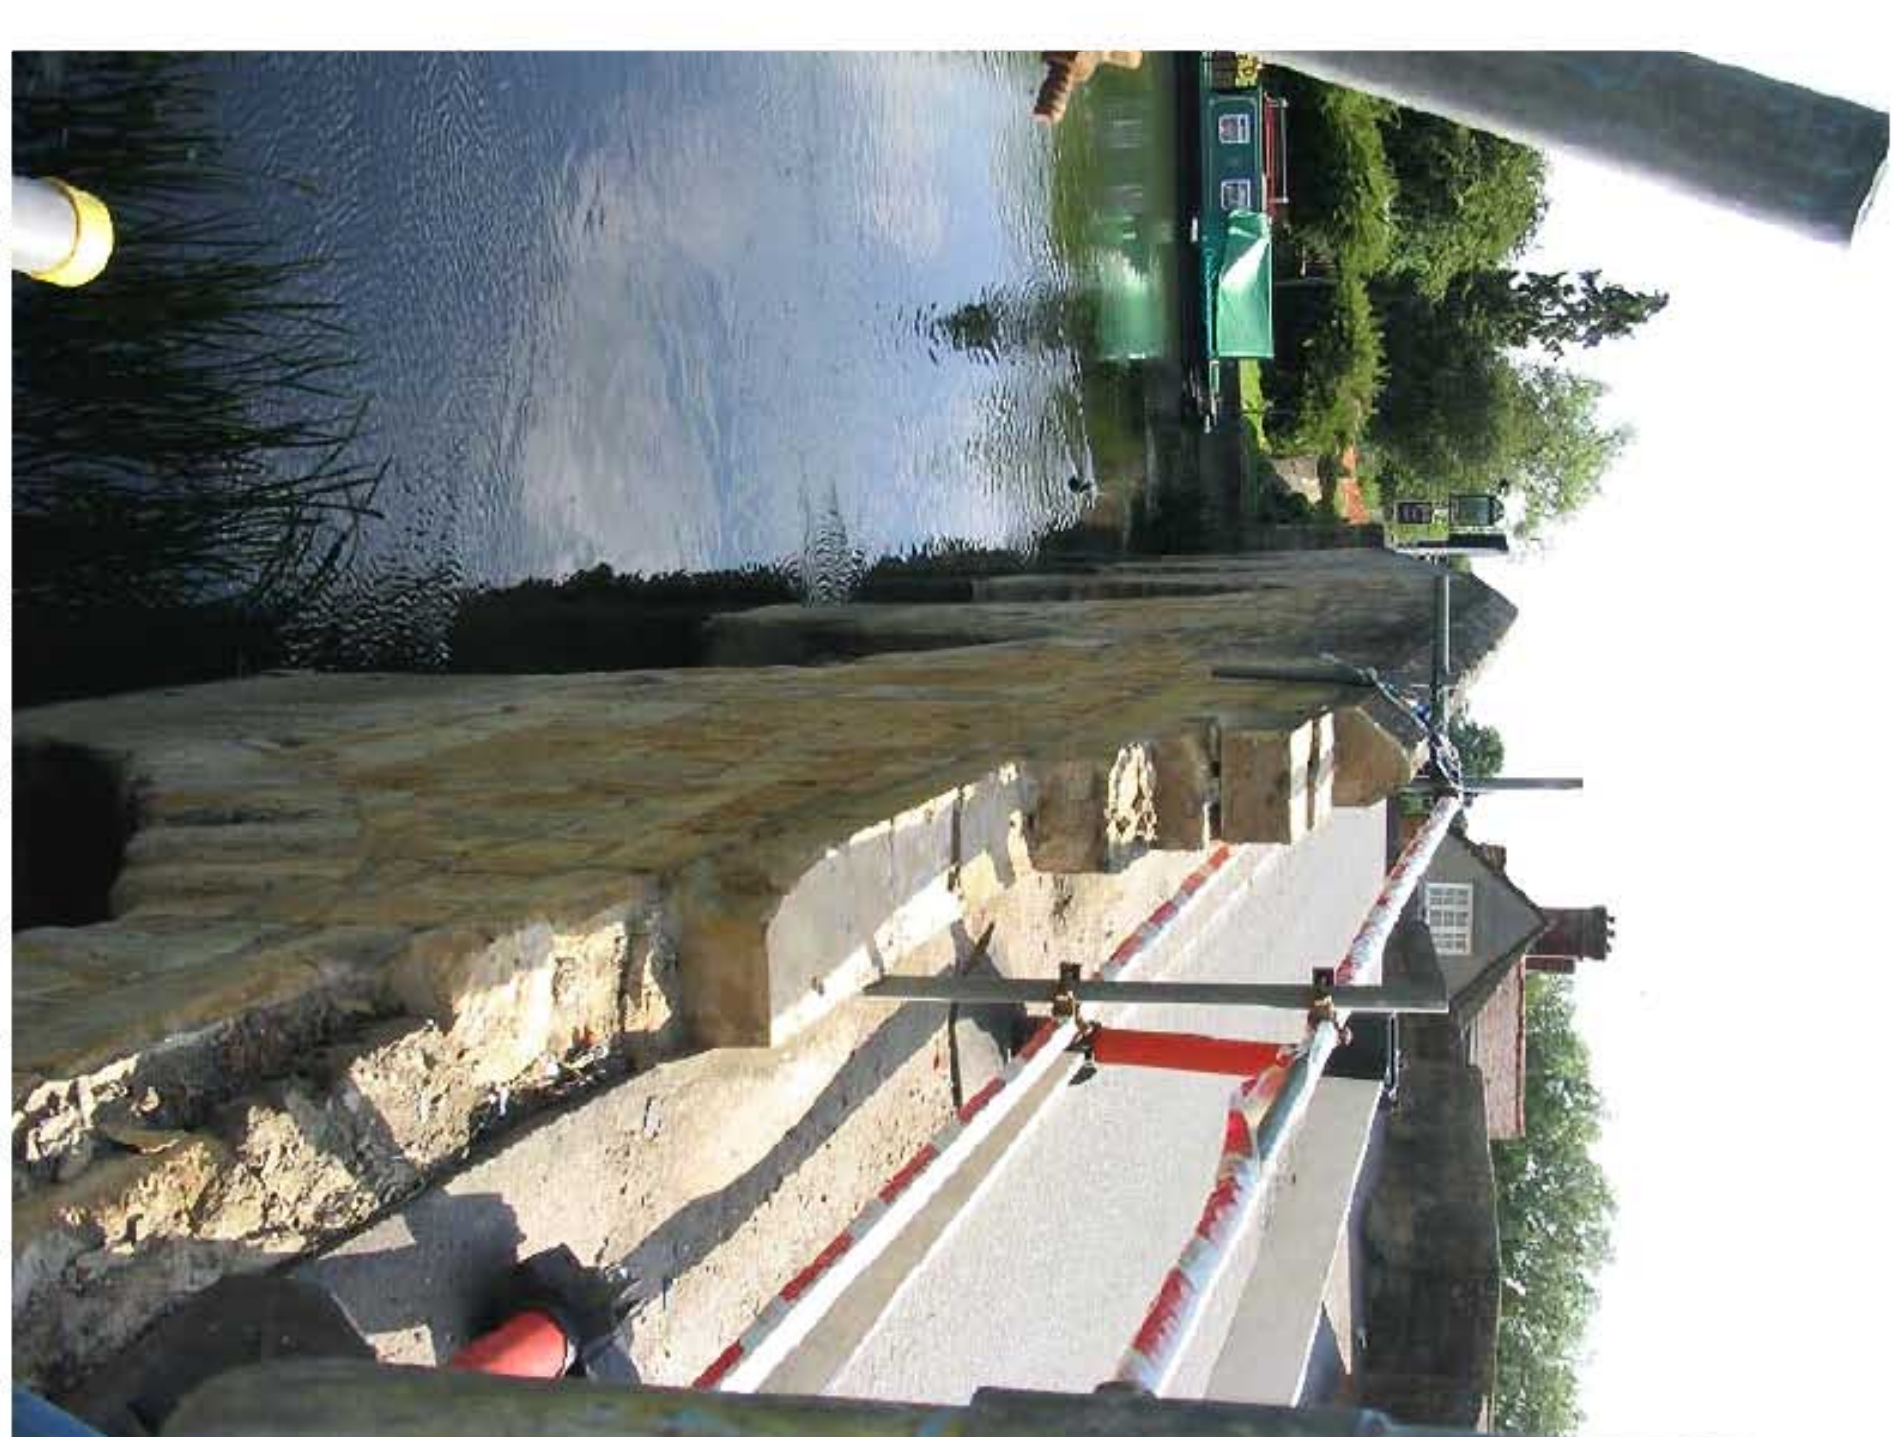
Vehicle Impact Damage to Parapets - 1

Newbridge's parapets are hit and damaged by vehicles quite regularly as can be seen in the photographs included on this panel. At the north-west corner of the bridge the parapet has been splayed back to reduce the number of times it is struck, but this area is still regularly damaged as can be seen by the cracks in the stonework in the photo centre right.

The frequency of parapet impacts is no doubt partly due to the poor horizontal alignment of the A415 approach from the north, and also partly due to the narrow width of Newbridge. In addition Newbridge has a humped-backed vertical profile that causes the underside of some long vehicles to ground on the crest of the bridge.

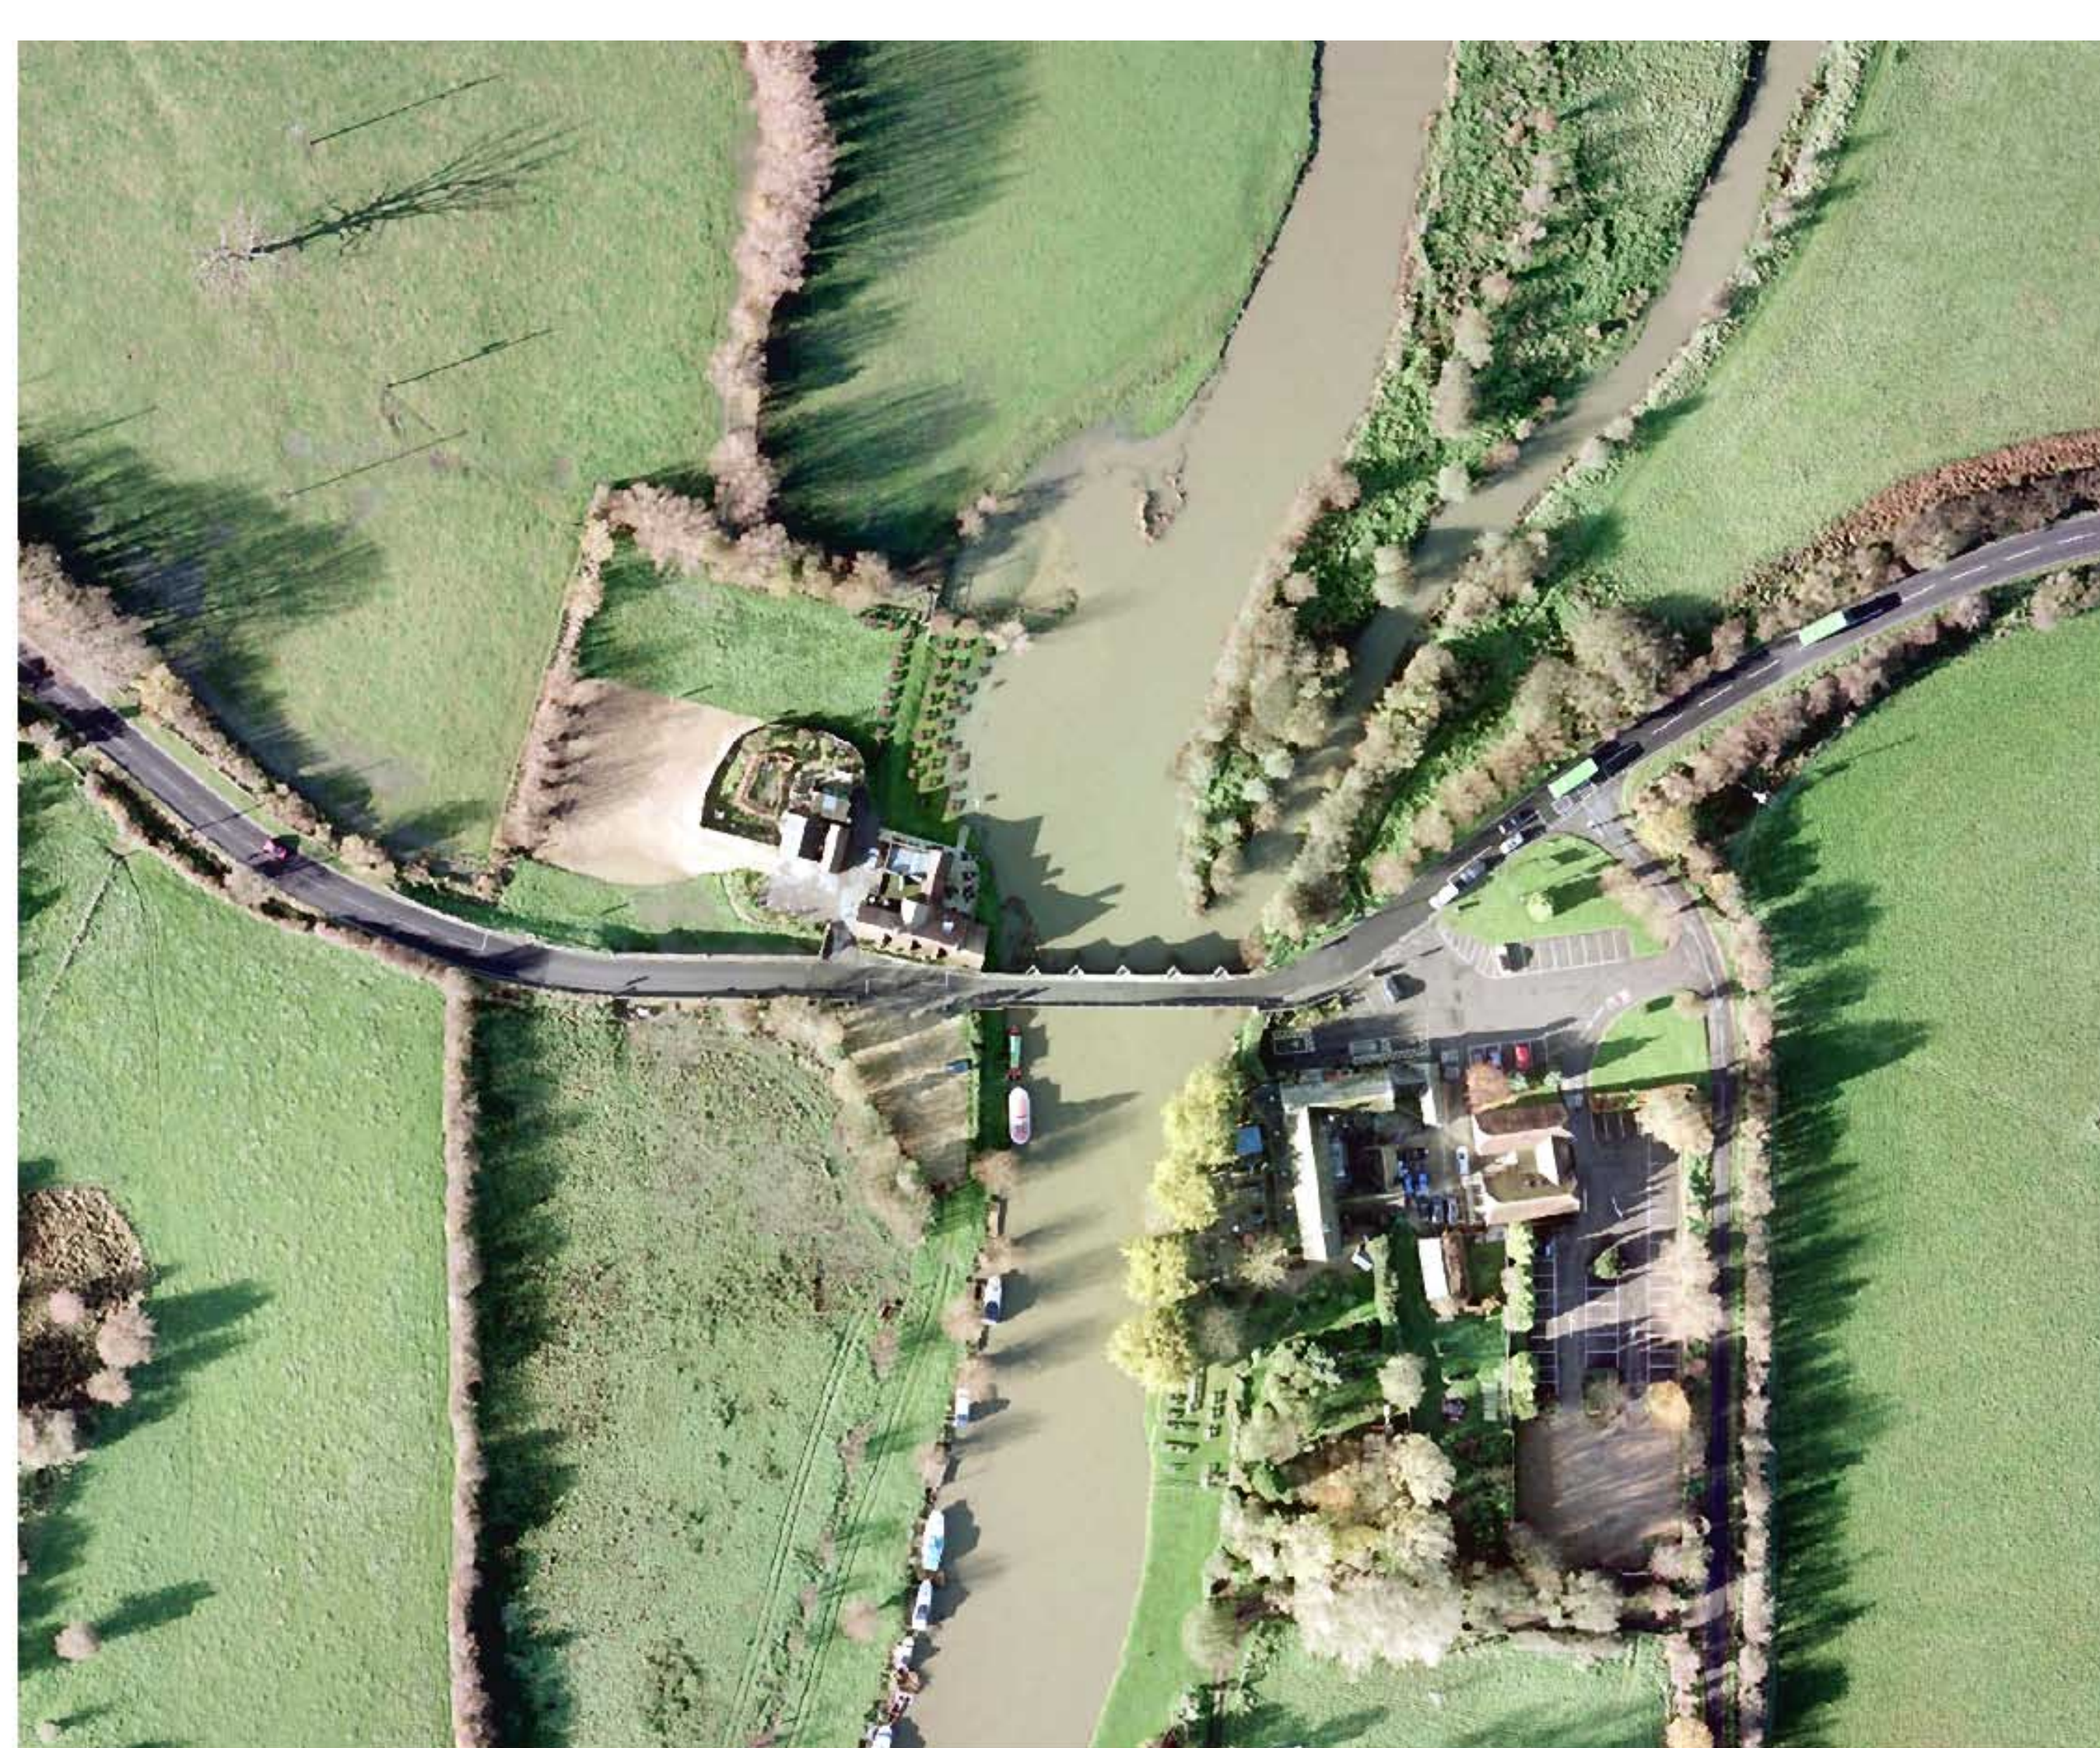
Aerial Photograph of Newbridge showing the sharp bend on the A415 immediately to the north of Newbridge

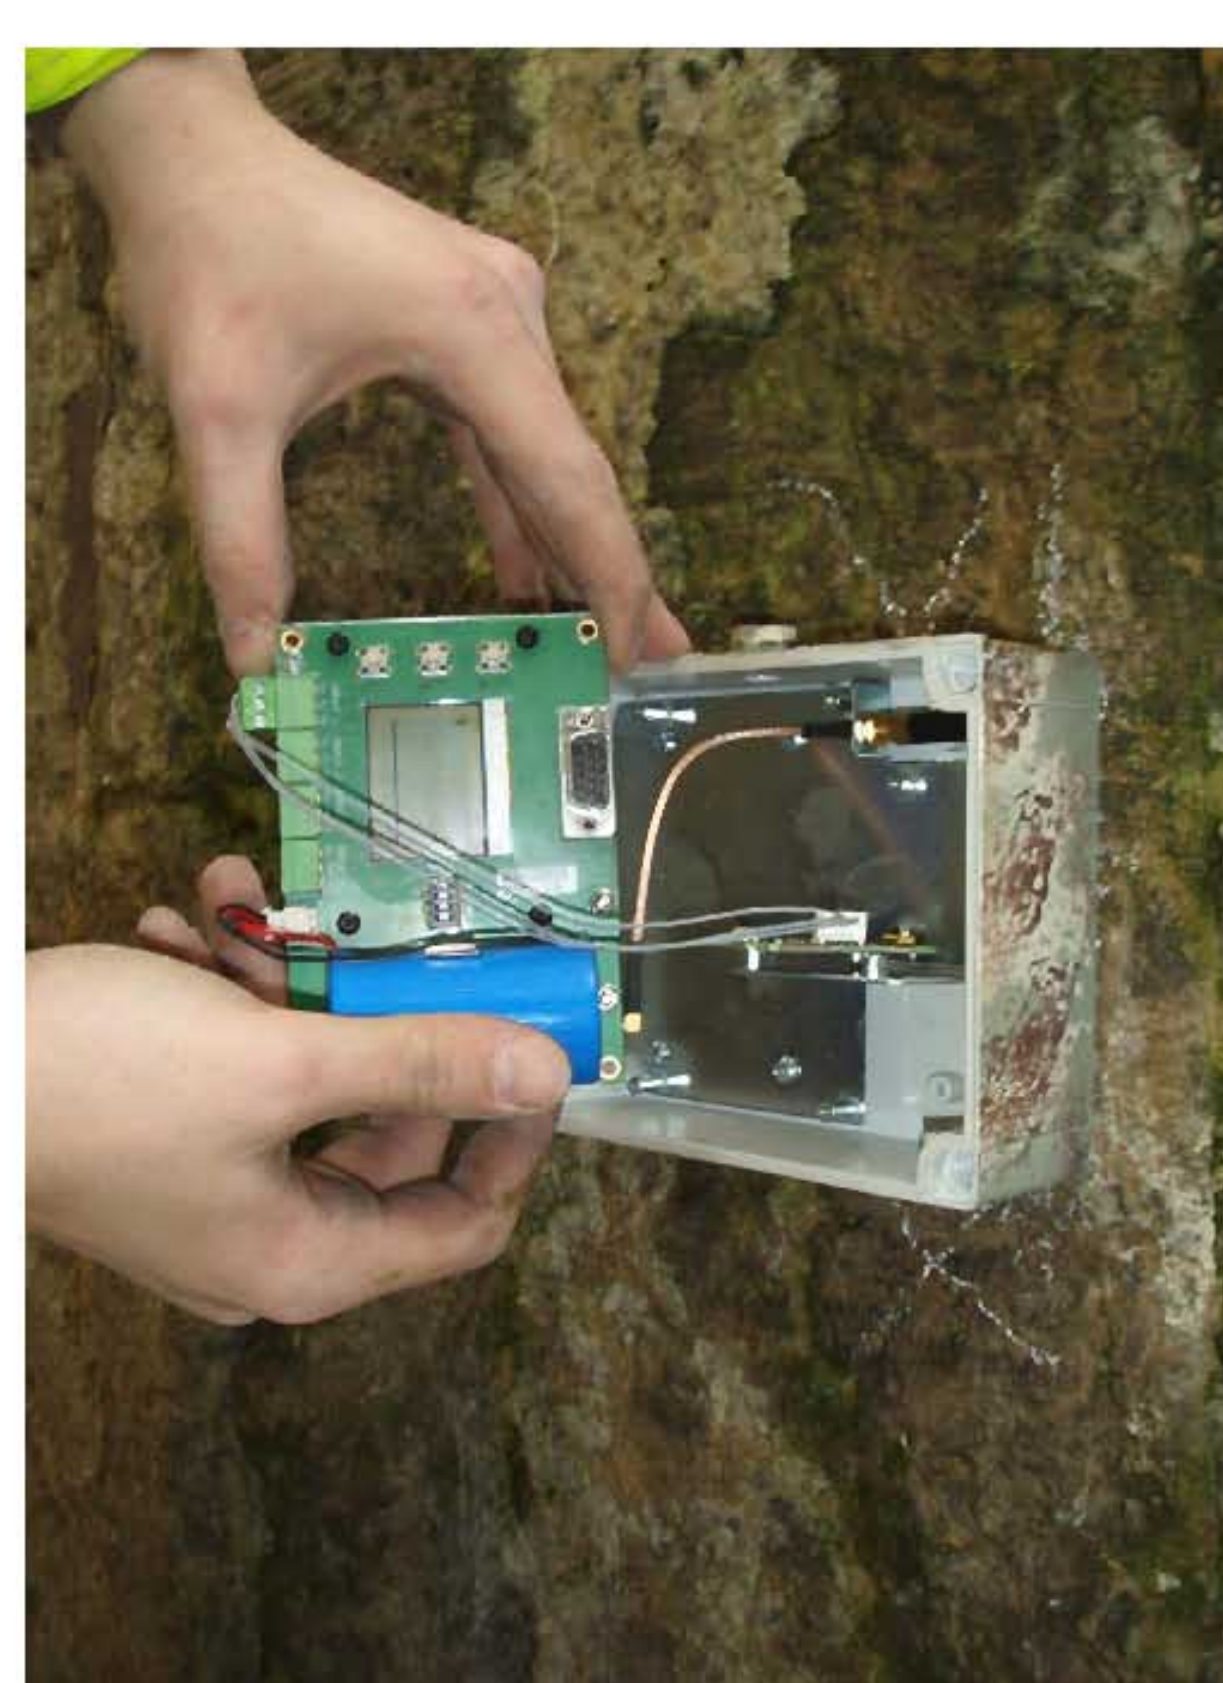
As well as more frequent physical inspections, remote crack and tilt monitoring equipment has been temporarily installed in various positions on the bridge which report via an internet based system every 24 hours. This remote monitoring and inspection regime has been in operation since March 2008 and currently has not yet identified any movements sufficient to cause concern or require the 18 tonne weight limit to be lowered any further.

One of the electronic devices used to monitor movement of structure
