Oxfordshire  
Highways

# **Cogges Link Road Geomorphology Study**

B0834600/Doc/CLR/Geo April 2008

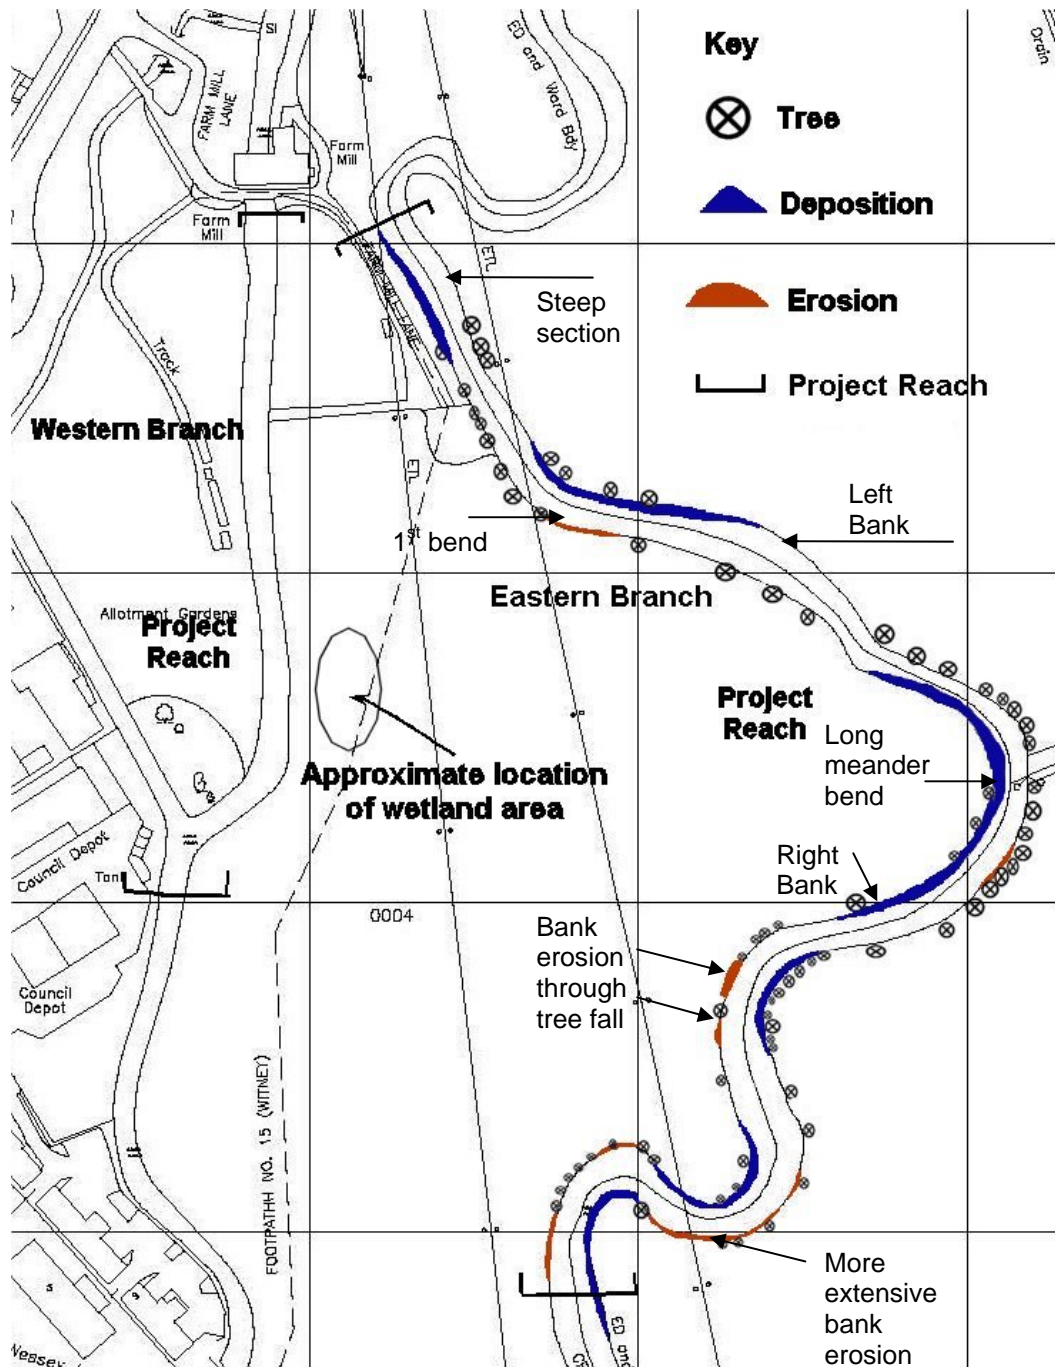
Figure 3: Stream reconnaissance results

assessed effectively. A map showing key features on the reconnaissance survey is provided in Figure 3. Photographs of the key features are detailed in Appendix A.

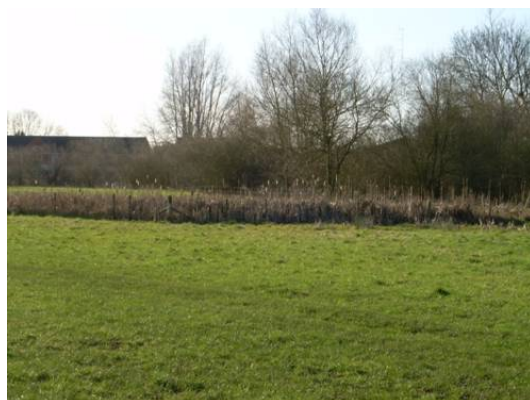
Plate 1: Steep gradient reach

- 4.2.3 At the start of the project reach (ie upstream) there is long straight section of channel (Photograph 1). This has a significantly steeper bed gradient than in the main project reach. At this location, the River Windrush flows over an old terrace of the River Thames as the river enters the main Thames floodplain. The bed of the channel appears to be a mix of natural gravels and coarser deposits indicating that it could be palaeohydrological sediments (derived from the terrace) or that it could have been used as a ford crossing at some stage (coarser sediments perhaps having been artificially laid). There is a large depositional berm on the right bank within this part of the reach (Photograph 1). Tree lining is scattered along both channel banks.

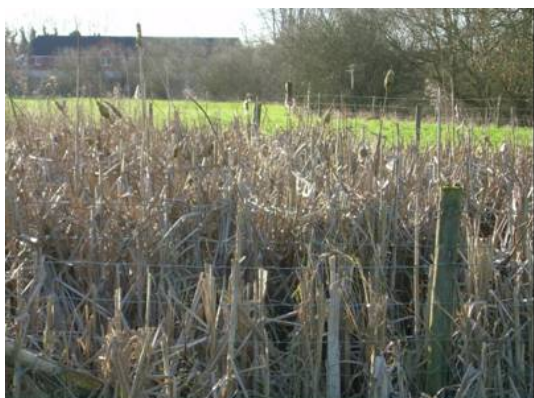
Plate 2: Wetland area

- 4.2.4 Between the Western and Eastern branches of the River Windrush a small wetland area exists (Photographs 2, 3 and 26). This has been fenced off. The wetland would be lost with the construction of the road and as such the loss of habitat would need to be mitigated against. A compensation package has already been agreed with the Environment Agency.

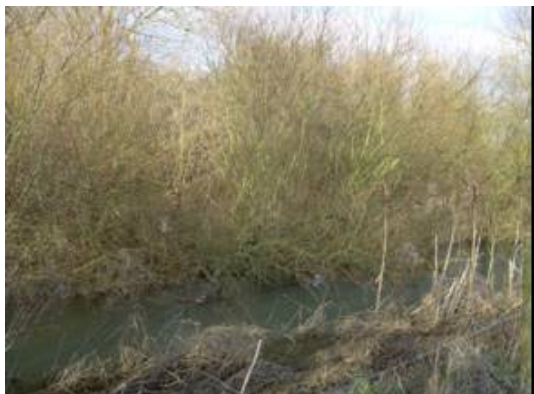
Plate 22: Typical straightened section

- 4.2.13 The Western branch of the River Windrush is the old artificial mill leat emerging from Farm Mill and, as such, is largely a straight section of channel. A well vegetated riparian corridor, particularly on the right bank, exists along the project reach (Photographs 22-25 and 27-29). A further by-pass channel around the mill comes in on the right bank (Photograph 24, SP35963 09027). This is called the Farm Mill Side Channel. The main channel itself is suffering from deposition at various points along both the channel margins (Photographs 22, 23, 25 and 27). Sediment is also being transferred through the reach. There were no signs of any bank erosion along the reach. This implies that the potential of bank erosion occurring as a result of diverting the channel is low.
