July 2007 Flood – River Windrush at Witney – Flood Level Data Supplied by EA

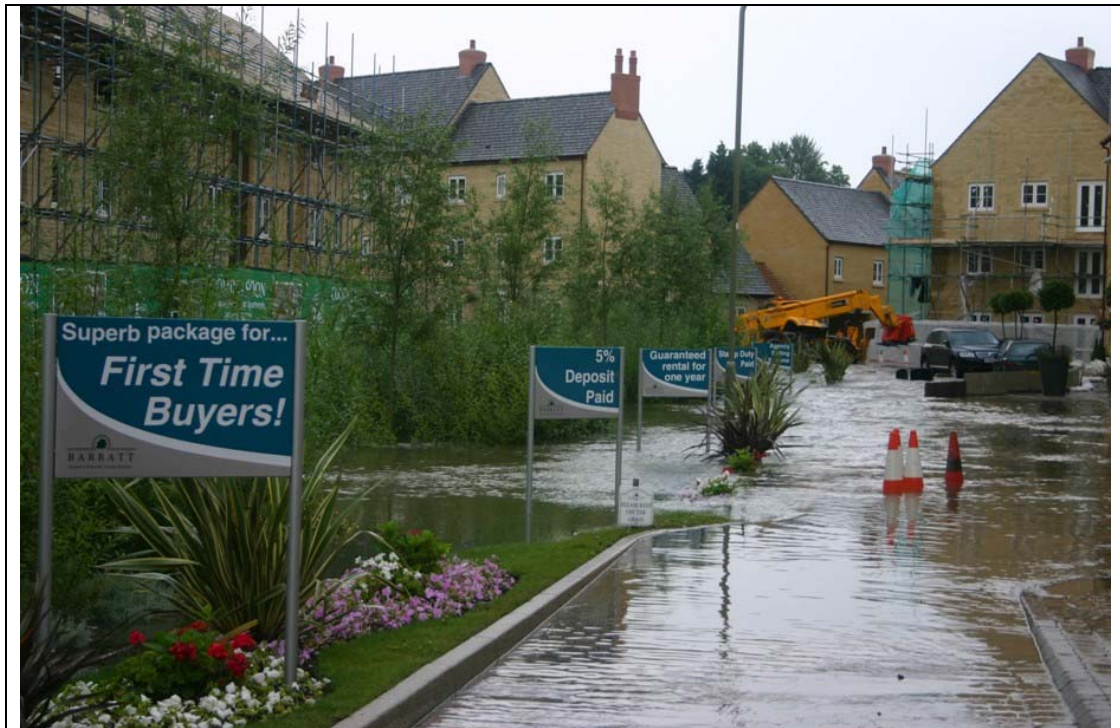
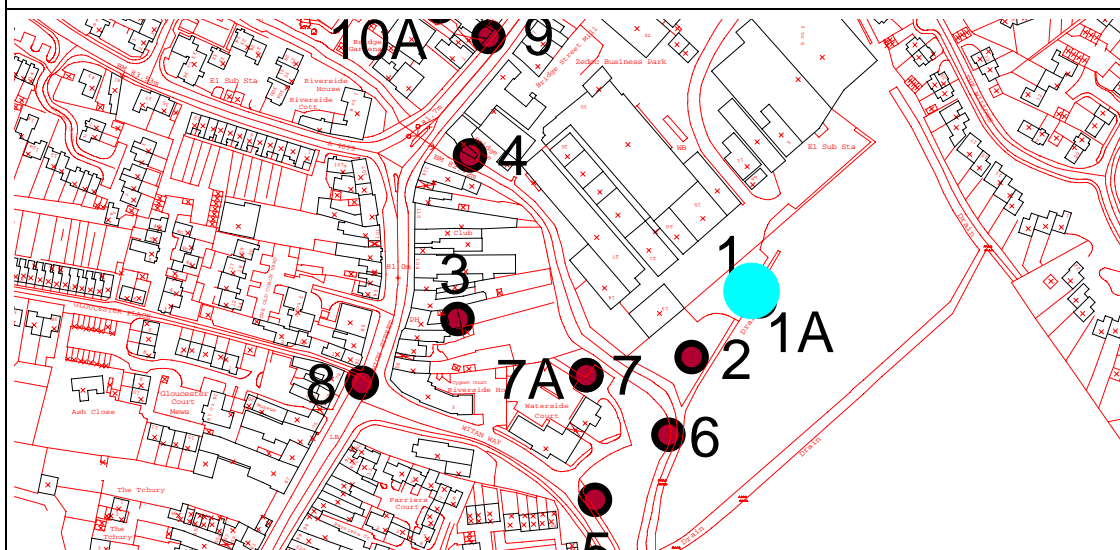
| Ref Number | 1 | | | |

| Job No. | 9383 | | | Taken from near point 2 |
| Level | 80.570 m OD | | | |
| Base of 5% deposit sign | | | | |
| Flood Extent (Y/N) | Y | | | |

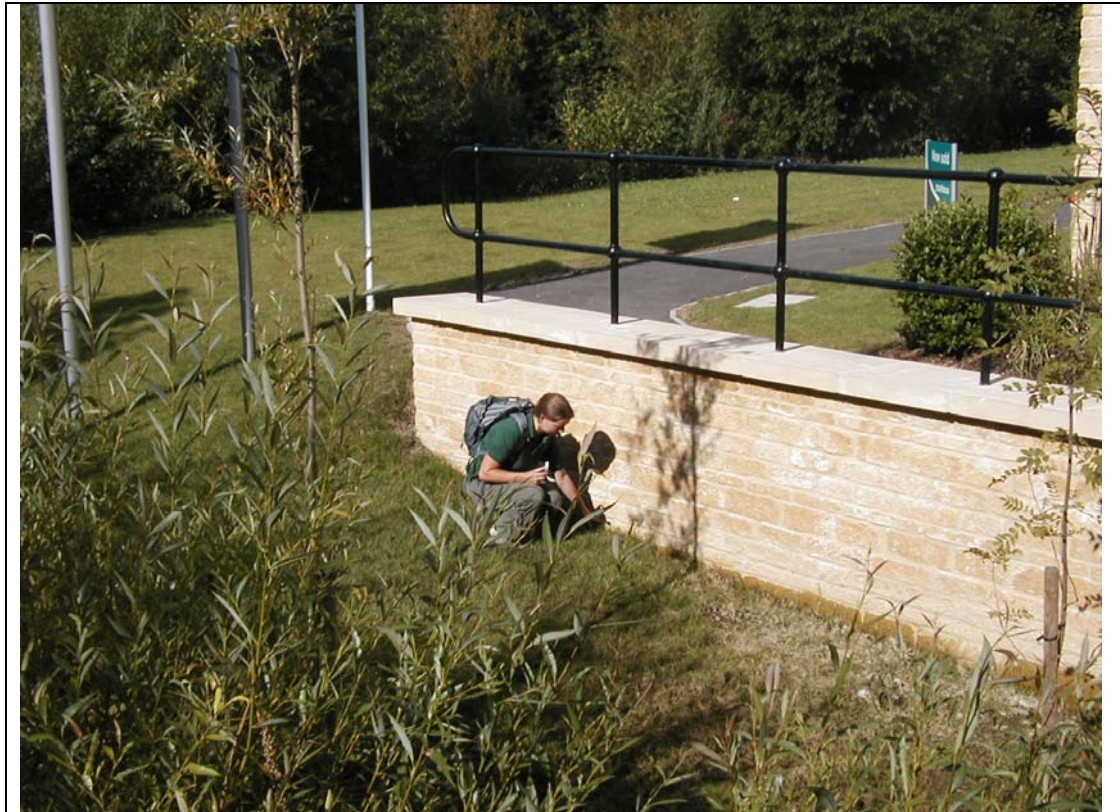
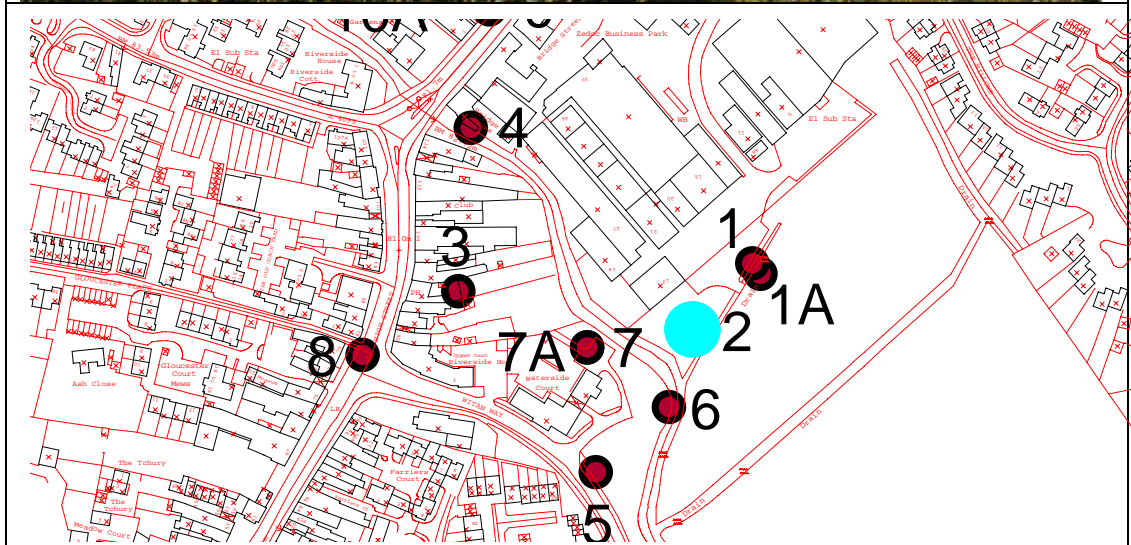
| Ref Number | 2 | | |

| Level | 79.890m OD | | |
| Photo Ref | MM2 - Wing Wall of Bridge to Windrush Quay | | |
| Flood Extent (Y/N) | N | | |

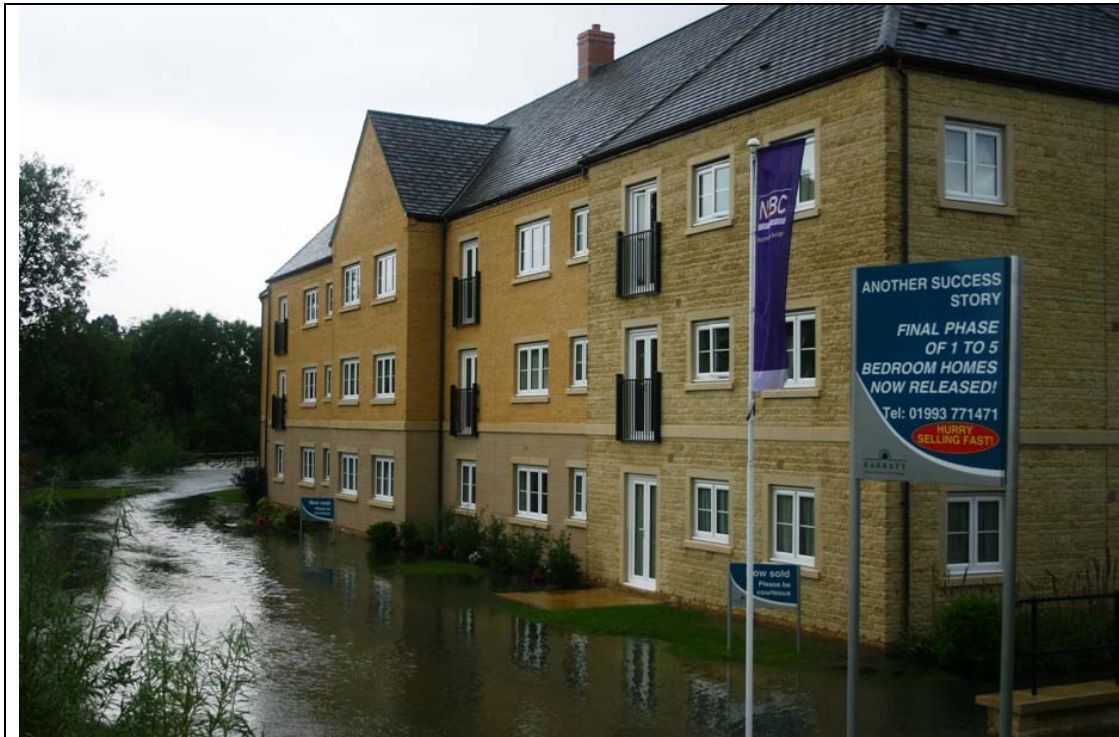
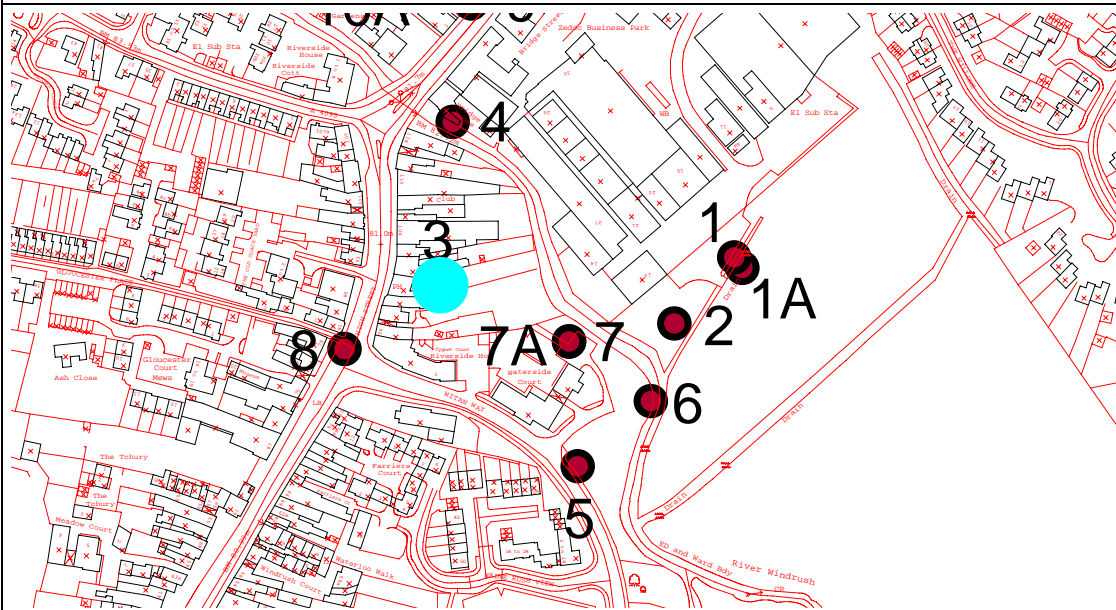
| Ref Number | 3 | | | |

| Job No. | 9383 | | Location as EA list – probably taken from near point 2. | |
| Level | 80.860m OD | | | |
| Flood Extent (Y/N) | N | | | |

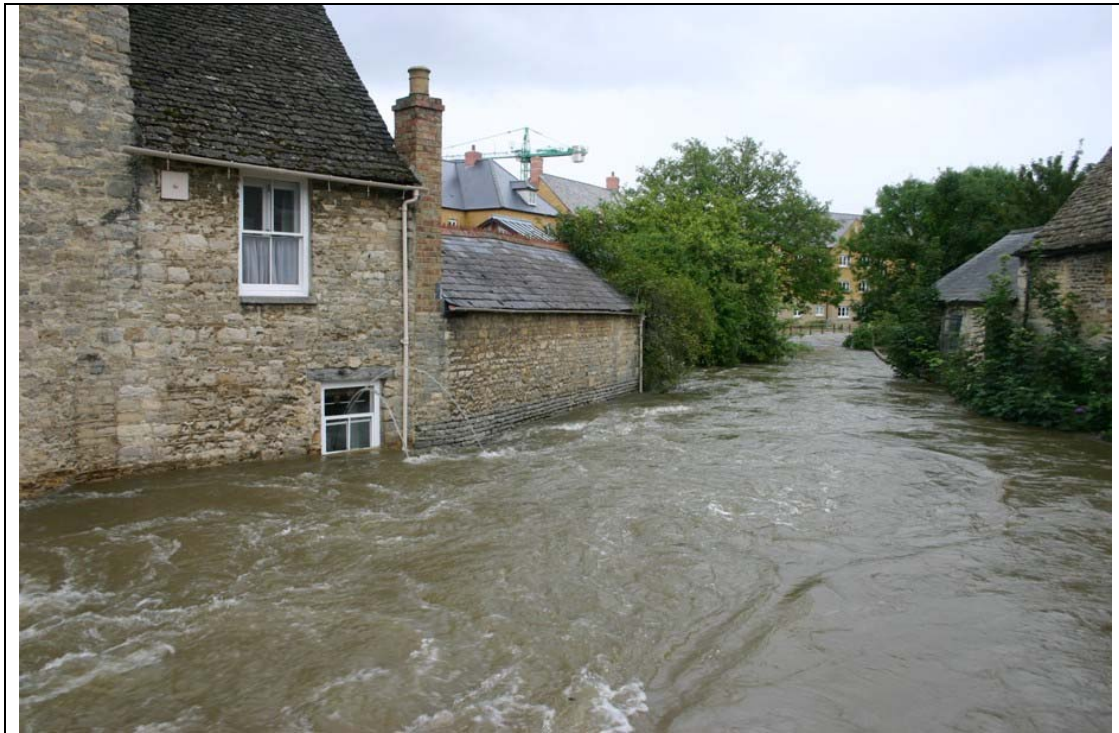
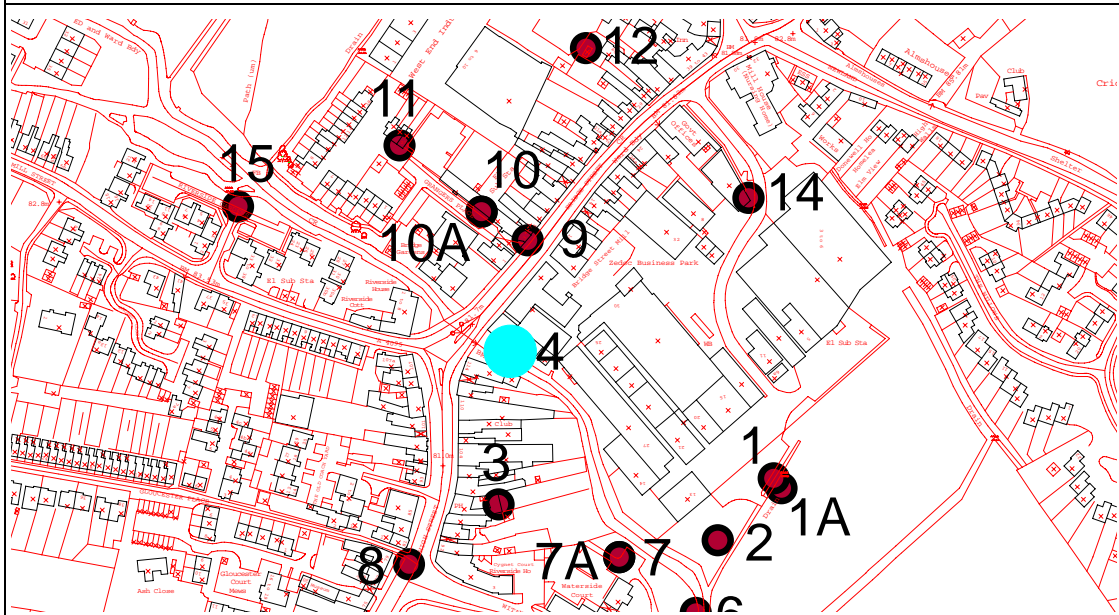
| Ref Number | 4 | | | |

| Job No. | 9383 | | | Position of level surveyed queried with EA survey department. Level believed to be to flooded window sill approximated by following coursing of stonework to face of bridge. |
| Level | 81.190m OD | | | |
| Flood Extent (Y/N) | N | | | |

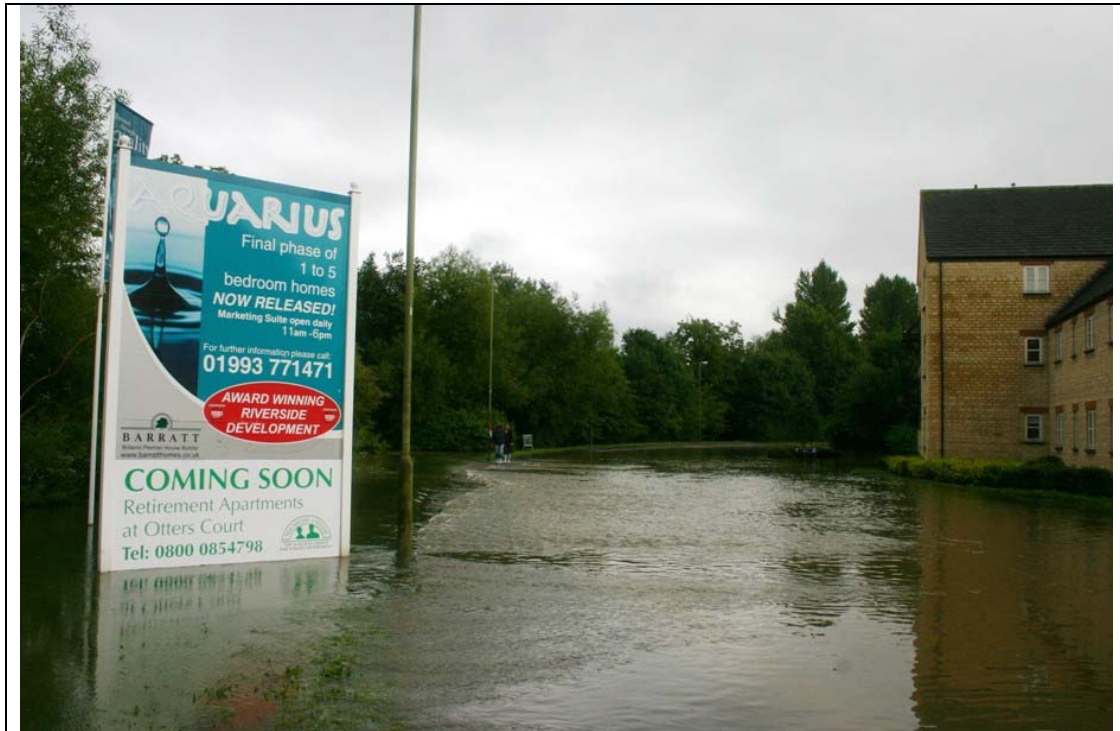
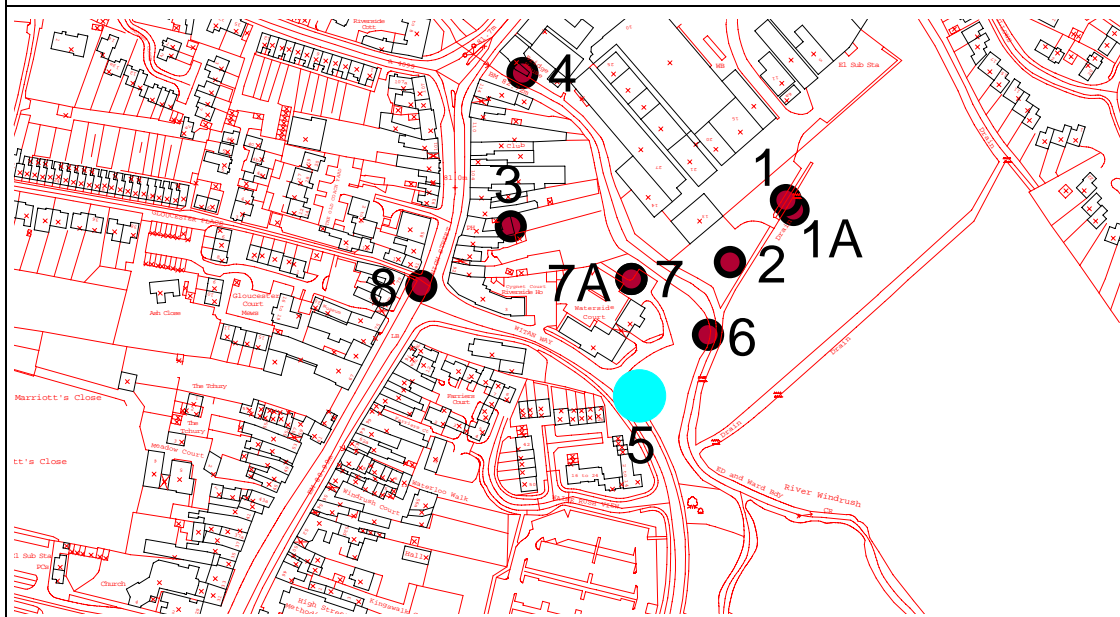
| Ref Number | 5 | |

| Job No. | 9383 | View south down Witan way |
| Level | 80.500m OD | |
| Flood Extent (Y/N) | N | |

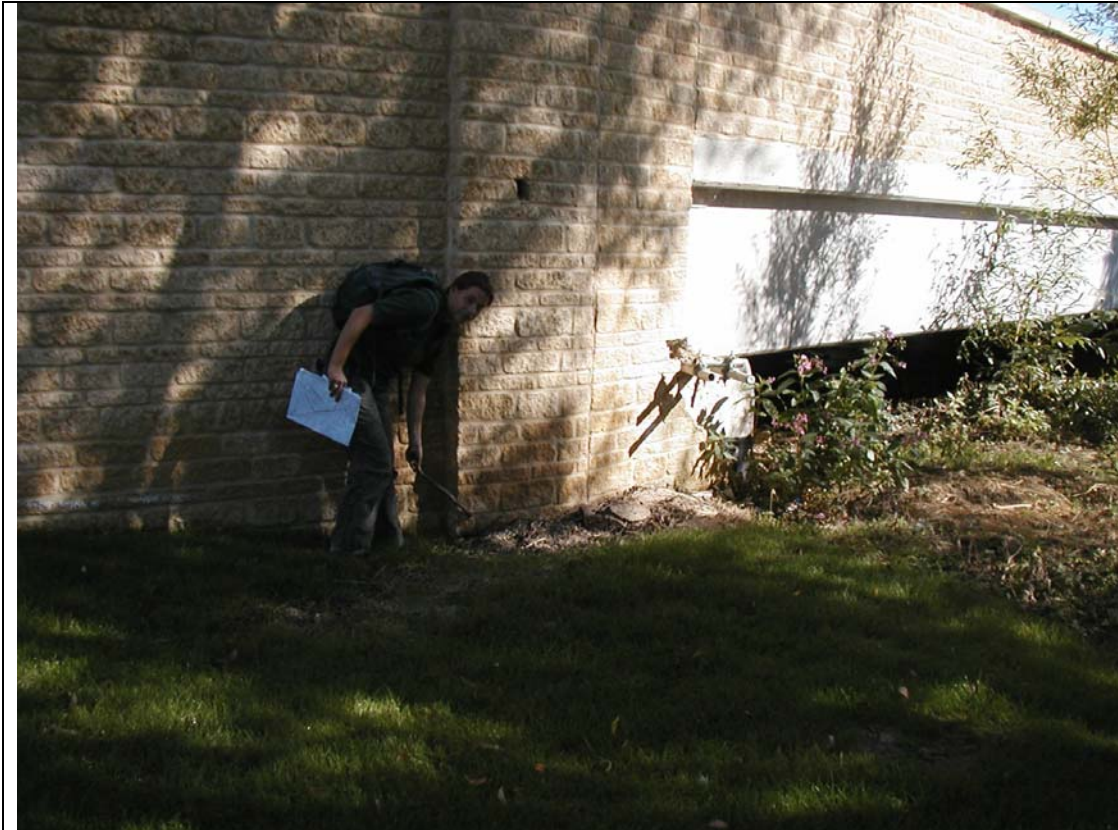
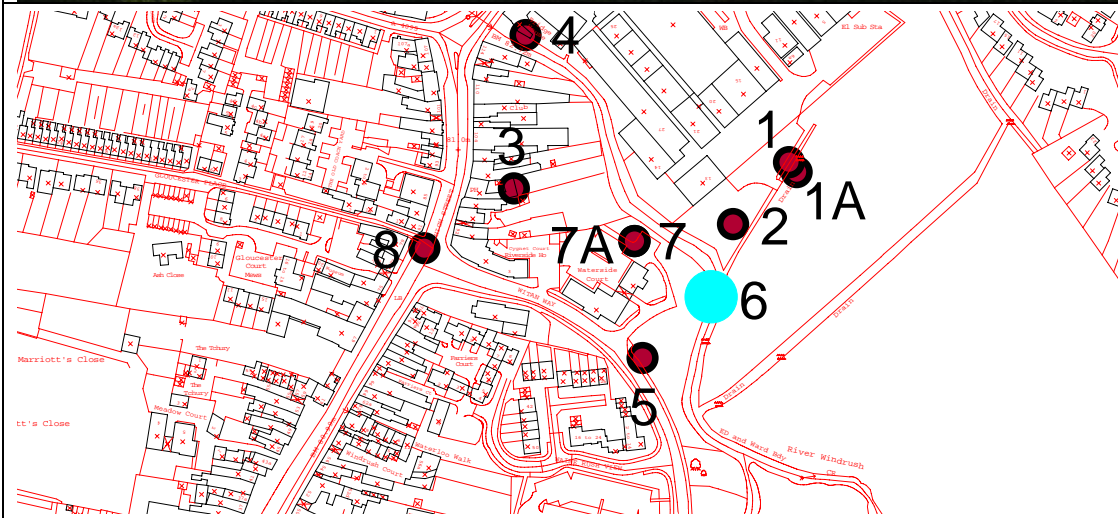
| Ref Number | 6 | | |

| Level | 80.090m OD | | |
| Photo Ref | MM1 - d_s right Aquarius Access Bridge | | |
| Flood Extent (Y/N) | N | | |

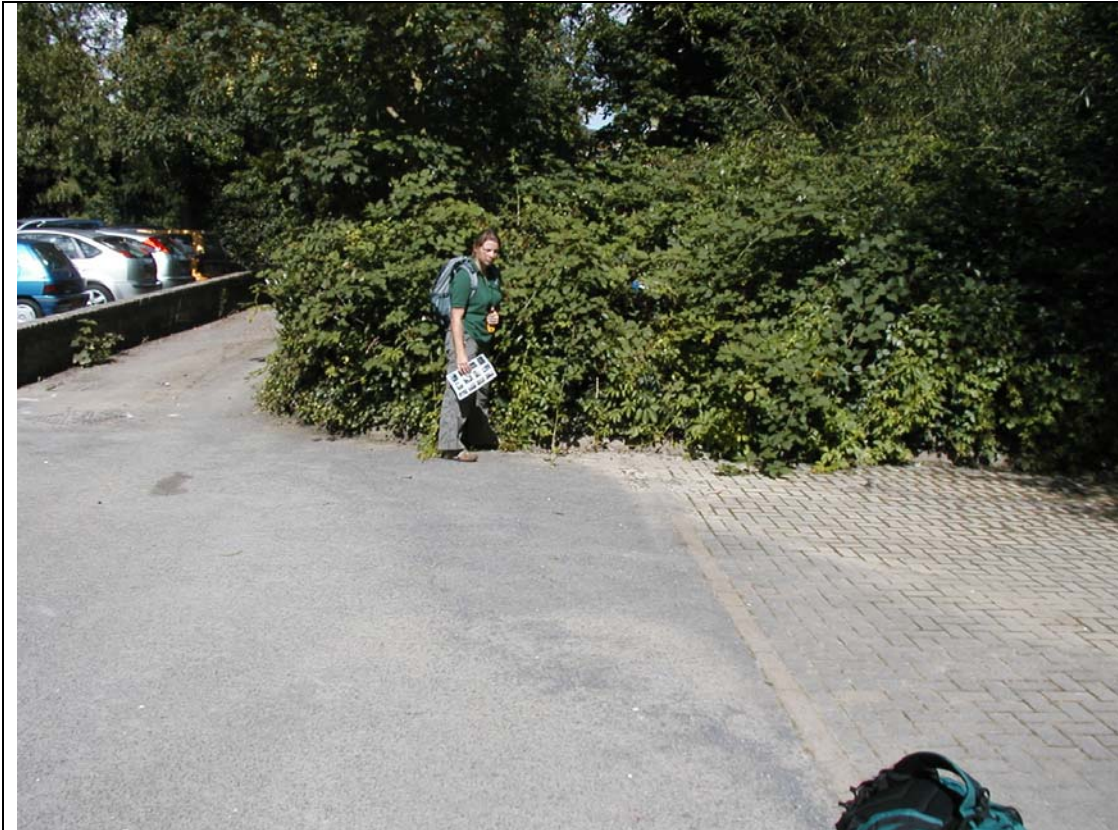
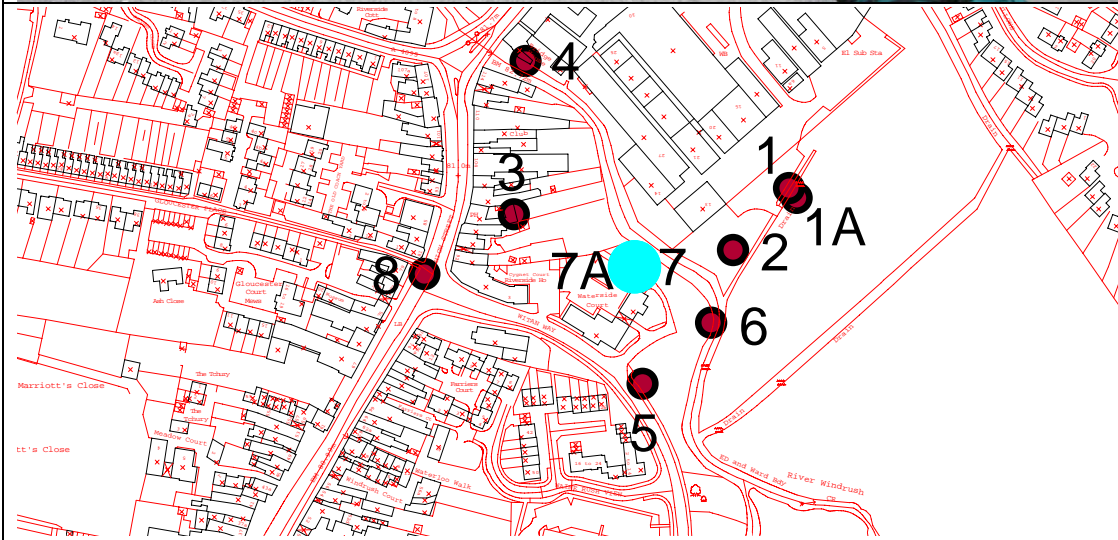
| Ref Number | 7 | | |

| Level | 80.080m OD | | |
| Photo Ref | MM8 - Parking behind Waterside Court | | |
| Flood Extent (Y/N) | Y | | |

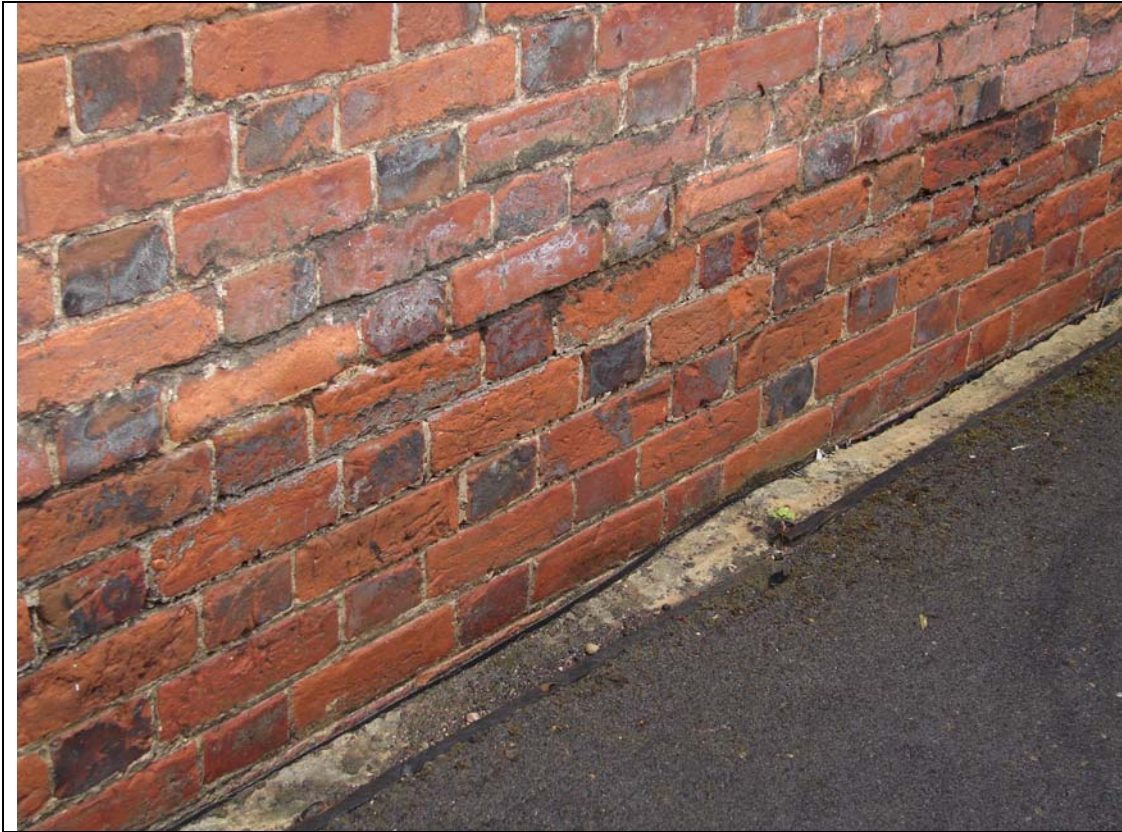
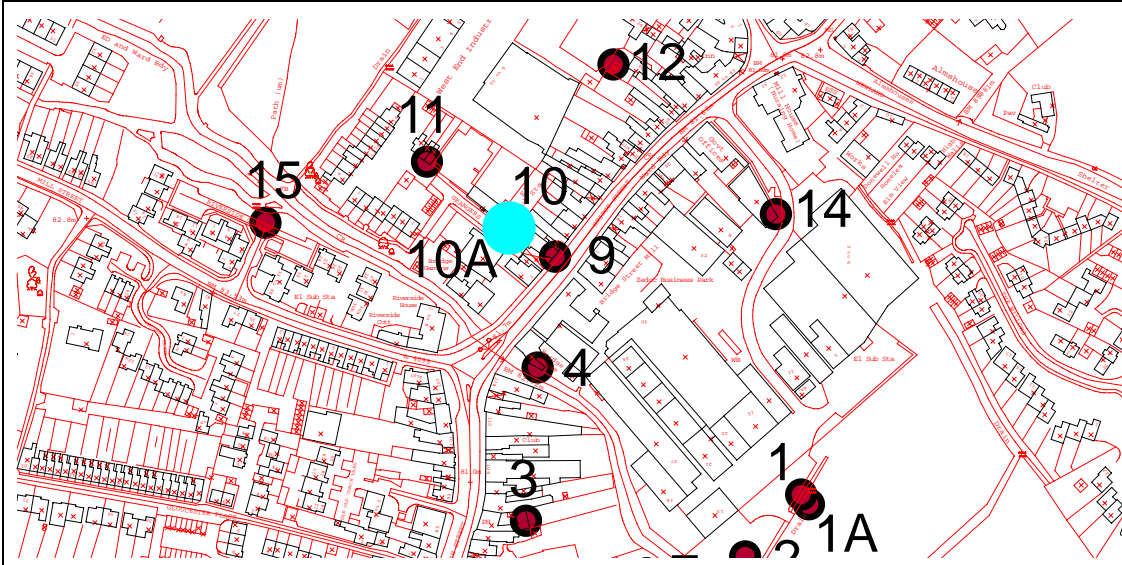
| Ref Number | 10 | | | |

| Job No. | 9383 | | | Not clear if this is actually a flood level. |
| Level | 81.730m OD | | | |
| Top of wet mark surveyed | | | | |
| Flood Extent (Y/N) | N | | | |

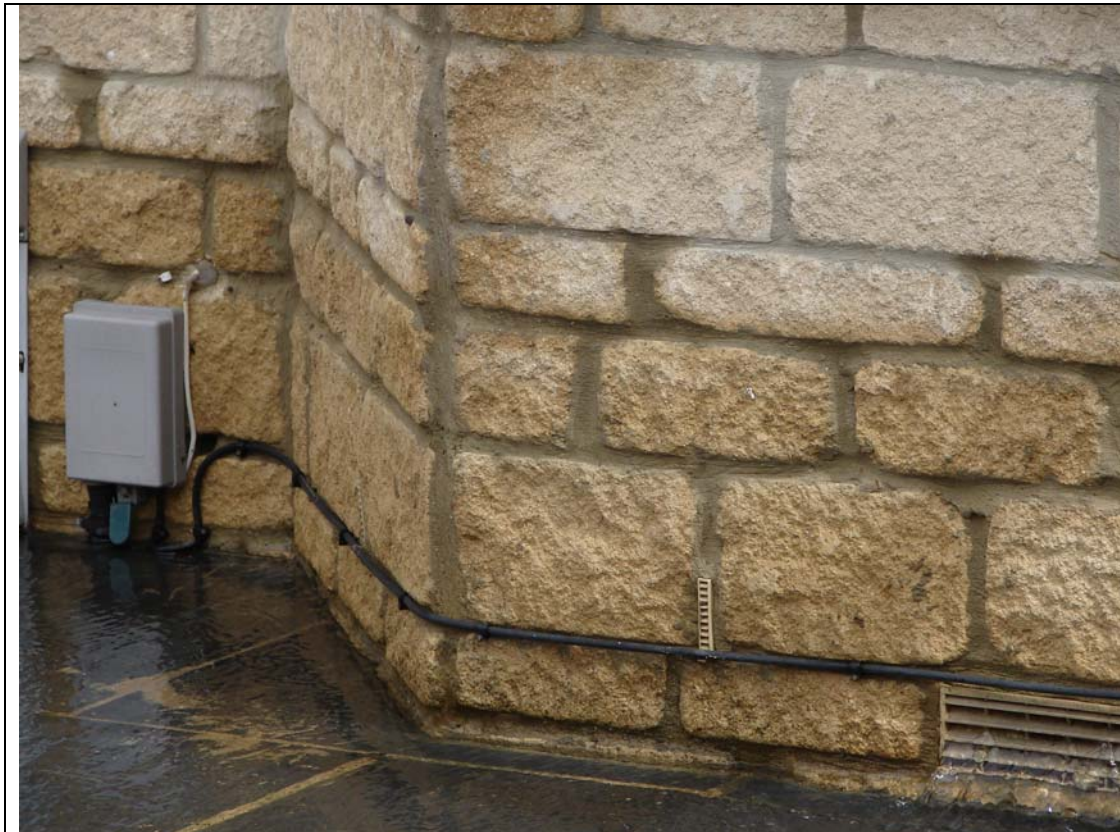
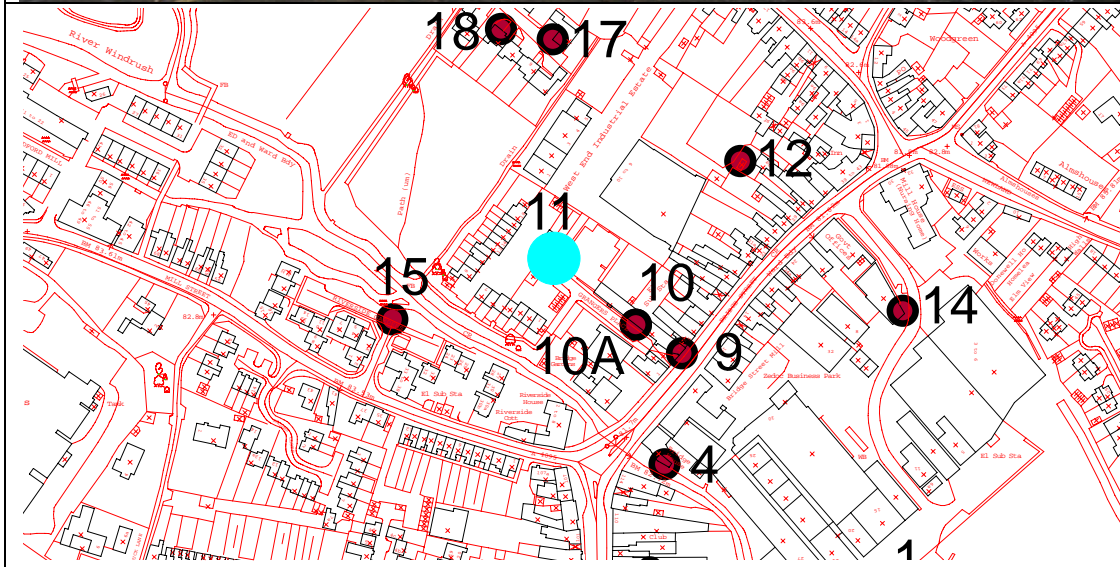
| Ref Number | 11 | | |

| Level | 81.840m OD | | |
| Flood Extent (Y/N) | N | | |

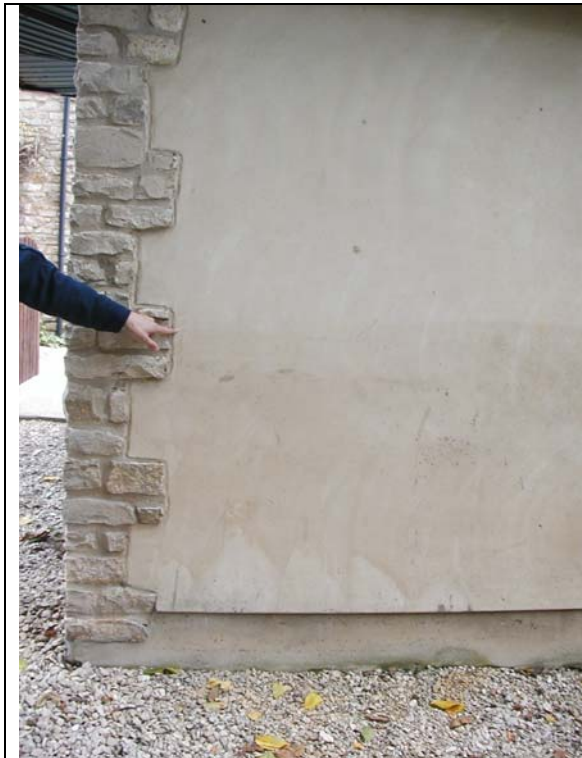
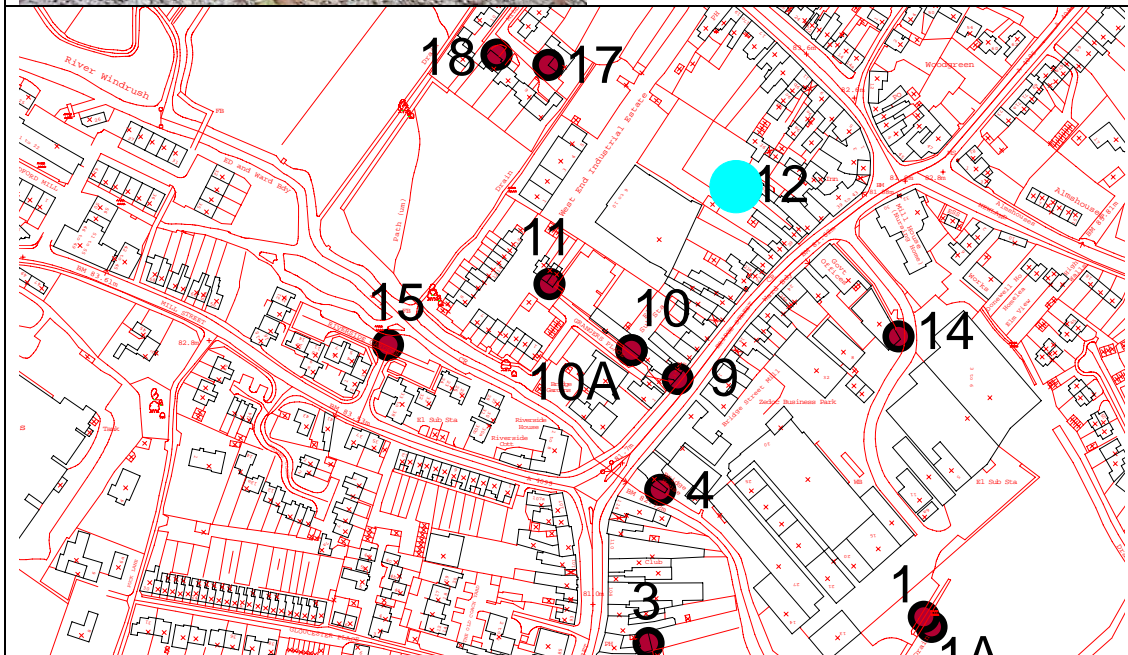
| Ref Number | 12 | | |

| Level | 82.060m OD | | |
| Photo Ref | MM15 - Garage 9g West End | | |
| Flood Extent (Y/N) | N | | |

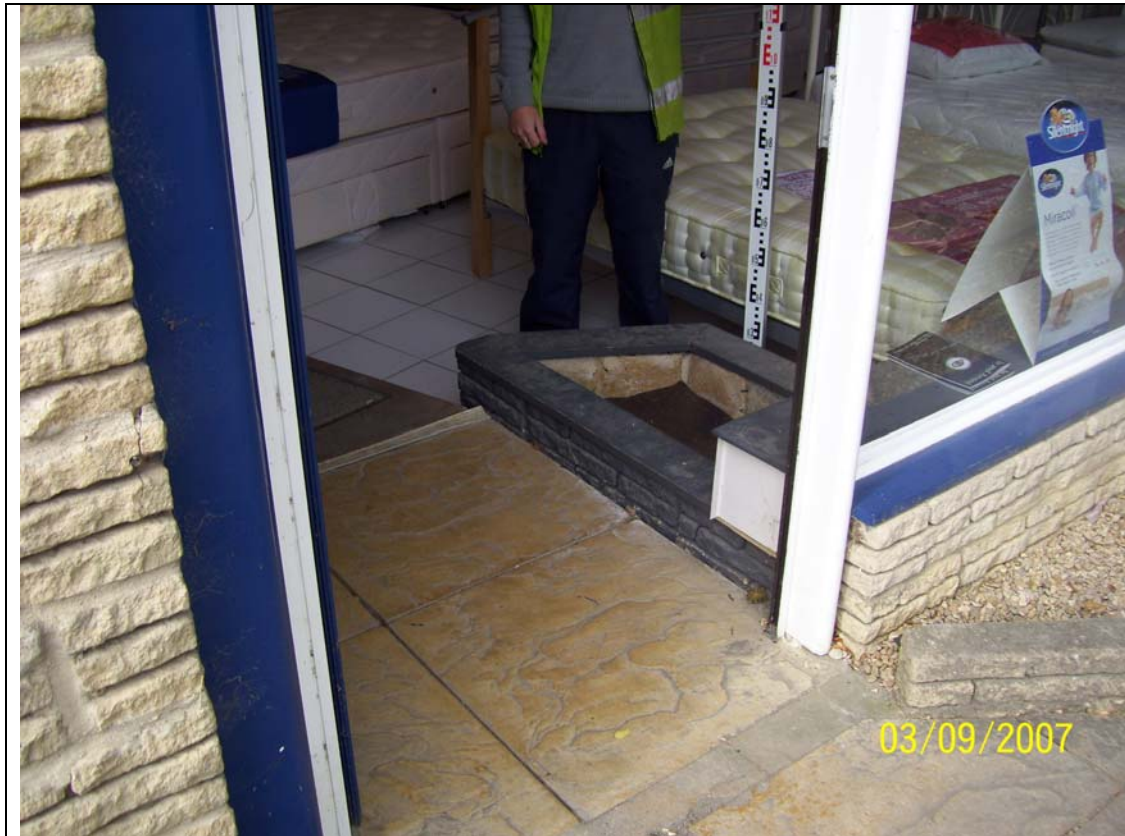
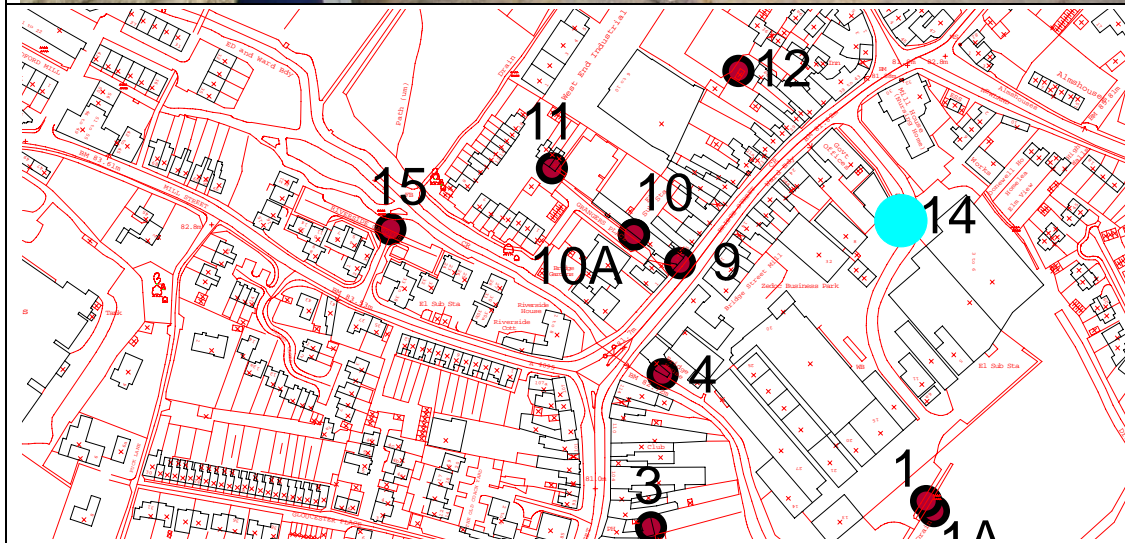
| Ref Number | 14 | | |

| Level | 81.200m OD | | |
| Building floor level = 80.60, THL = 80.80 | | | |
| Flood Extent (Y/N) | N | | |

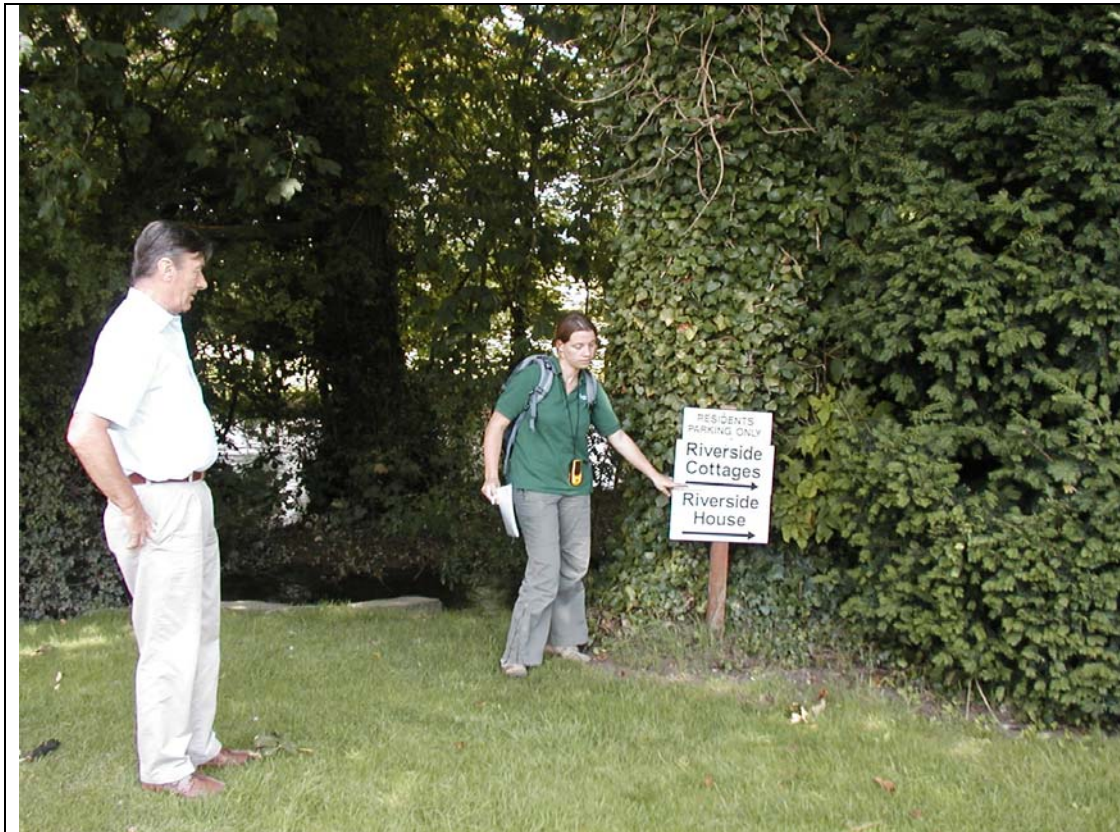
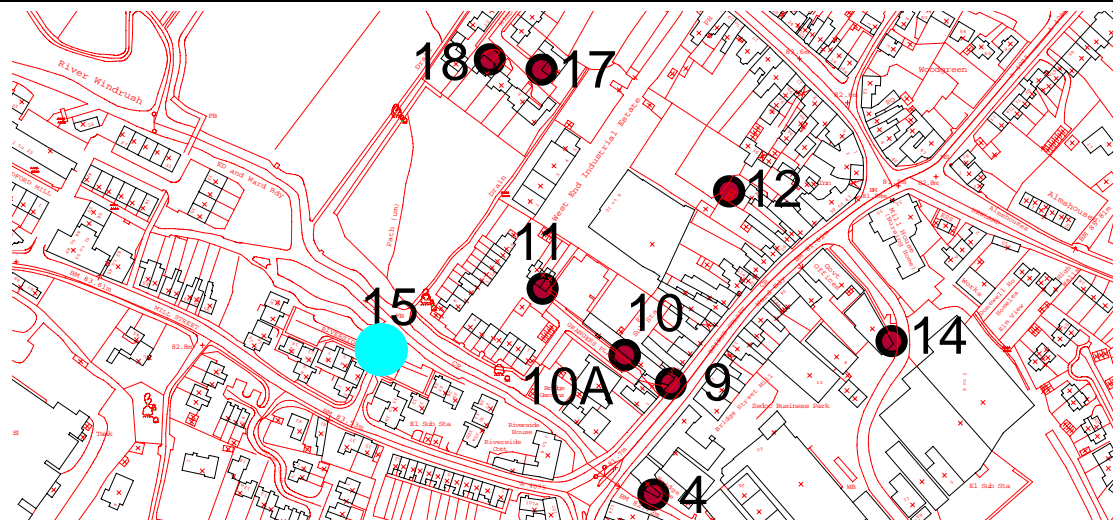
| Ref Number | 15 | | |

| Level | 82.060m OD | | |
| Photo Ref | MM12 - Sign in Riverside Gardens | | |
| Flood Extent (Y/N) | N | | |

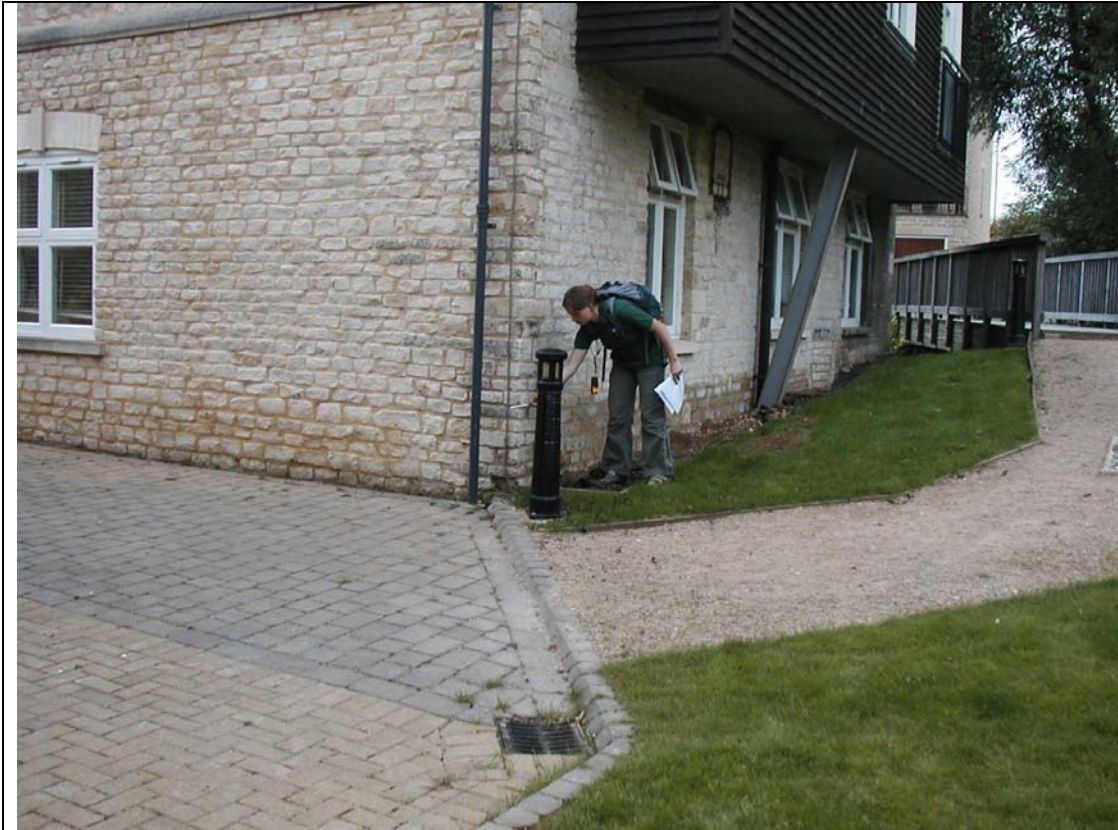
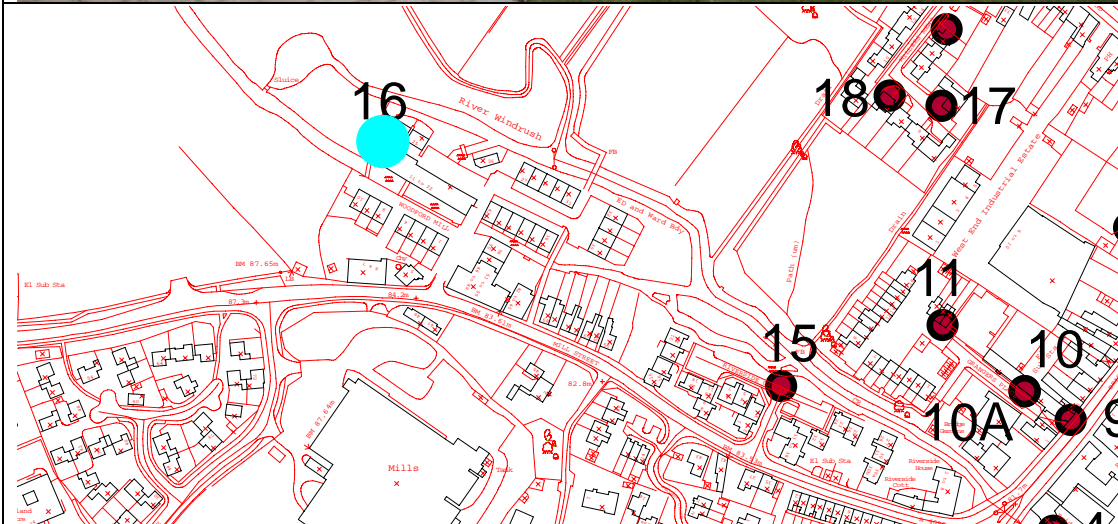
| Ref Number | 16 | | |

| Level | 82.220m OD | | |
| Photo Ref | MM11 - North corner 11-22 Woodford Mill | | |
| Flood Extent (Y/N) | N | | |

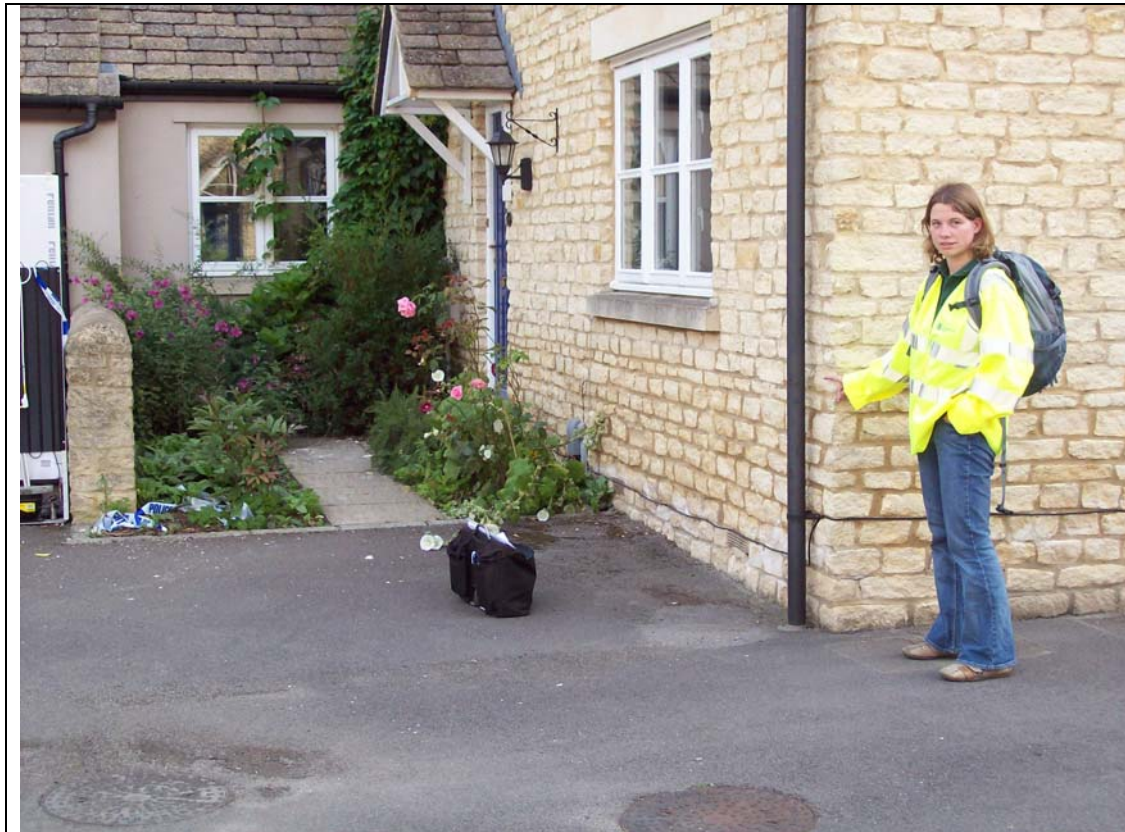
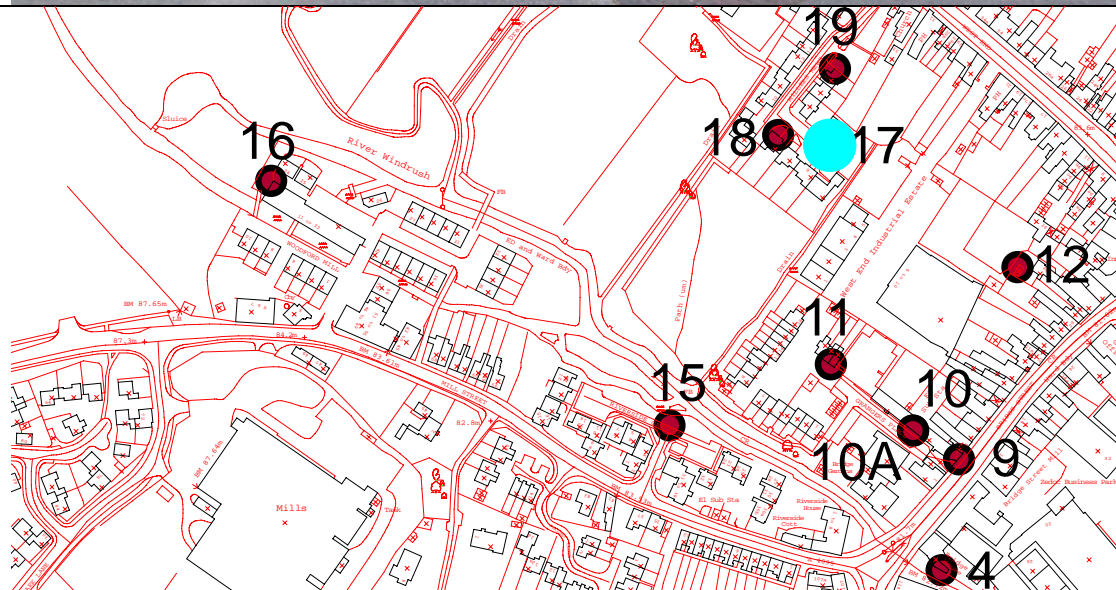
| Ref Number | 17 | | |

| Level | 82.140 m OD | | |
| Flood Extent (Y/N) | N | | |

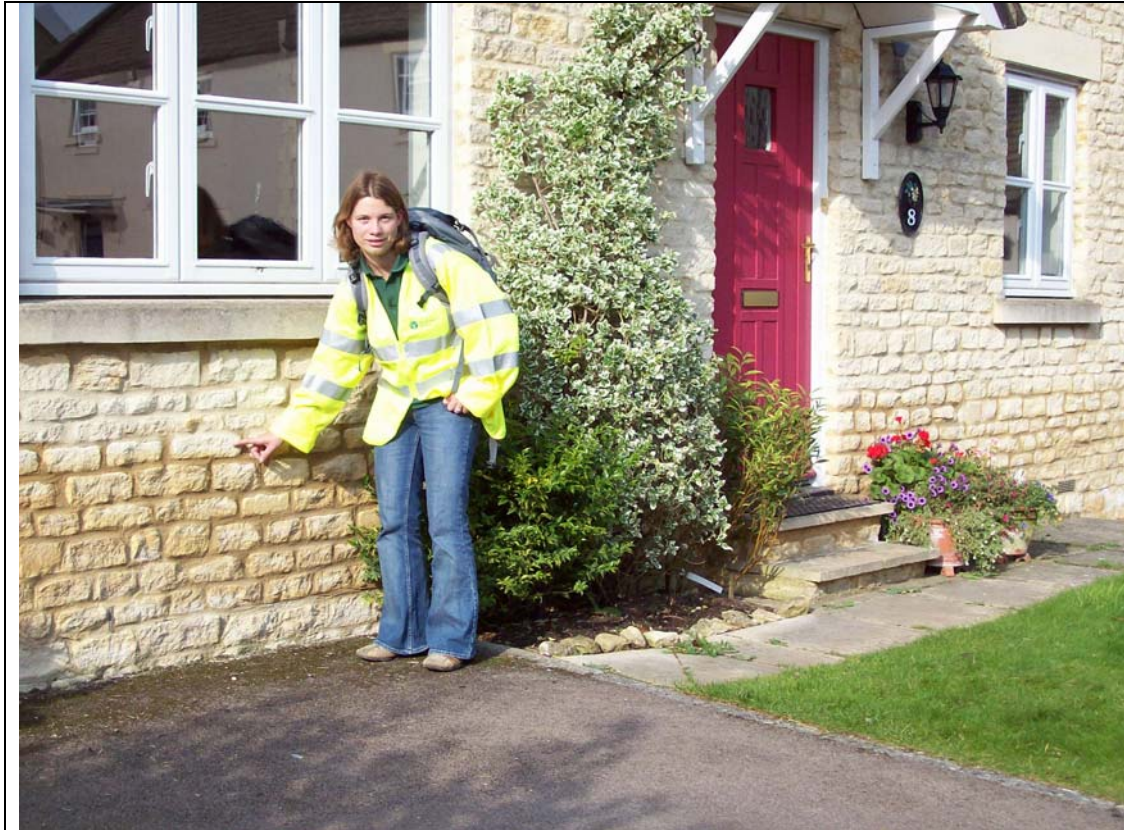
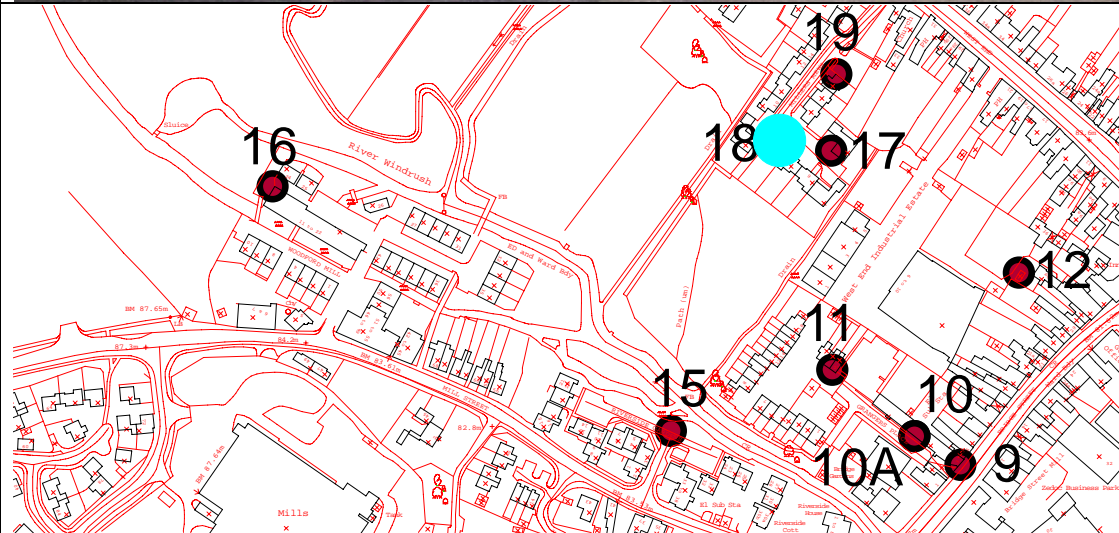
| Ref Number | 18 | | |

| Level | 82.140m OD | | |
| Flood Extent (Y/N) | N | | |
