July 2007 Flood – River Windrush at Witney – Flood Level Data Supplied by EA

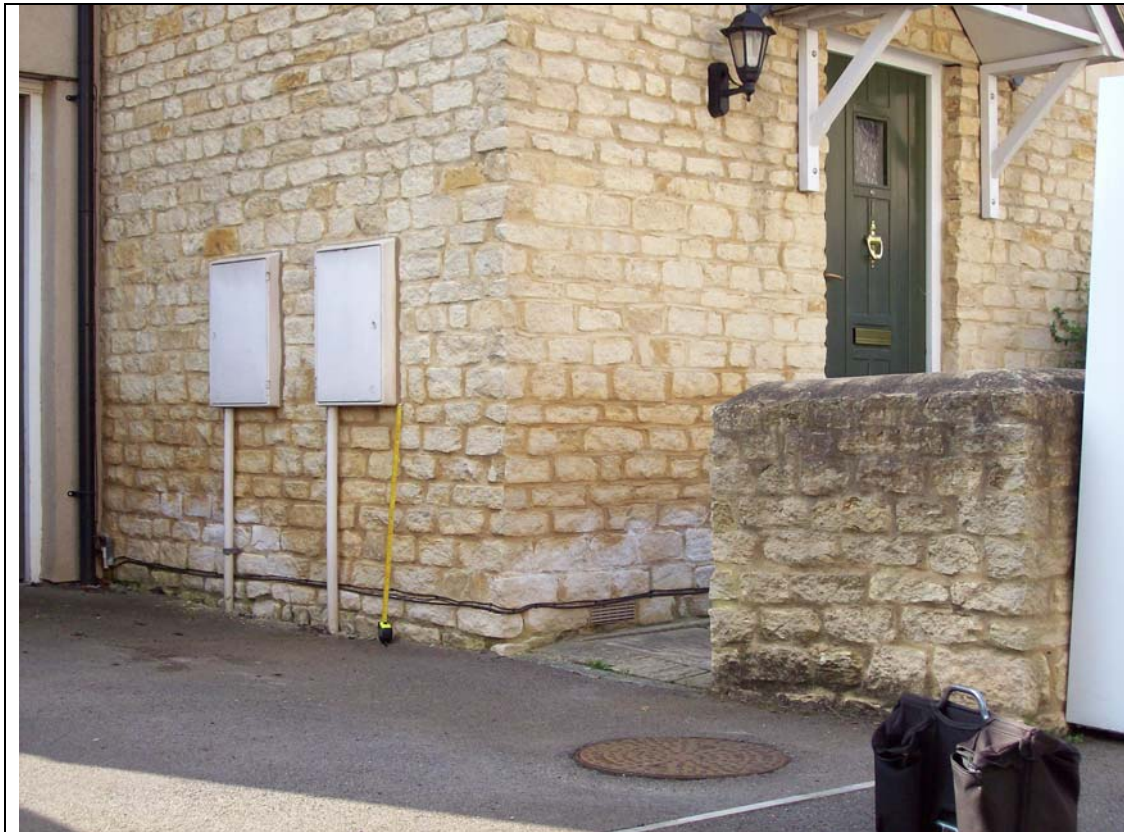
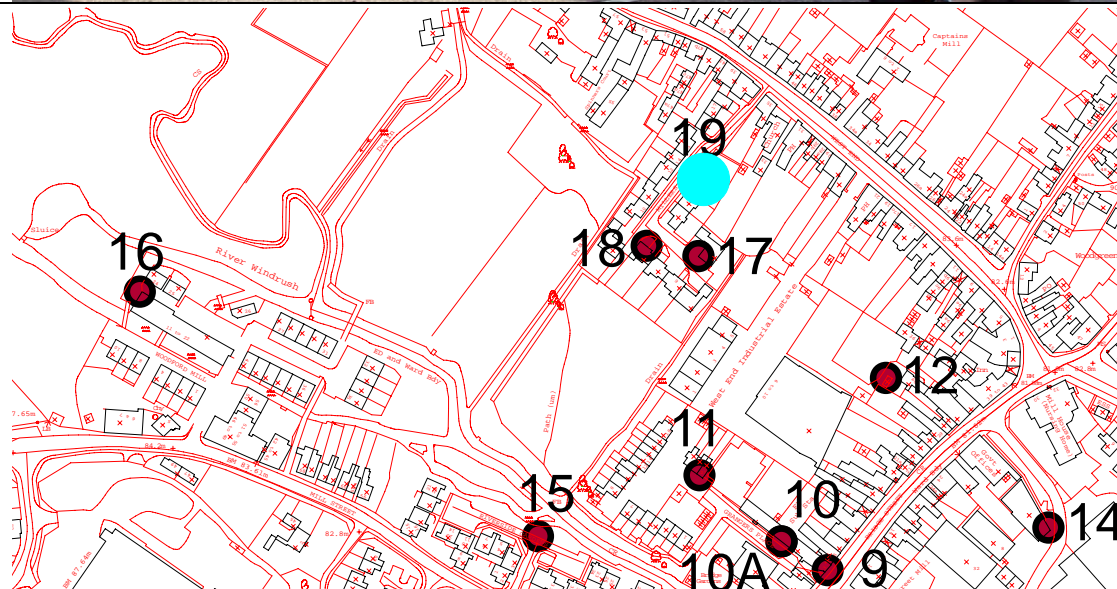
| Ref Number | 19 | | |

| Level | 82.080m OD | | |
| Flood Extent (Y/N) | N | | |

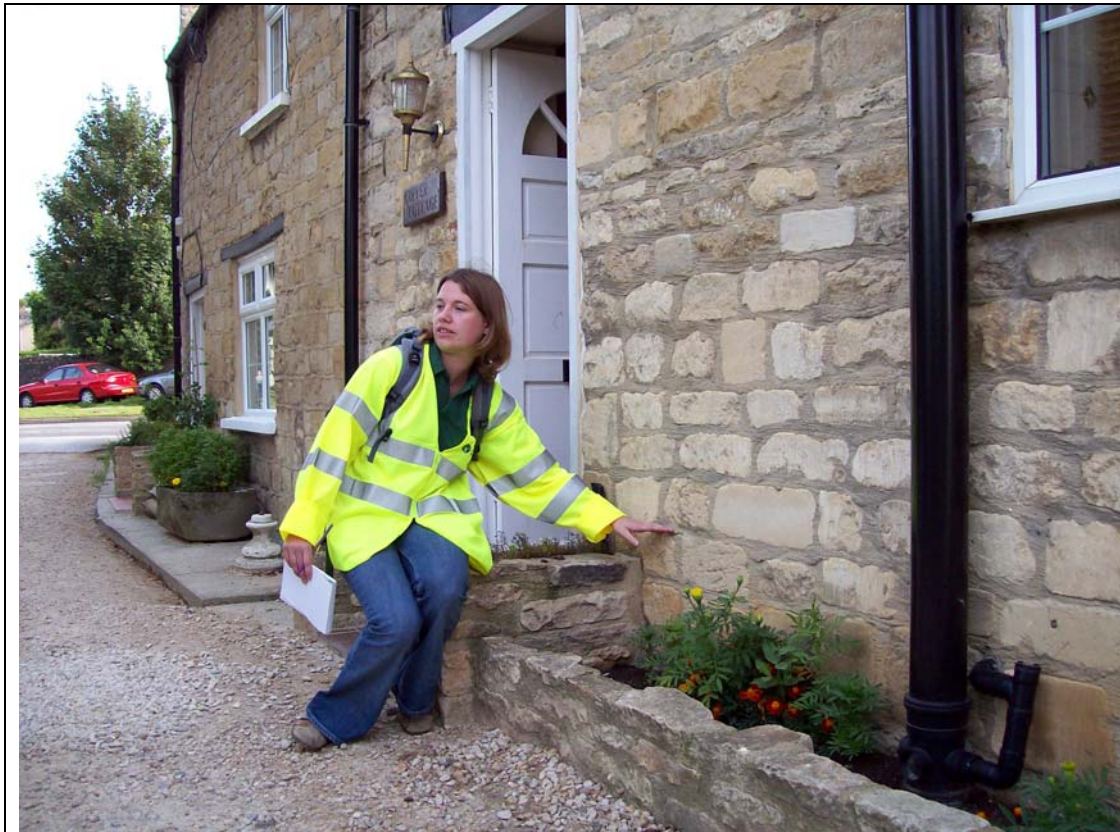
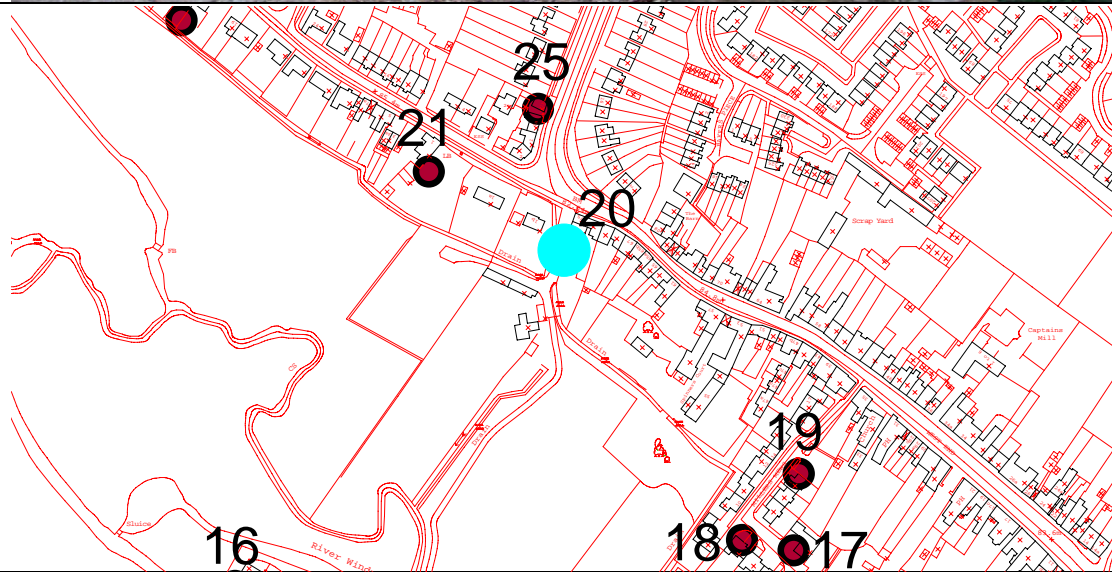
| Ref Number | 20 | | |

| Level | 82.370m OD | | |
| Flood Extent (Y/N) | N | | |

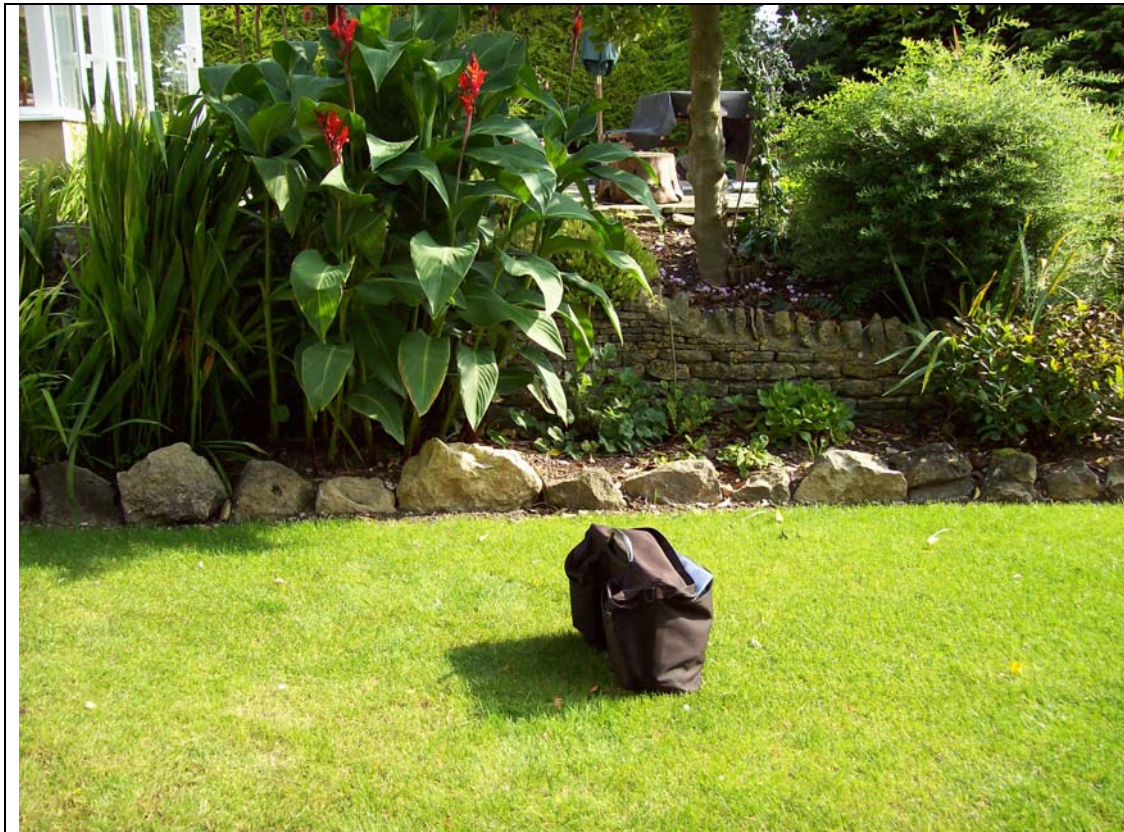
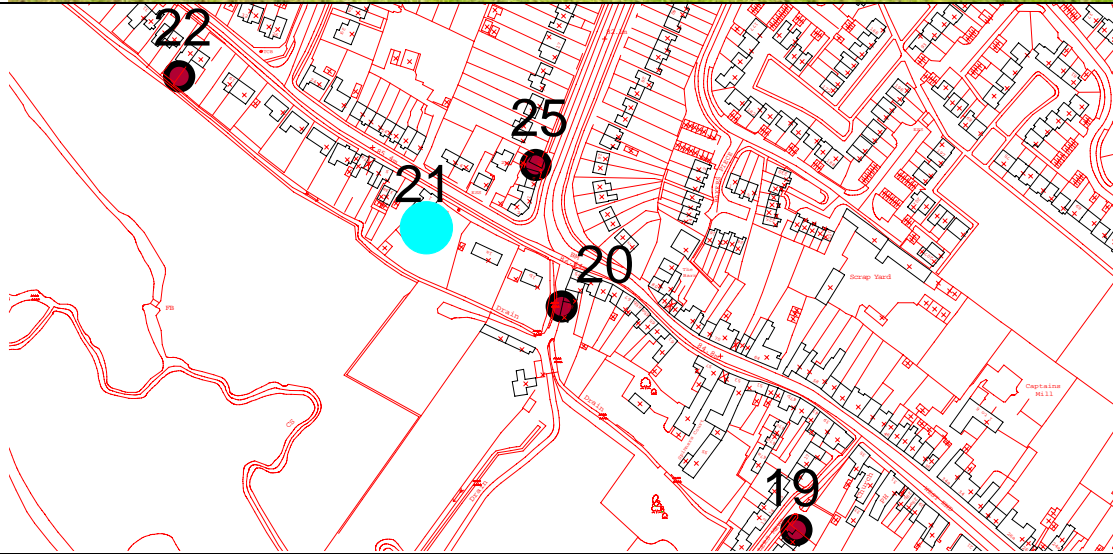
| Ref Number | 21 | | |

| Level | 82.060m OD | | |
| Flood Extent (Y/N) | Y | | |

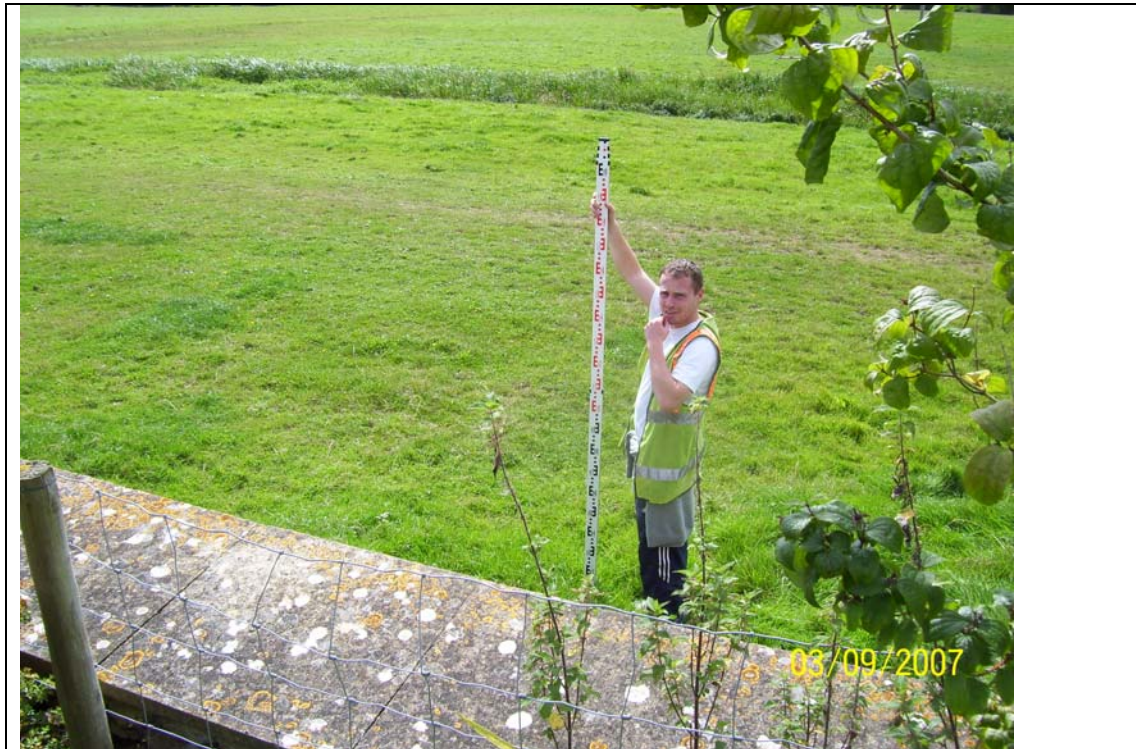
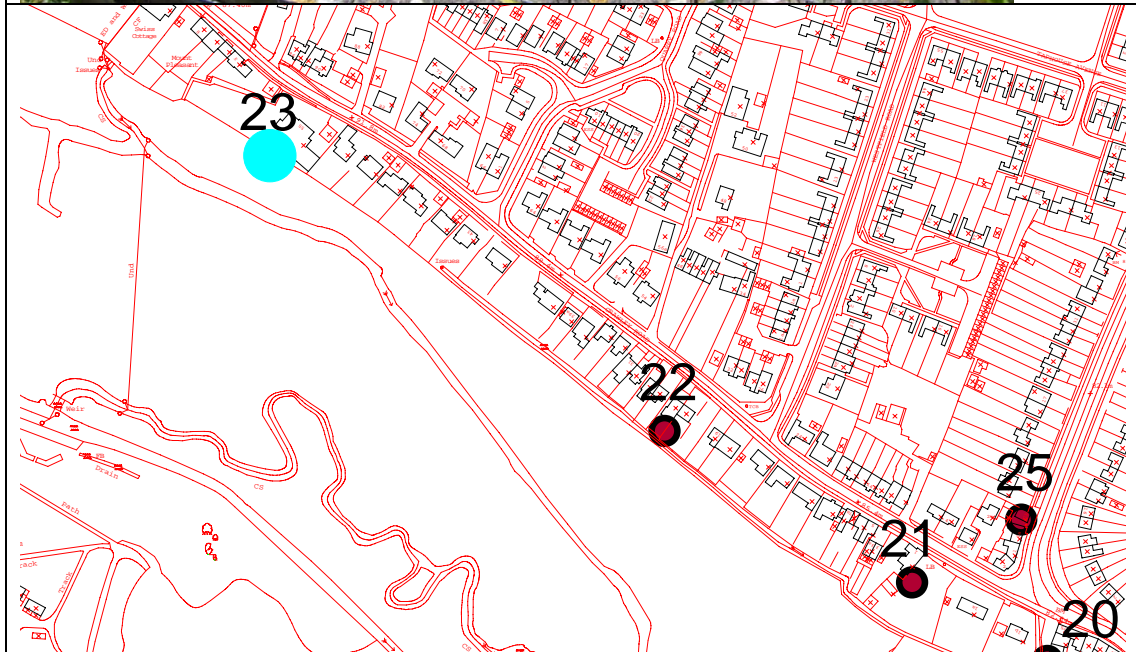
| Ref Number | 23 | | |

| Level | 82.520m OD | | |
| Ground level to be taken 1.5 - 2m from the base of wall | | | |
| Flood Extent (Y/N) | Y | | |

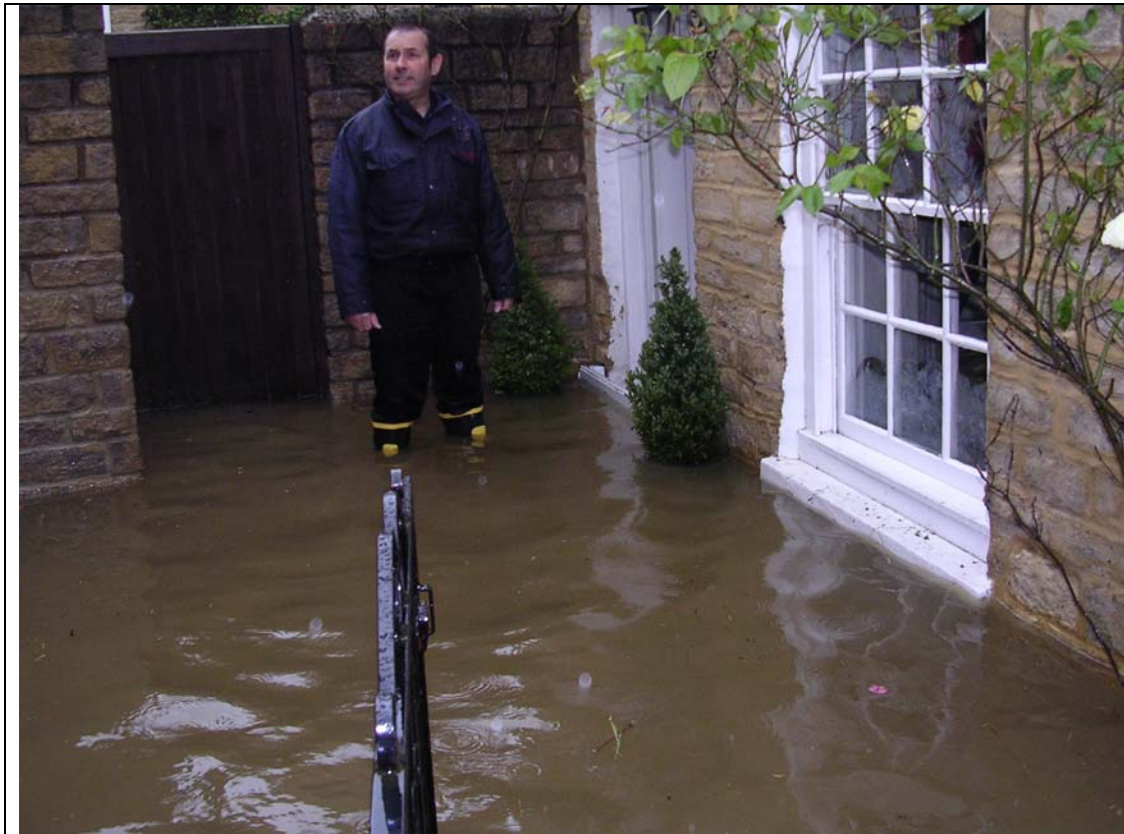
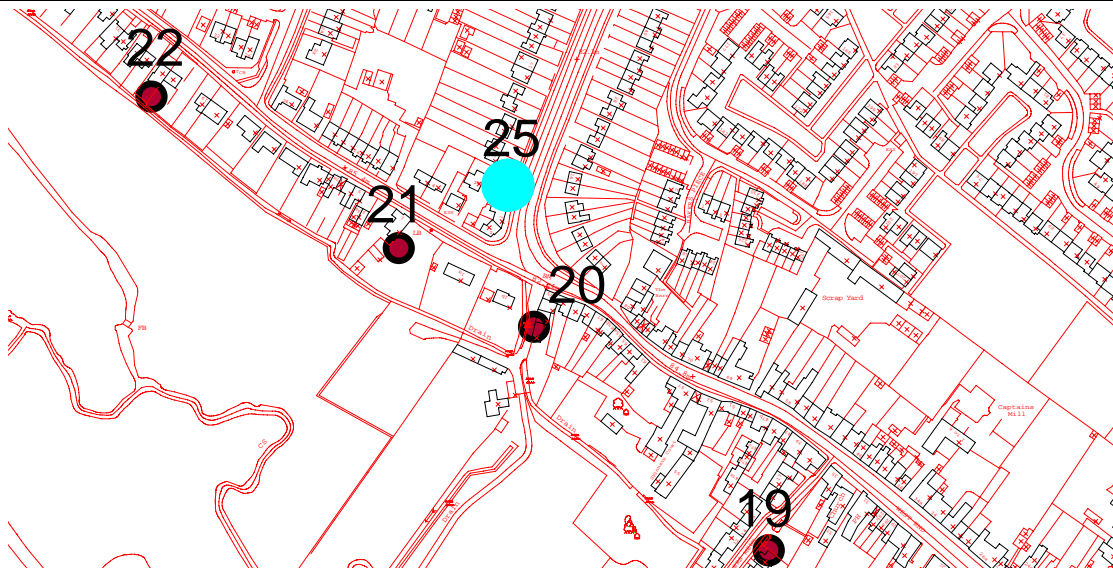
| Ref Number | 25 | | |

| Level | 82.420m OD | | |
| Flood Extent (Y/N) | N | | |

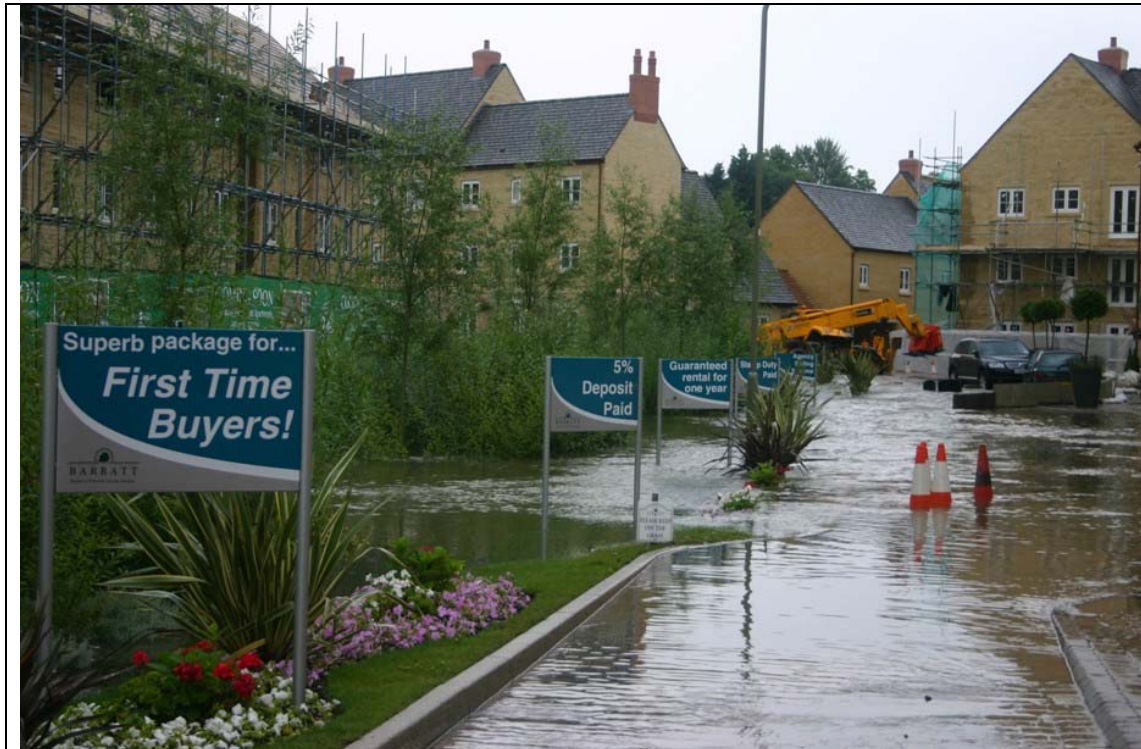
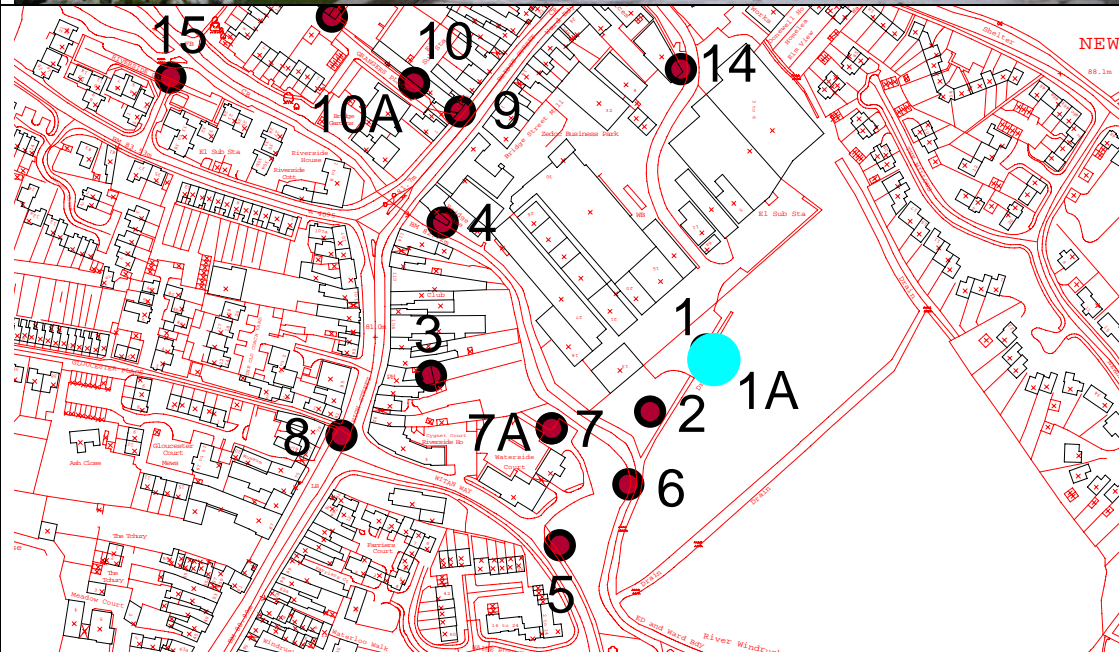
| Ref Number | 1A | |

| Job No. | 9383 | Is this the intended photo (used twice)? |
| Level | 80.720m OD | |
| Top of kerb | | |

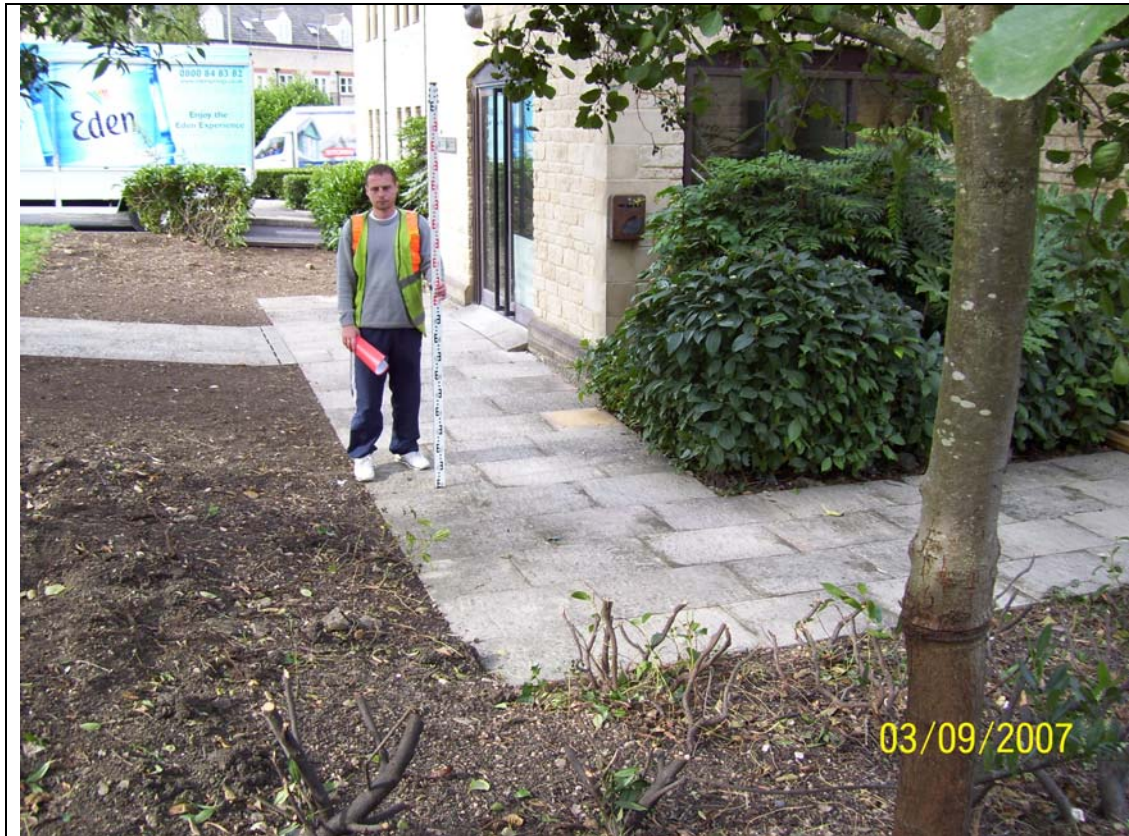
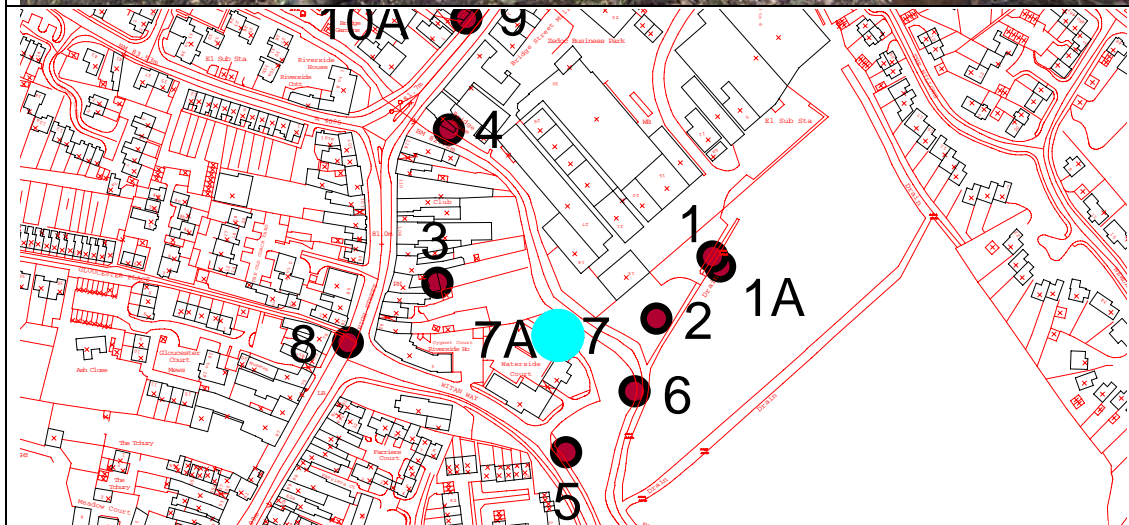
| Ref Number | 7A | | |

| Level | 80.760m OD | | |
| Path by Waterside Court as pointed out by builder | | | |
| Flood Extent (Y/N) | Y | | |
